**Arboricultural Assessment
Report**

Bruny Island House of Whisky

**360 Lennon Road, North Bruny
7150, TAS**

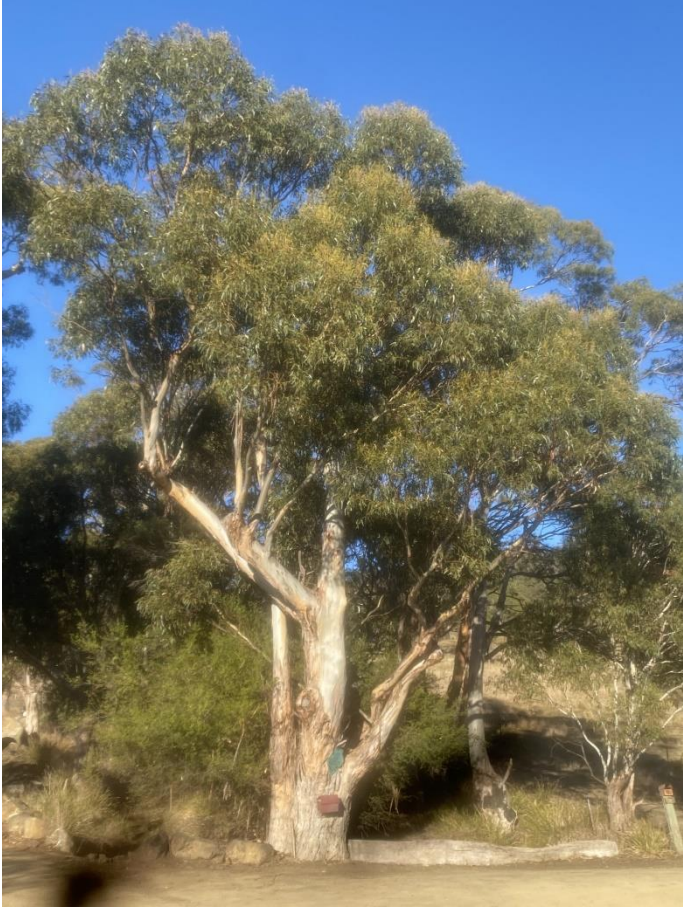
Tree 88

Tree ID	<i>Eucalyptus viminalis</i>
Common Name	White Gum
Age	Mature
Origin	Native
D.B.H	1.5m
Height	15m
Width	8m
Health	Fair
Structure	Fair
Retention Value	dry forest, any species >70 cm DBH & <i>E. viminalis</i> >25 cm DBH
Risk	Acceptable
Comments: <ul style="list-style-type: none"> • Tree has been reduced previously • Wooden logs around base can be move out to protect more area around trees • Tree next to creek, potentially sourcing everything from there

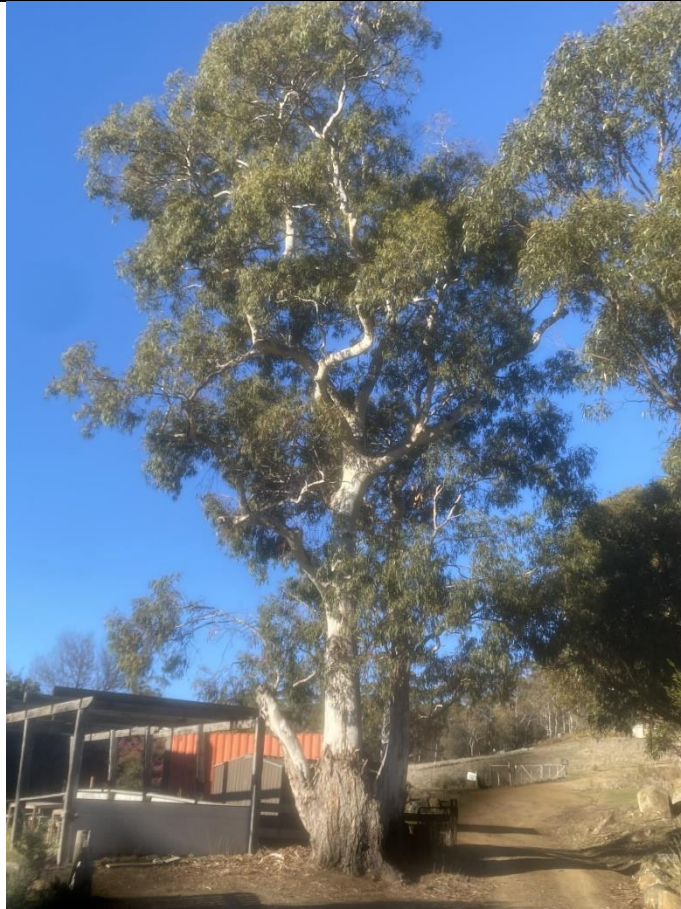
Tree 89

Tree ID	<i>Eucalyptus globulus</i>
Common Name	Tasmanian Blue Gum
Age	Mature
Origin	Native
D.B.H	1.78m
Height	16m
Width	8m
Health	Fair
Structure	Fair
Retention Value	dry forest, any species >70 cm DBH
Risk	Acceptable

- Bracket fungus on the Southern stem
- Branches extending over outdoor area
- Room around base to excluded for mulch and protect tree
- Good view of existing roadway. Increase profile to help with compaction.

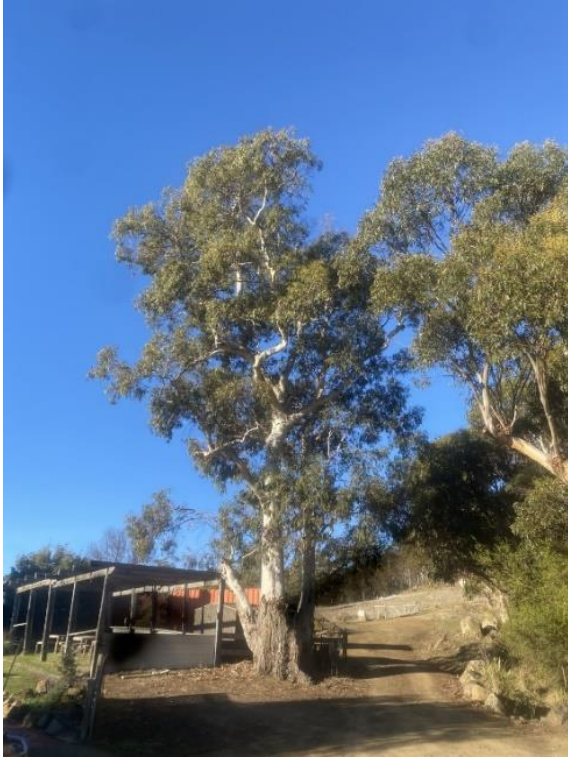
Figure 2. Image of entrance and Tree 88.

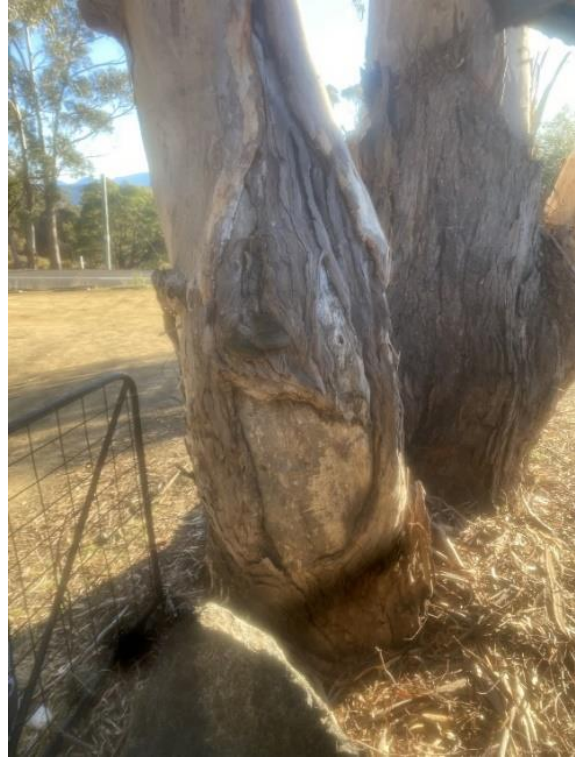
Figure 3. Image of Southern stem of tree 88.
Minor weight reduction recommended.

- Deadwood prune Tree 88 and 89 to give a baseline for the tree health into the future.
- Minor weight reduction pruning of Tree 88, Eucalyptus viminalis. This tree overhangs the grassed area. Pruning at the discretion of the arborist.
- Minor Pruning to tree 88 to give clearance for larger vehicles.
- All Pruning works to be carried out to development in line with Australian Standards 4373-2007 by a suitably qualified person, Certificate 3 in Arboriculture.
