GEO-ENVIRONMENTAL SOLUTIONS

LANDSLIDE RISK ASSESSMENT

Proposed Residential and Visitor Accommodation
4101 Channel Highway, Flowerpot

April 2021
Version 1.0

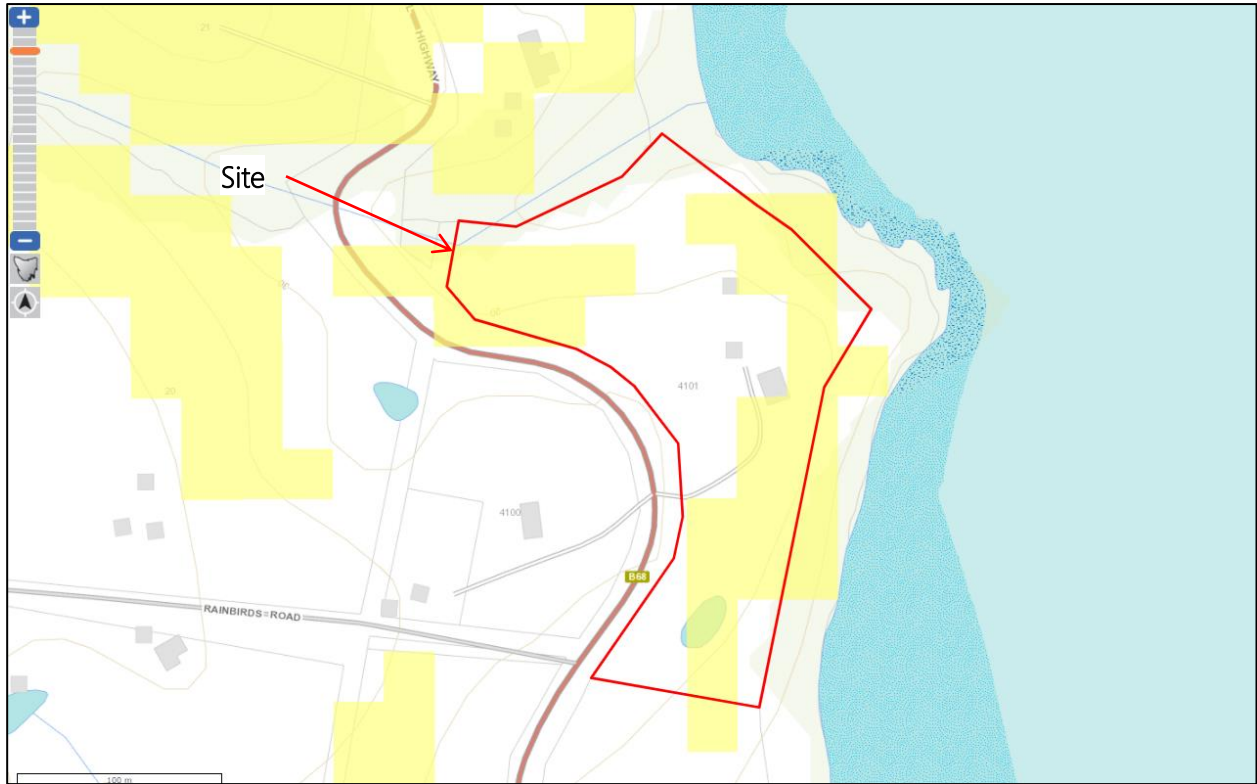
Figure 3 Interim Planning Scheme Landslide Hazard Area Overlay

Majority of the site falls within the Interim Planning Scheme (IPS) Low Landslide Hazard Area overlay (yellow = low) (Figure 3).

The proposed development does not meet E3.7.1 A1 and E3.7.3 A1 acceptable solutions as there are no acceptable solutions to “Buildings and Works, other than Minor Extensions” E3.7.1 A1 or “Major Works” (E3.7.3 A1). As such Performance Criteria E3.7.1 P1 and E3.7.3 P1 are required to be assessed.

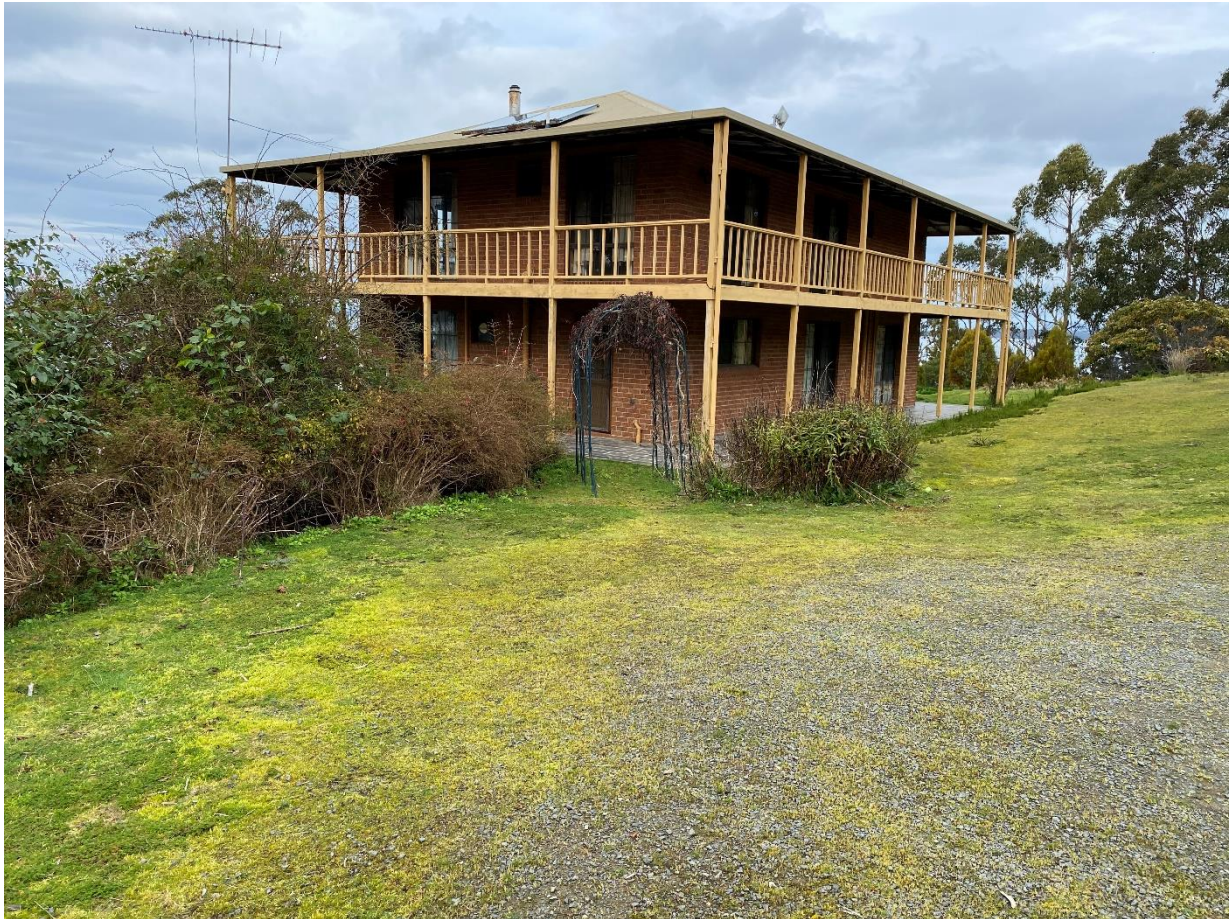
Figure 5 Looking SE at The existing dwelling.

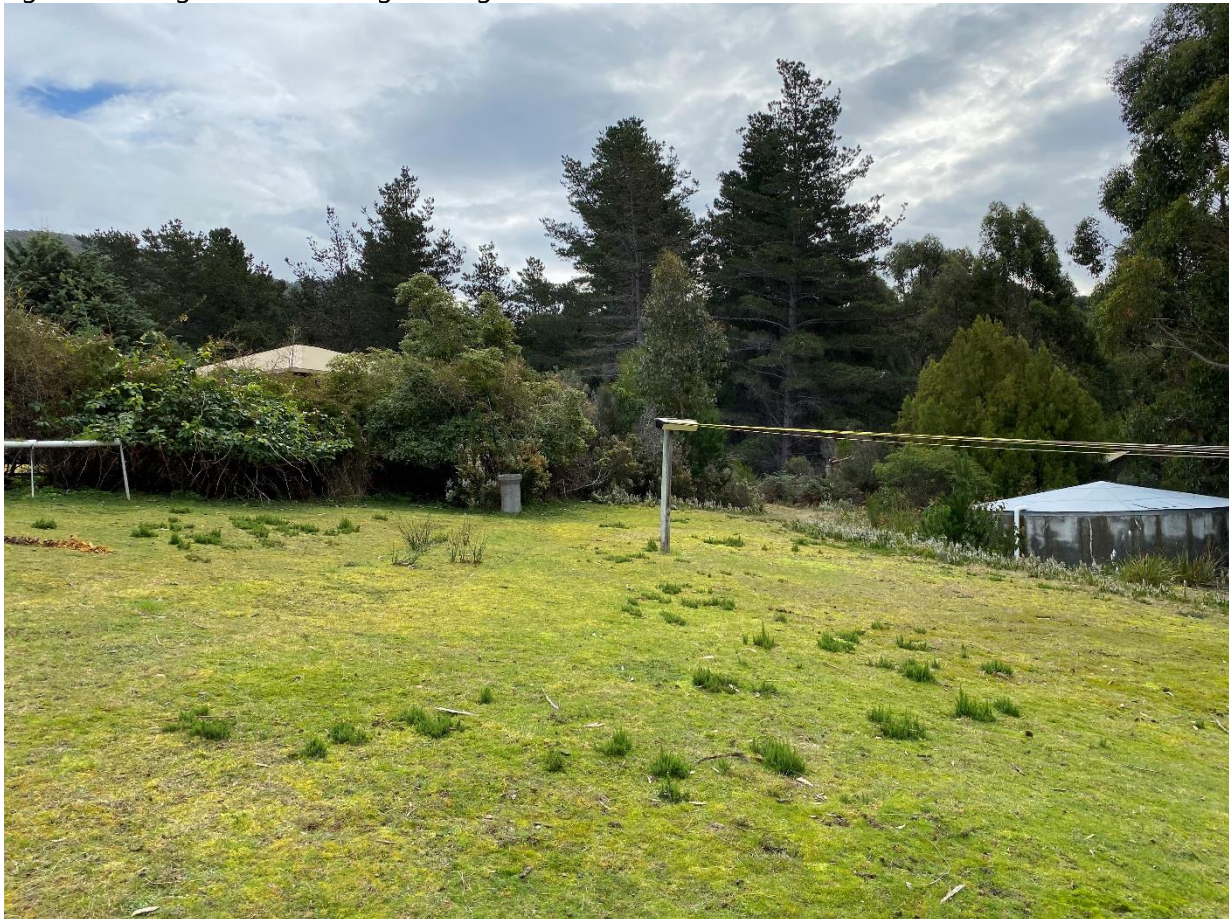
Figure 6 Looking N across site at the proposed sauna location.

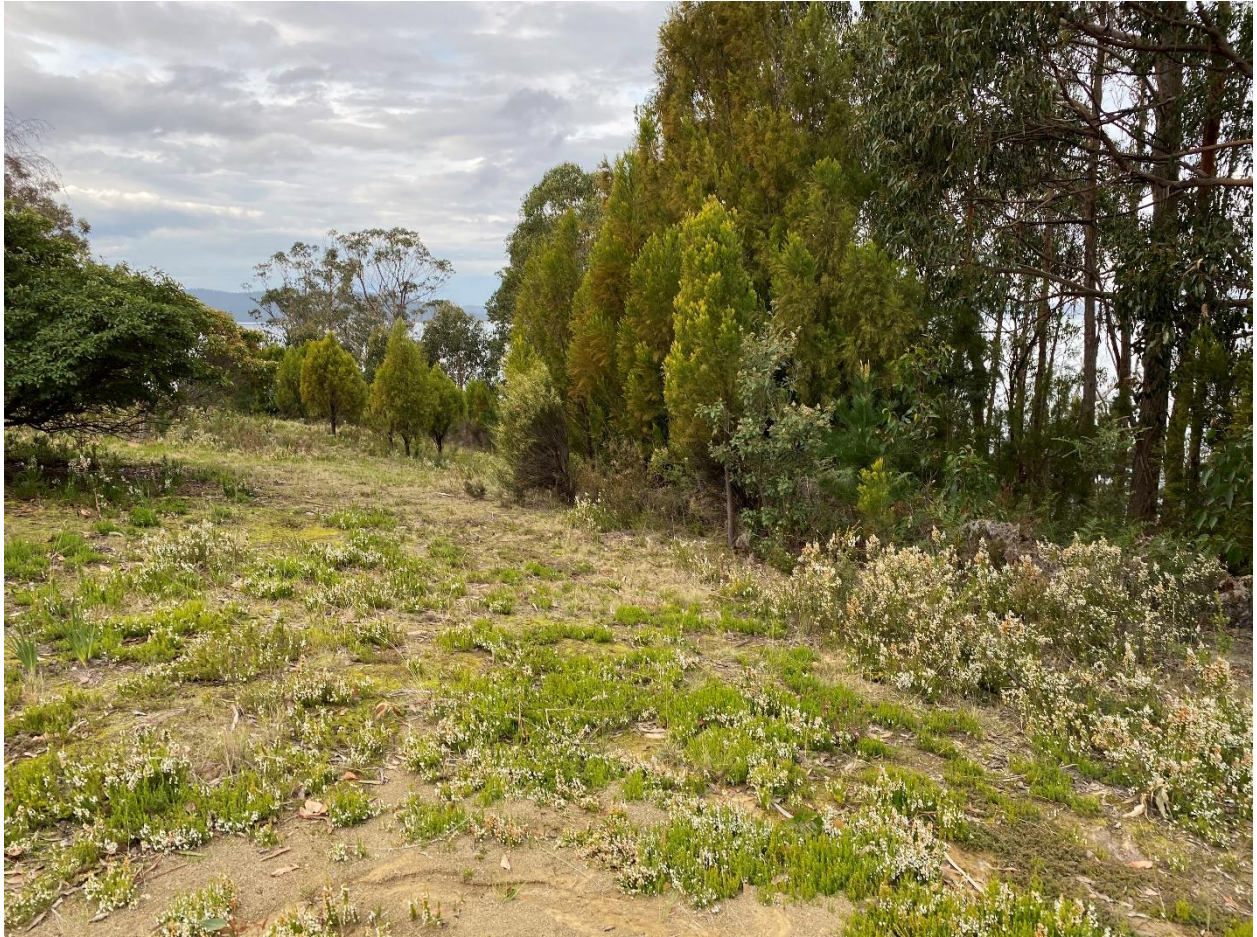
Figure 7 Looking NE across eastern part of the site.

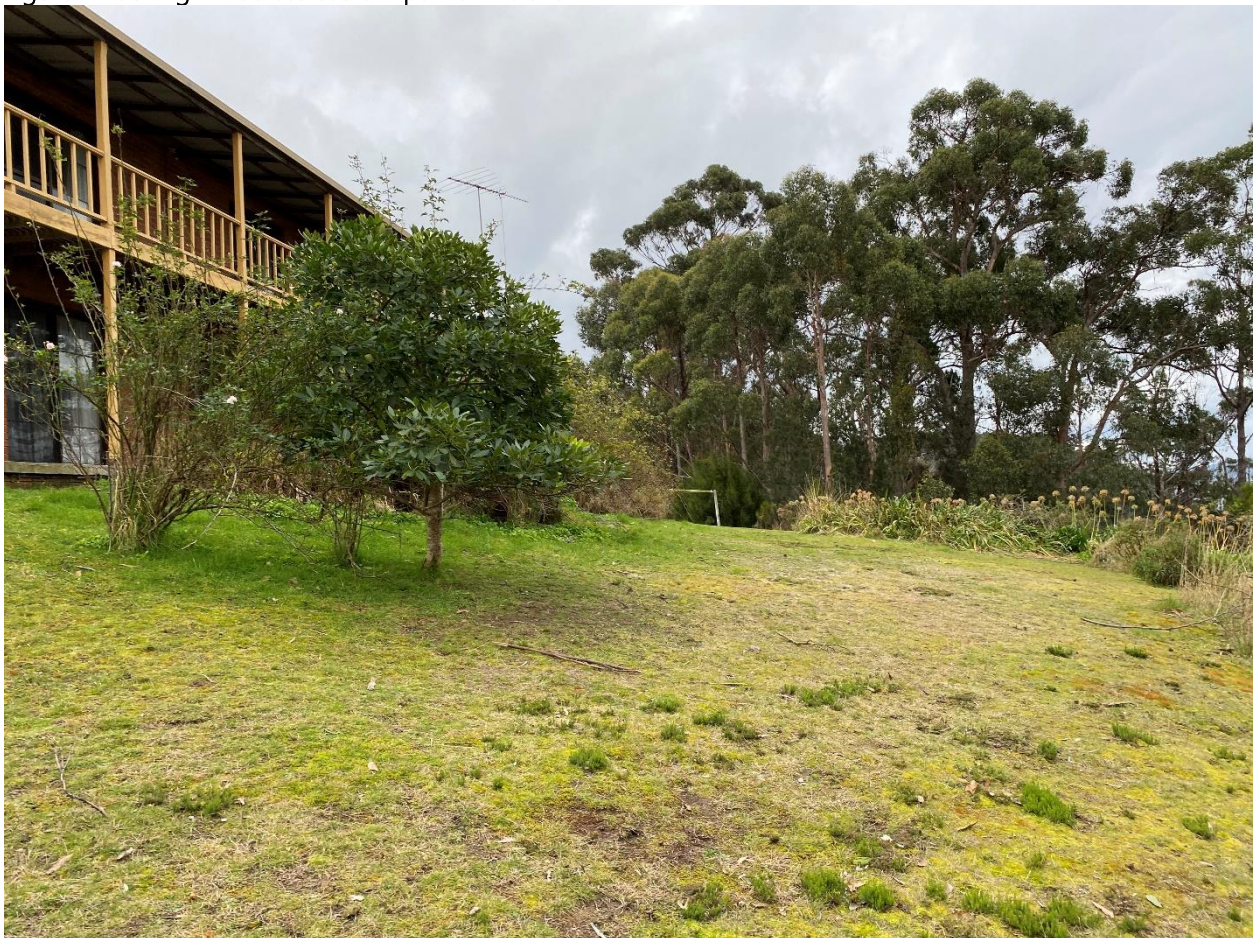
Figure 8 Looking N showing the site slopes immediately below the existing dwelling.

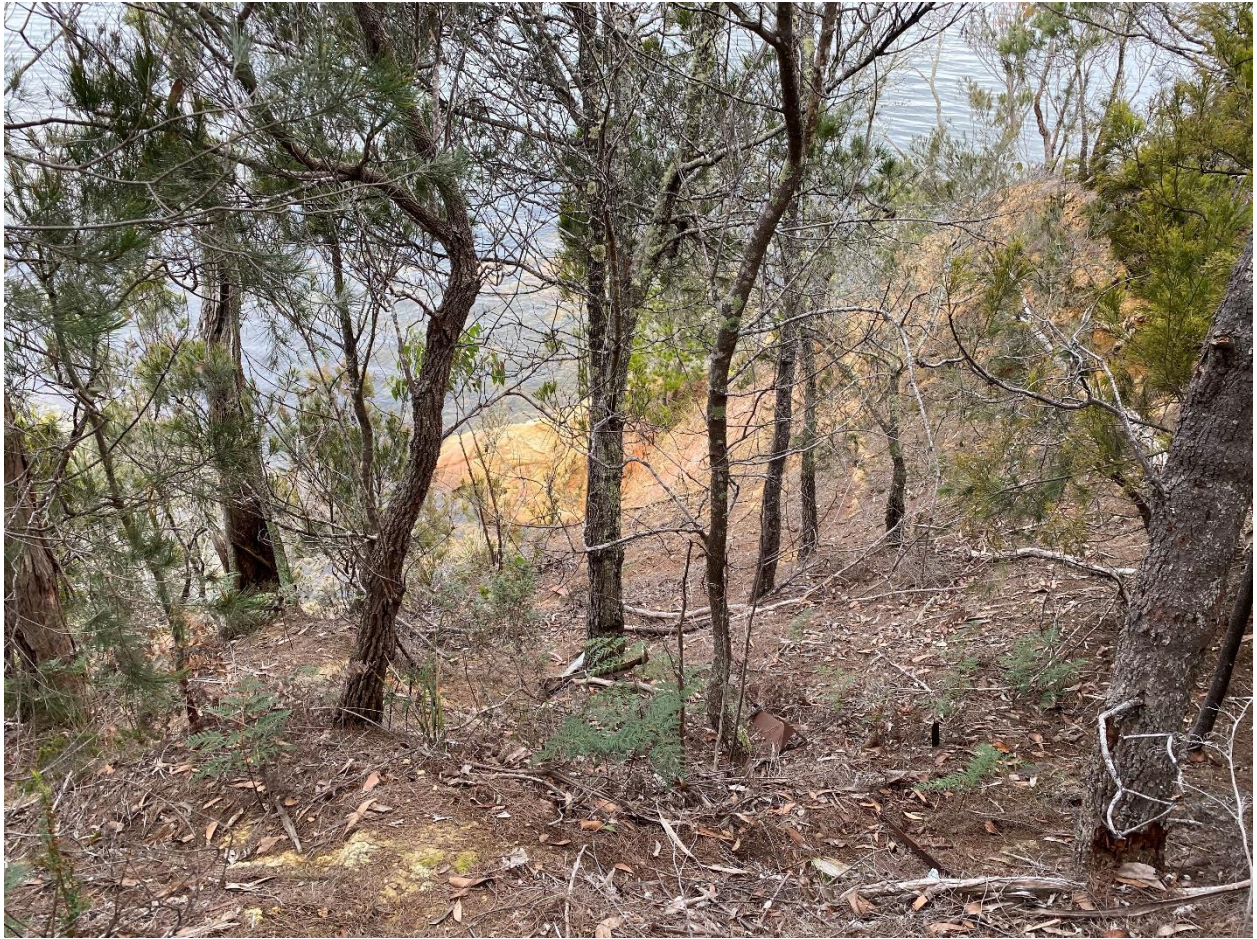
No historic slope instability has been noted near the proposed development. There is likely to be past evidence of instability on the southeast facing coastal cliff beyond the site boundary. However, this is far enough removed from the proposed development.

Figure 9 Looking SE down the coastal cliff.
