## **SITE AND SOIL EVALUATION REPORT** **LANDSLIDE ASSESSMENT REPORT**

**1886 Bruny Island Main Rd,**

**Great Bay**

**June 2026**

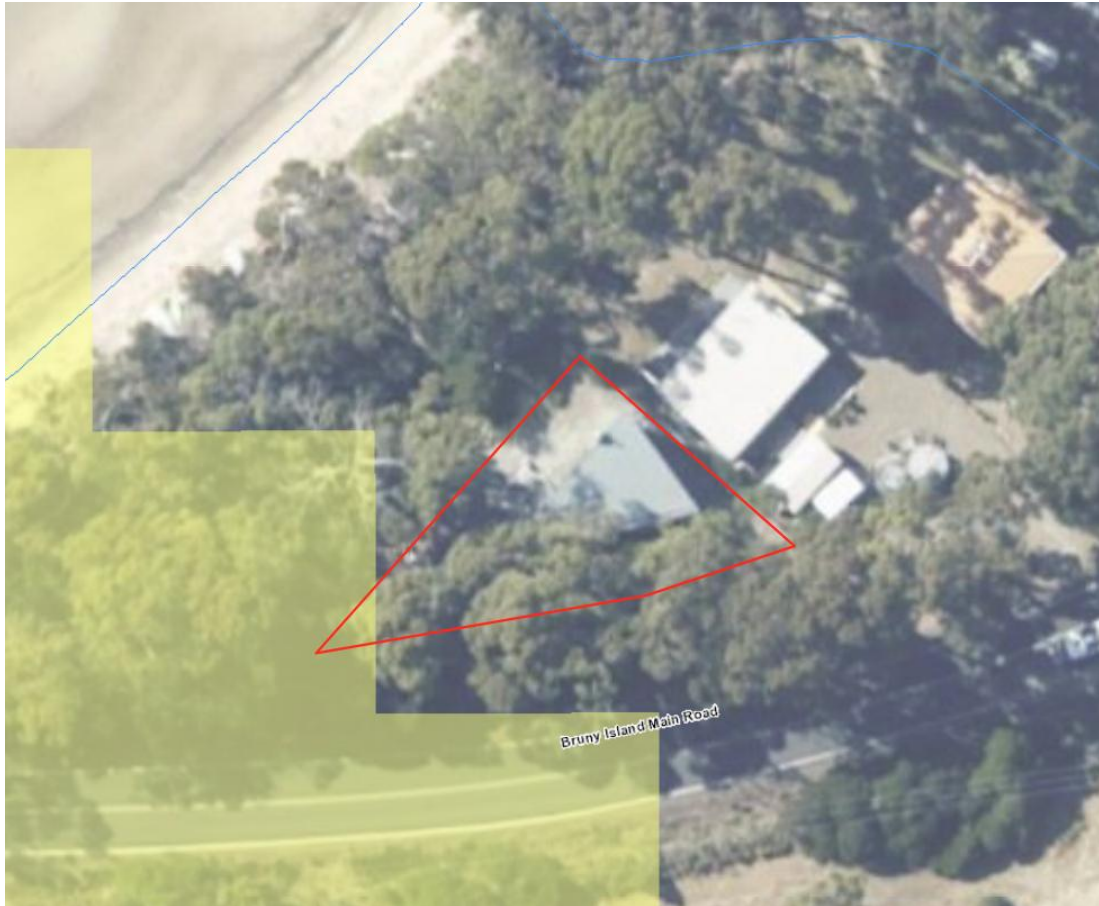
A very small 13m<sup>2</sup> section of The Property falls within a Landslide Hazard Area overlay (Class: LOW) – see Figure 1. According to Mineral Resources Tasmania (MRT), these particular modelled areas have *“no known active landslides, however it has been identified as being susceptible to landslide”*. In this case, the areas in question have been so classified on the basis of being *“Remaining areas slopes 11-20 deg”*, meaning the landslide hazard is based on slope average slope of a 10 x 10 m pixel.

Figure 1: The Landslide Hazard Areas – Low - overlay (yellow) covers approximately 13m<sup>2</sup> of the site at 1886 Bruny Island Main Rd, Great Bay.

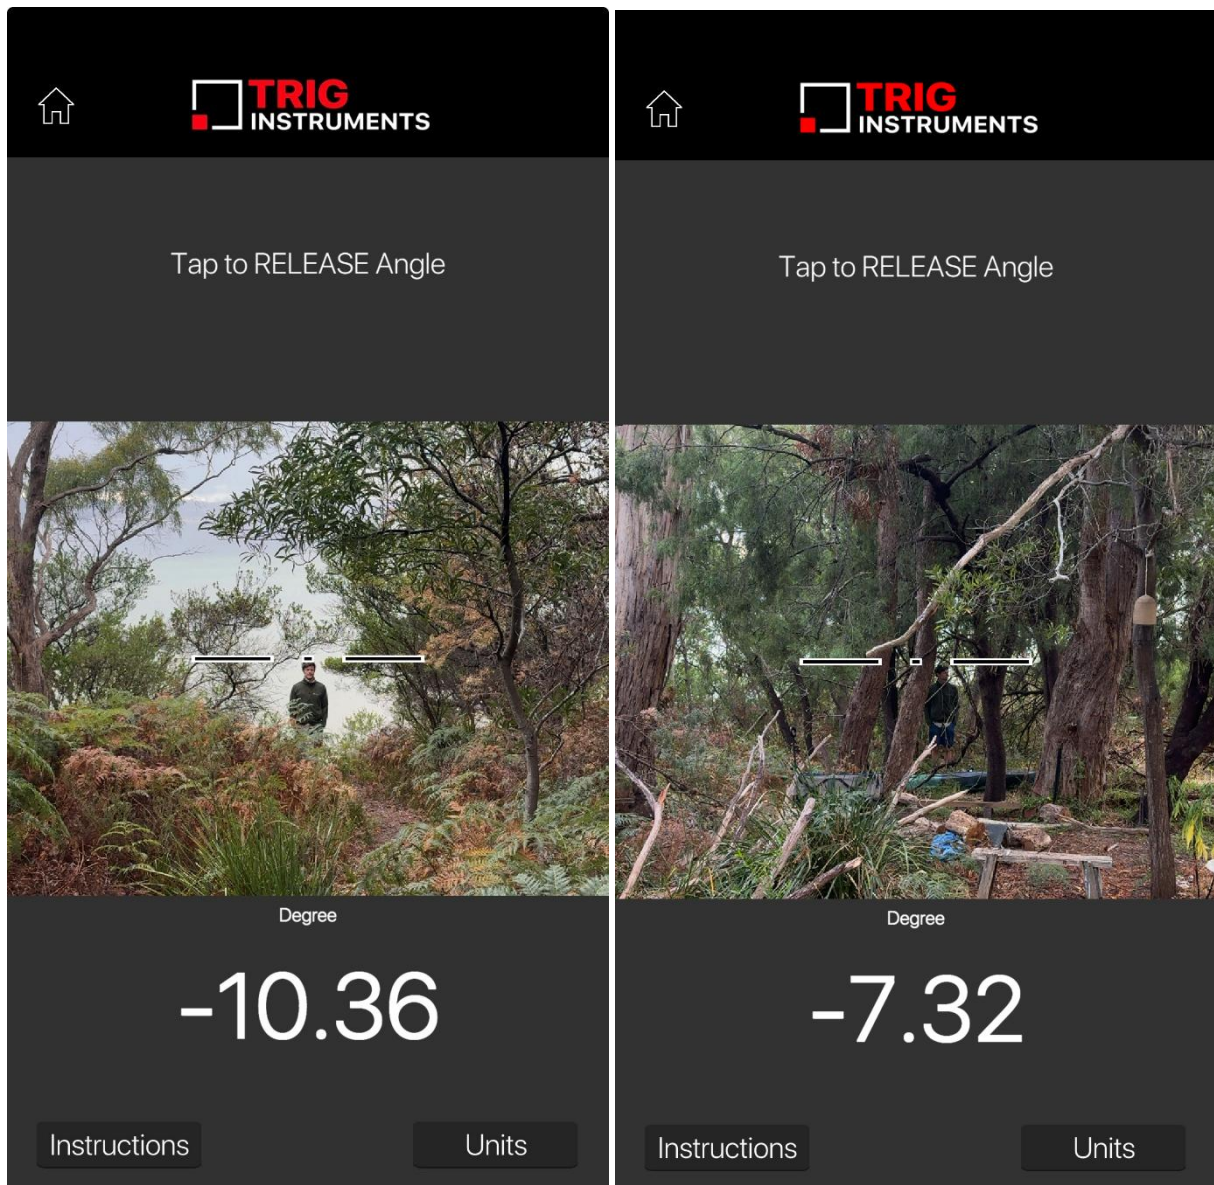
The site is at the foot of a moderate, waning, slope with a northerly aspect. Maximum (mid-slope) gradients are approximately 15° and 100 m upslope of The Property. The average slope angle on site is approximately 5°. Downslope of the Property are tidal flats/beach. The transition from aggraded colluvial slope deposits to beach is marked by a steep back-shore scarp, approximately 2-3 m high. Clinometer readings on site were up to approximately 10° at the Landslide hazard area and up to approximately 7° within the usable alfresco area (Figure 2)

Figure 2: Clinometer readings from The Property. Left is taken approximately within the mapped Landslide Hazard Area on site. Right is on the edge of the usable “alfresco” area on site.

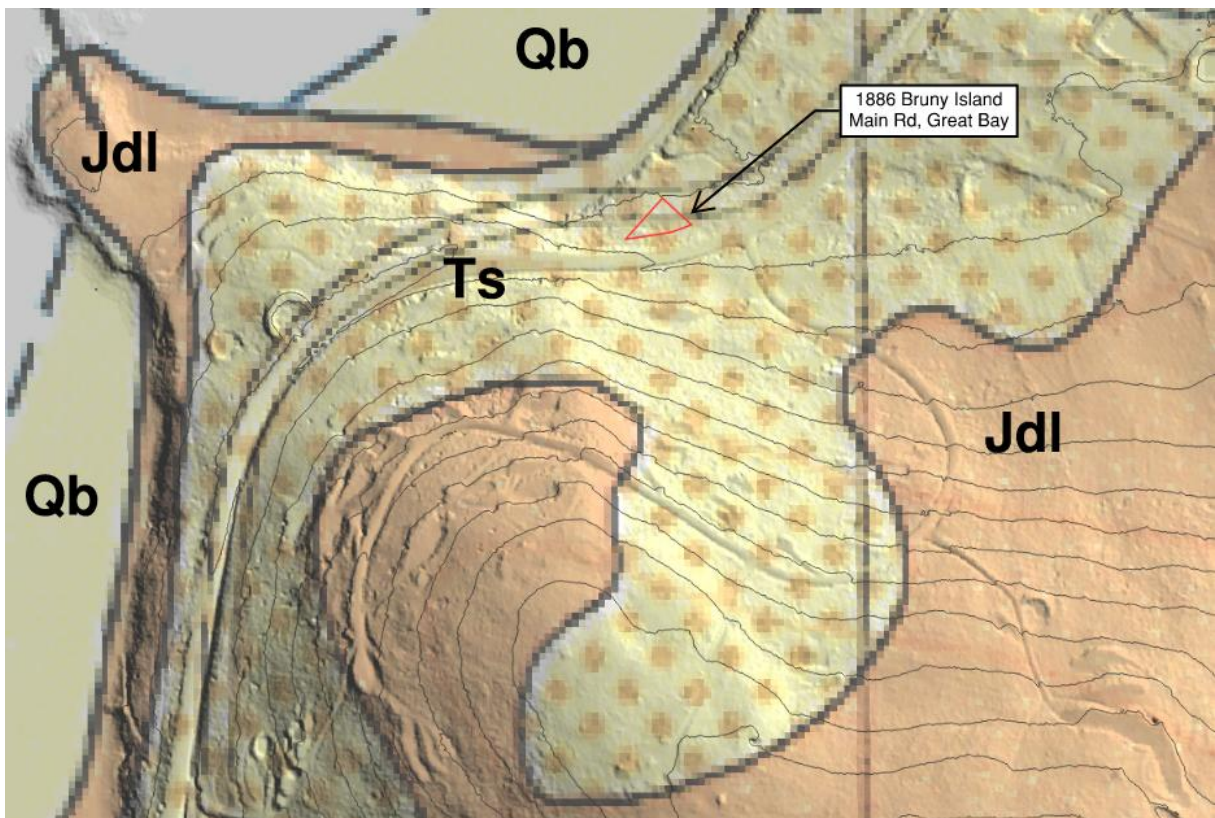
The natural soil profiles comprise windblown sands overlying clayey colluvium derived from Jurassic dolerite. A cemented sand ‘hard-pan’ is present at the transition from sands to clays. The clays are highly reactive, poorly structured, and moderately dispersive. The dolerite bedrock (mapped, Figure 3) is at approximately 2.4 m depth on the site and is visible in a highly weathered state at the shoreline below (Site Photos – Appendix 5).

Figure 3: MRT 1:50k Kingborough Sheet projected over a hill-shade map of the environs around The Property. 5m contours. Jdl = Jurassic dolerite, Ts = Tertiary sediments (of gravel, sand, silt and clay), Qb = Quaternary beach and tidal flat deposits. Map created in QGIS by Doyle Soil Consulting

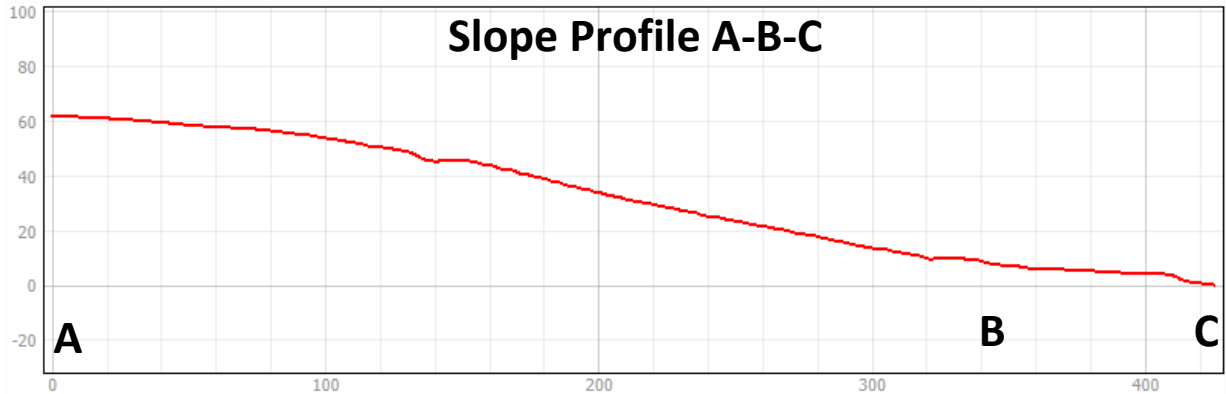
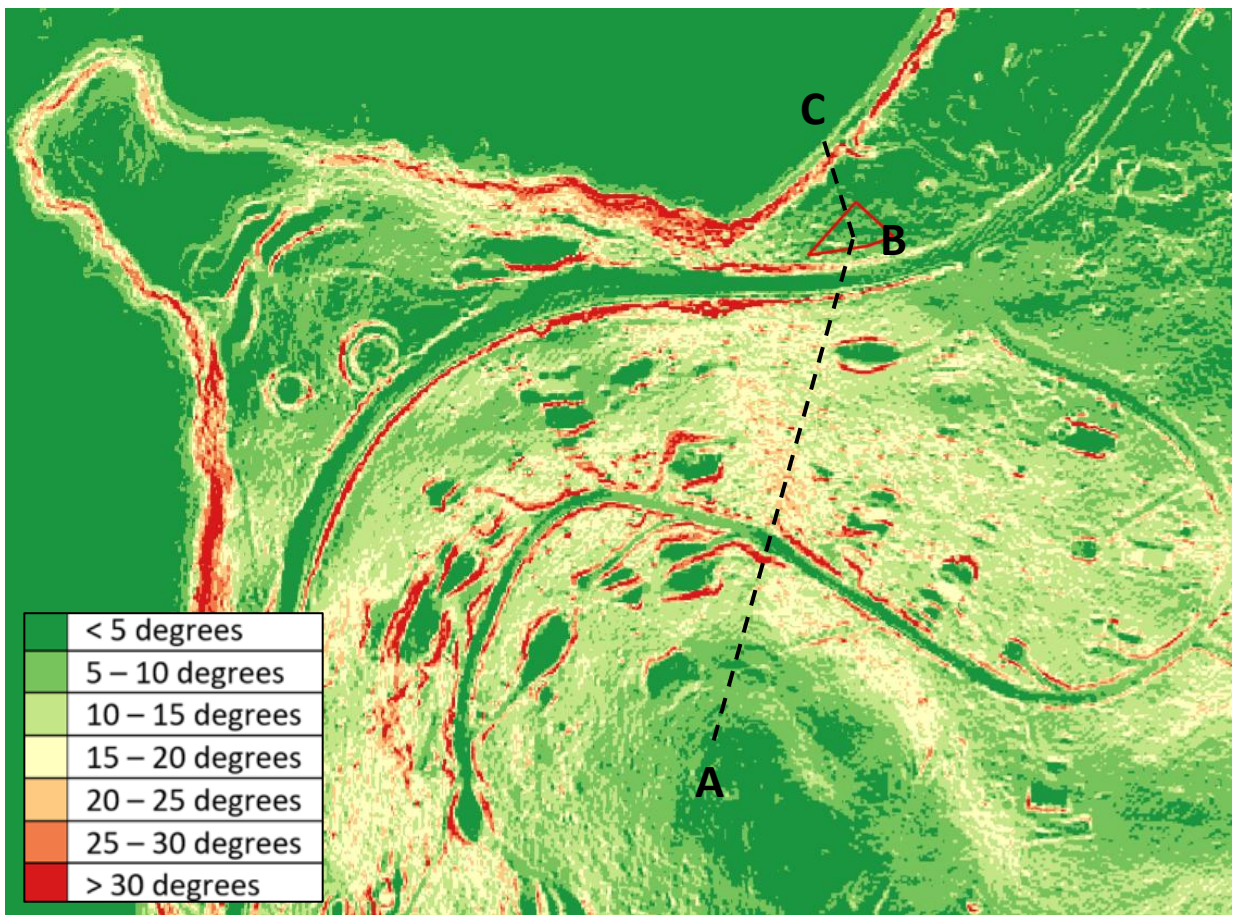
### Appendix 3 – Slope Map

The maximum slope is approximately 15 degrees and is about 100 m up slope of the property, which is located at point “B”.

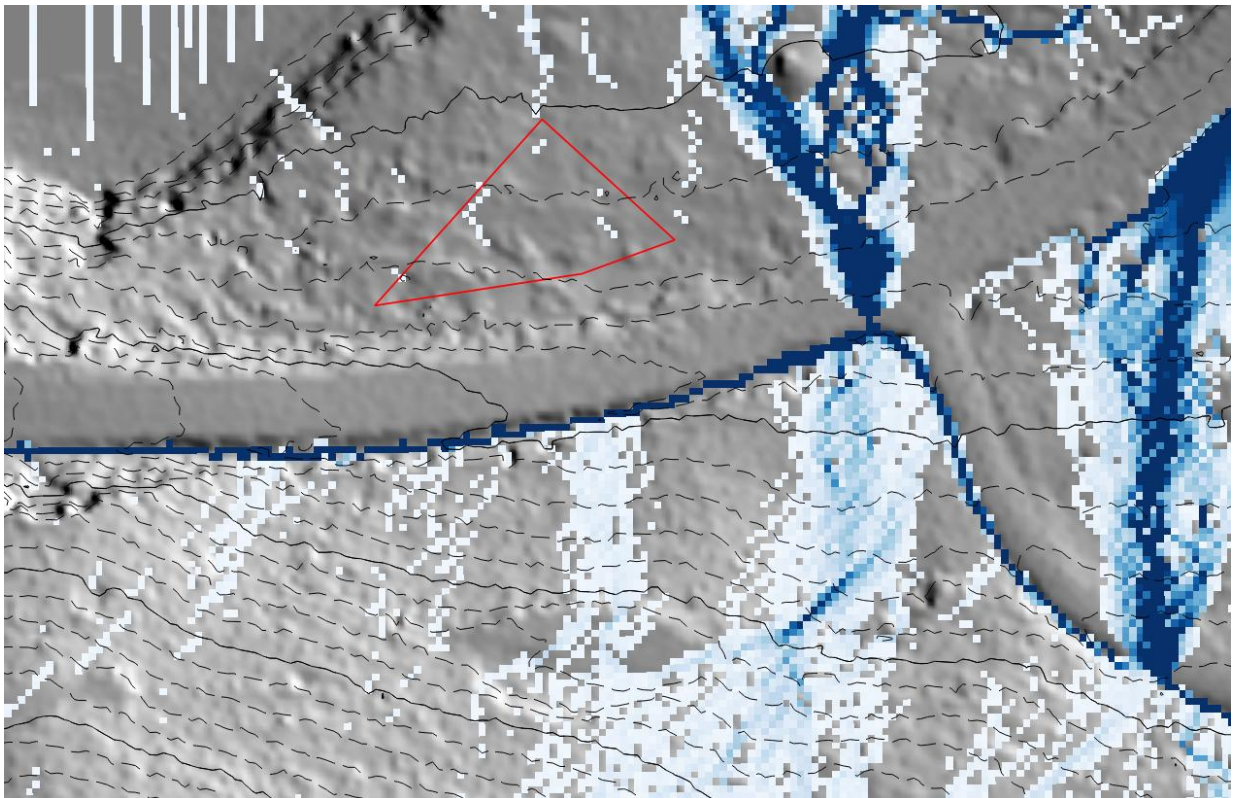
## Appendix 4 – Surface Flow Accumulation Model

The site is low in the landscape and naturally subject to run-on (surface and subsurface) from upslope areas. The main road, above the site, and associated drain are expected to direct most surface run-on away from The Property (Appendix 4). Subsurface run-on (mass flow) may cause the local subsoils to be poorly drained. The hard pan layer at approximately 1.0 depth is indicative of seasonally perched water table.

All modelled surface water flows are diverted away from The Property by upslope road drain. The model does not account for culverts, piping, etc, meaning the spillover at the road to the east of the property is unrealistic.

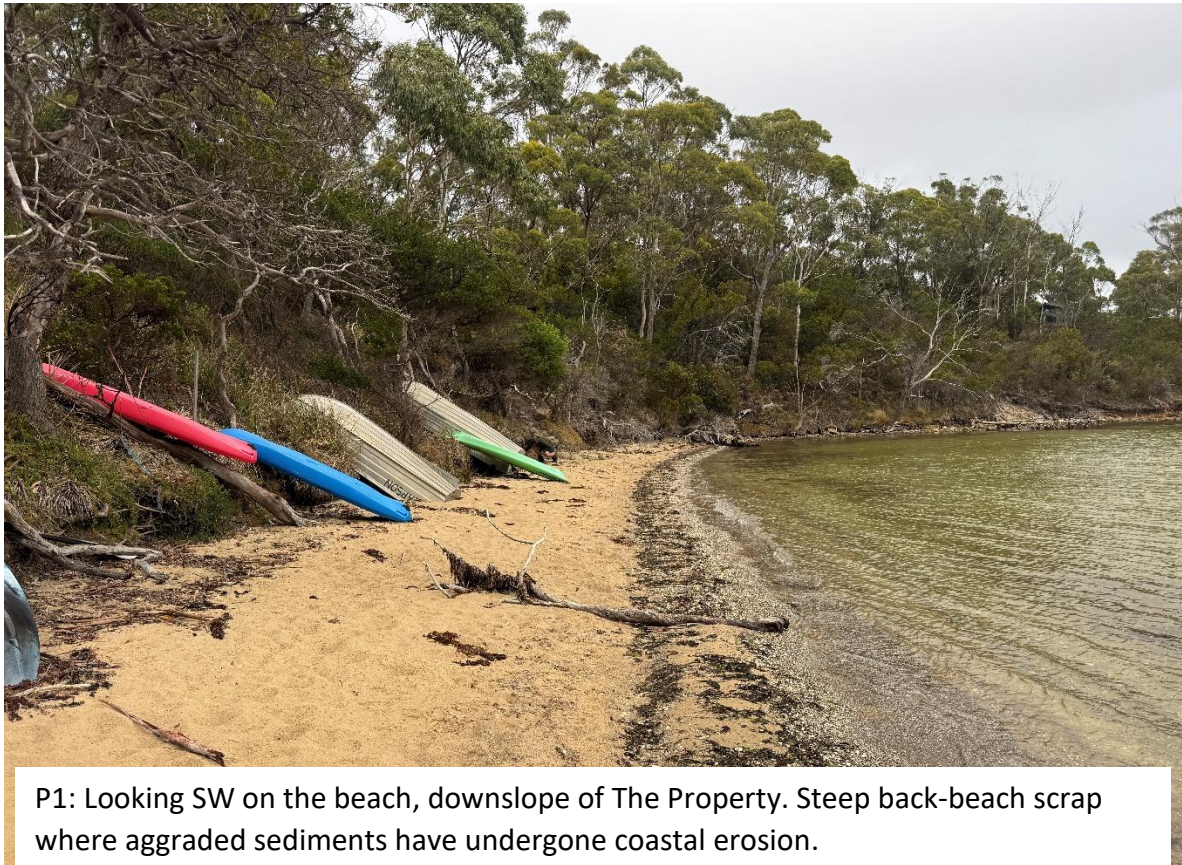
P1: Looking SW on the beach, downslope of The Property. Steep back-beach scarp where aggraded sediments have undergone coastal erosion.

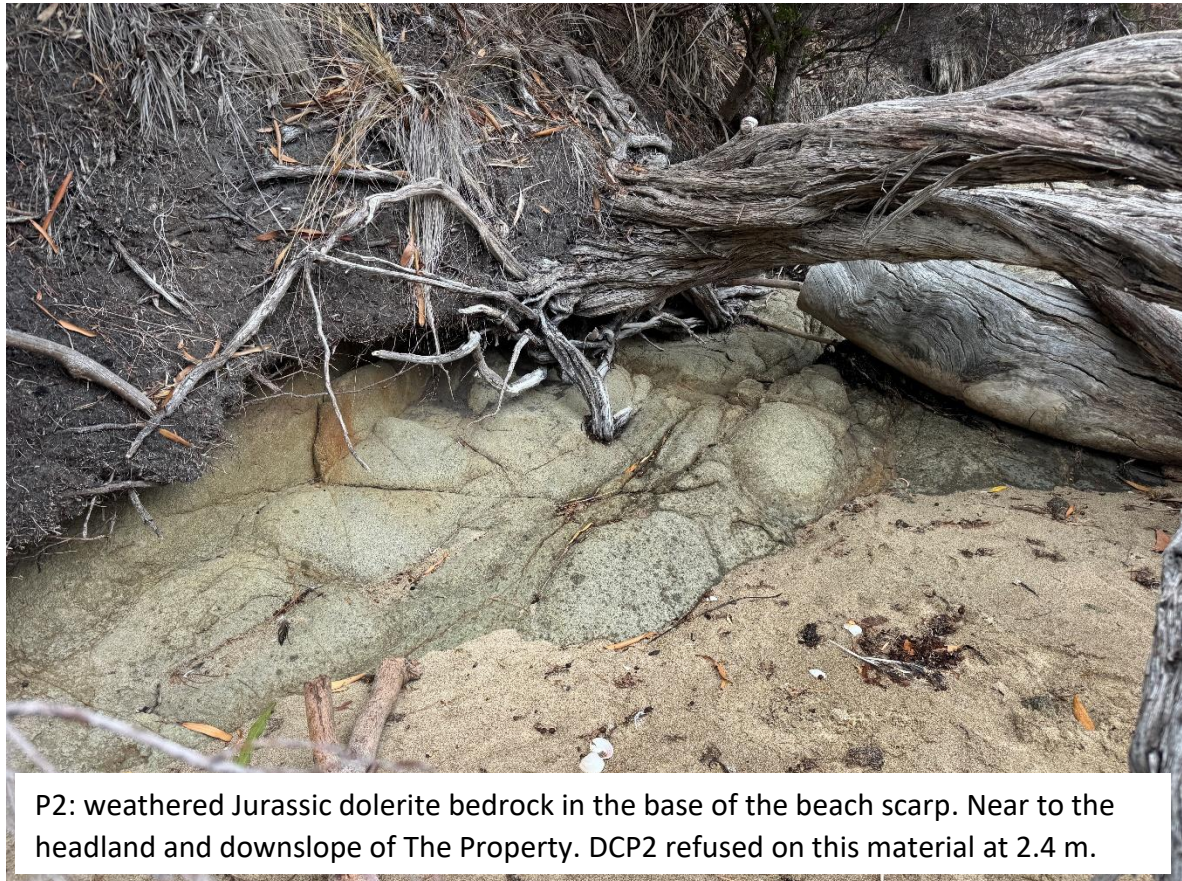
P2: weathered Jurassic dolerite bedrock in the base of the beach scarp. Near to the headland and downslope of The Property. DCP2 refused on this material at 2.4 m.

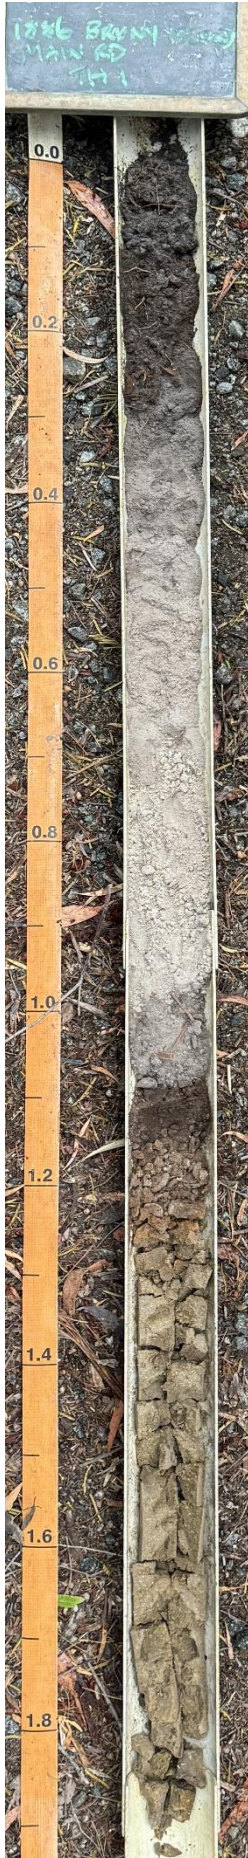
### Test Hole 1

Depth (m)	Horizon	Description and field texture grade	USCS Class
0 – 0.3	A1 <sub>1</sub>	Very dark grey (7.5YR 3/1), <b>Snad</b> , slightly moist, loose consistency, single grain, common roots	<b>SW</b>
0.3 – 0.7	A1 <sub>2</sub>	Grey (7.5YR 6/1), <b>Sand</b> , single grain, draw loose consistency	<b>SP</b>
0.7 – 1.0	A2	White (10YR 8/1), <b>Sand</b> , single grain, dry medium dense consistency	<b>SP</b>
1.0 – 1.1	A3	Grey (7.5YR5/1), <b>Snad</b> , single grain, dry dense consistency	<b>SP</b>
1.1 – 1.25	B2 <sub>1hs</sub>	Very dark brown (7.5YR 2.5/2) grading to dark brown (7.5YR 3/2), <b>Cemented Sand</b> , massive, dry hard consistency	<b>SC</b>
1.25 – 1.8	B2 <sub>2</sub>	Greyish brown (10YR 5/2), <b>Sandy Light Clay</b> , weak coarse blocky structure, dry stiff consistency  <b><u>No Refusal</u></b>	<b>CH</b>
