## LANDSLIDE RISK ASSESSMENT

### **PROPOSED DRIVEWAY 14 BATCHELORS ROAD - SANDFLY**

**Client:** Lachlan Joyce  
**Certificate of Title:** 134464/1  
**Investigation Date:** Monday, 20 January 2025

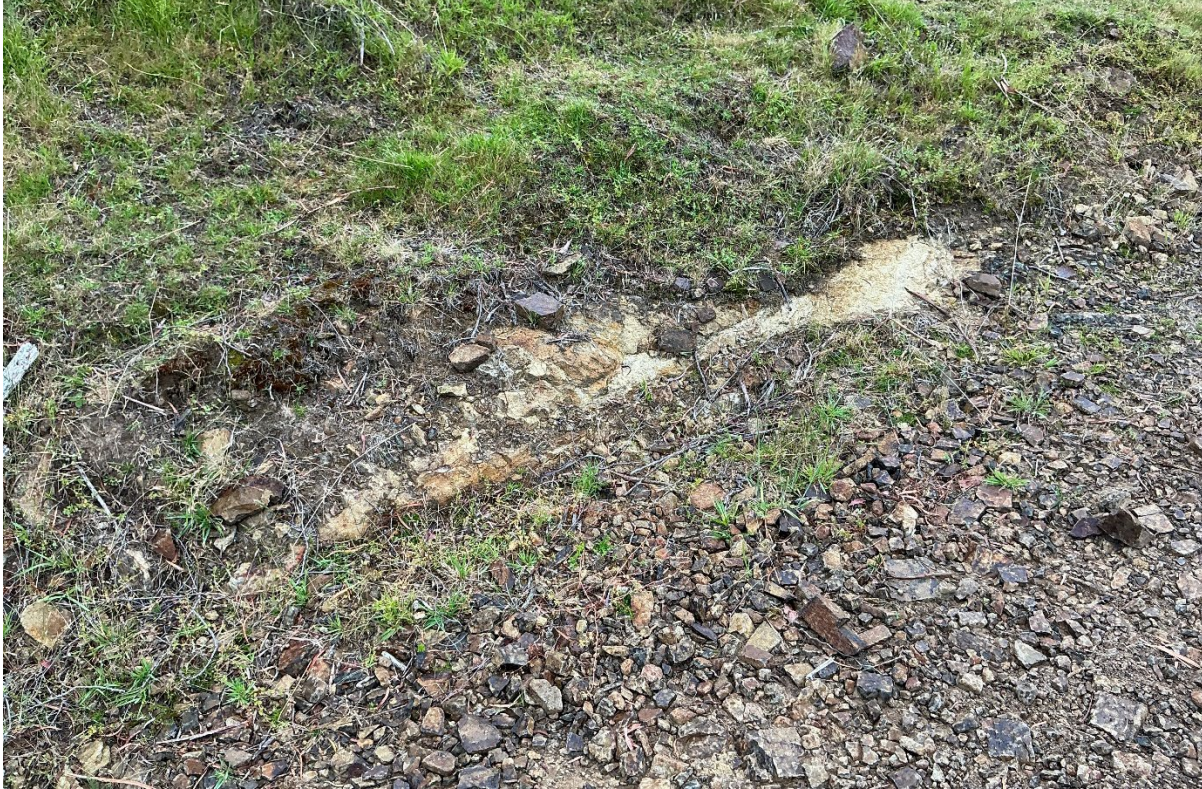
**Photo 1 Evidence of exposed dolerite bedrock on the lower section of the driveway**

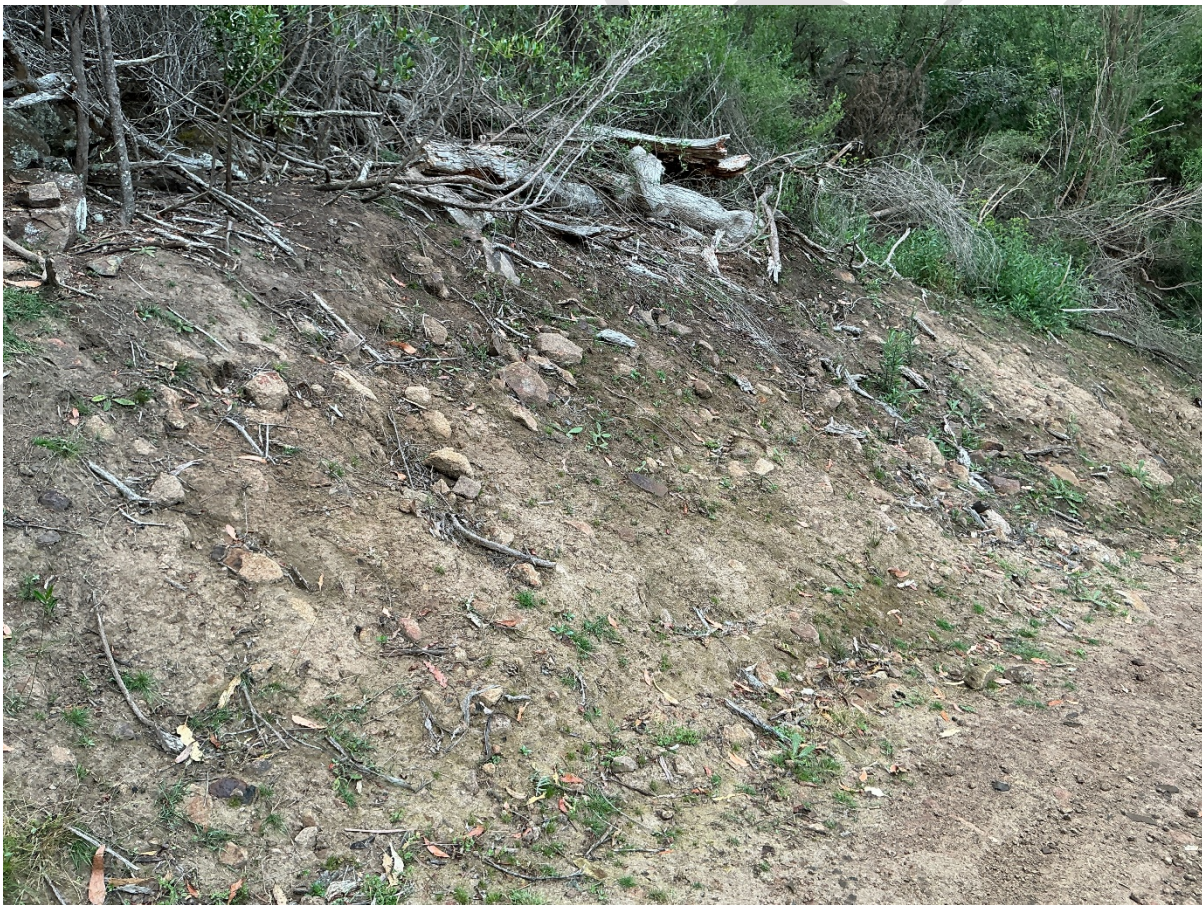
**Photo 2 Colluvium deposits in the existing road cut.**

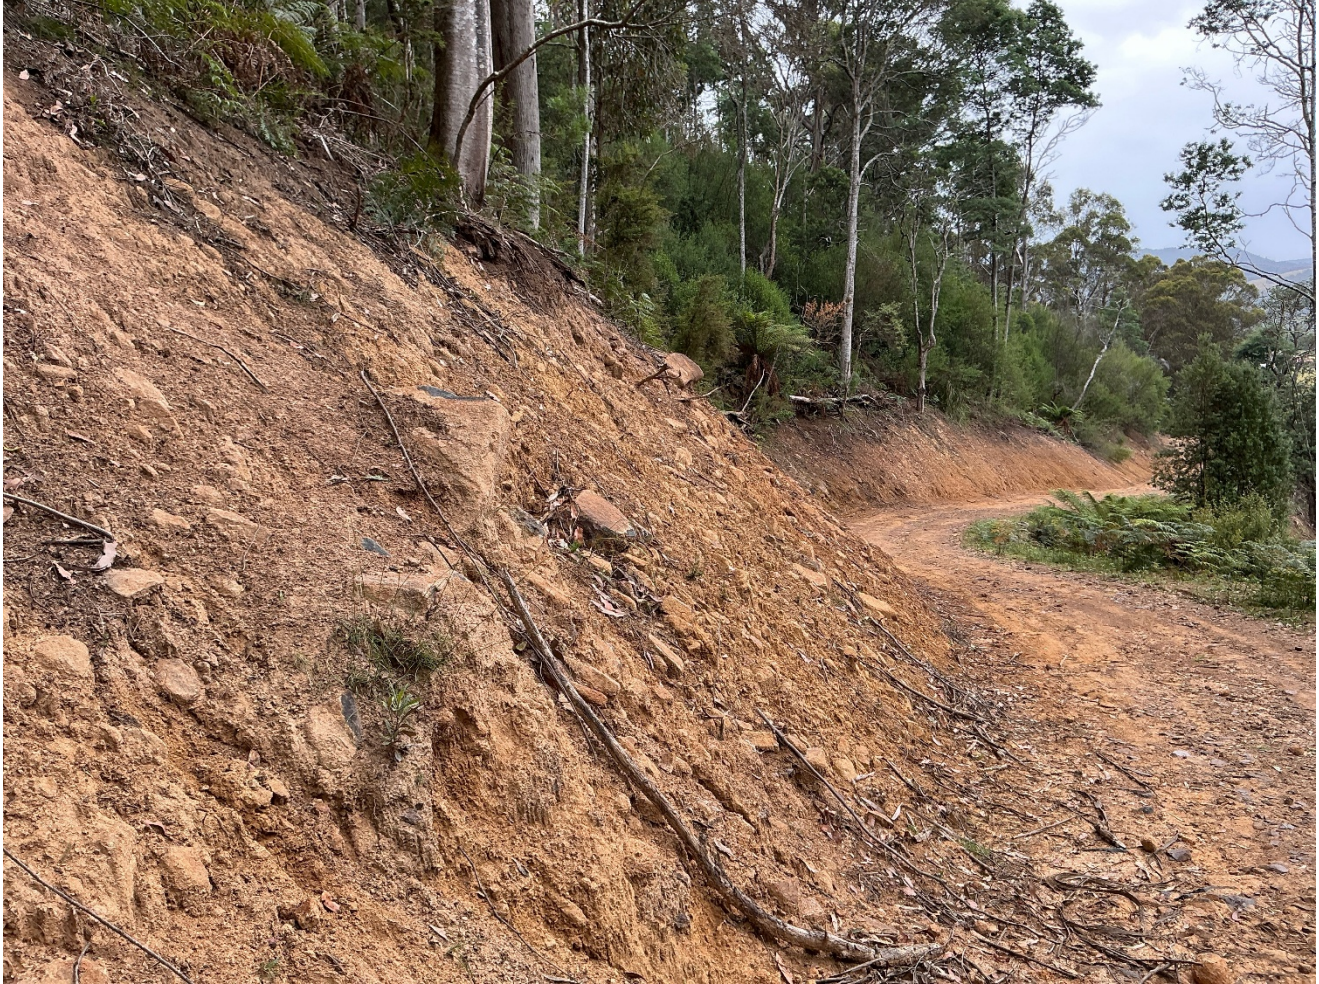
**Photo 3 Colluvium deposits in the existing road cut.**

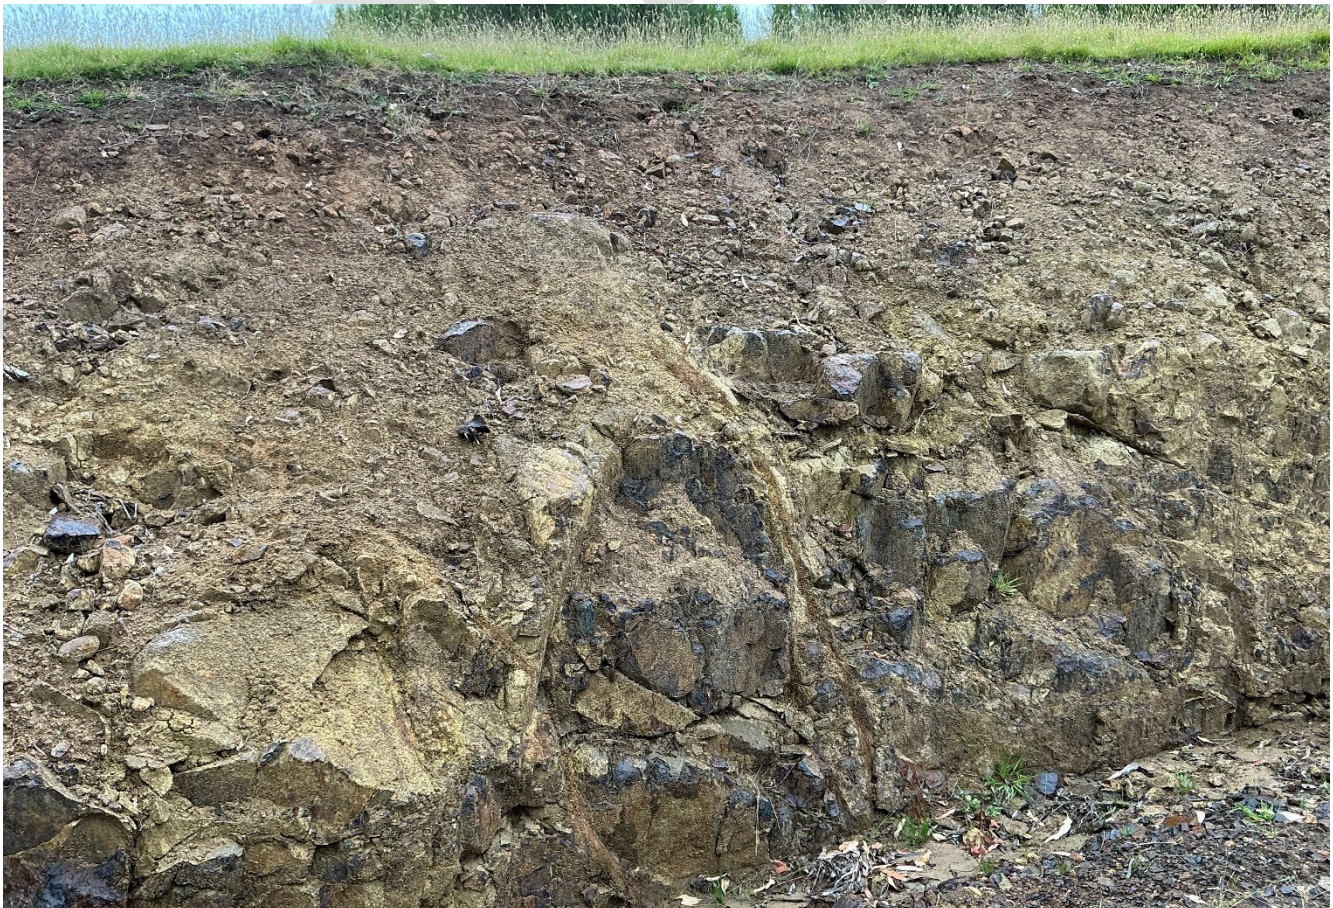
**Photo 4 Evidence of exposed slightly weathered dolerite bedrock on the upper section of the driveway**

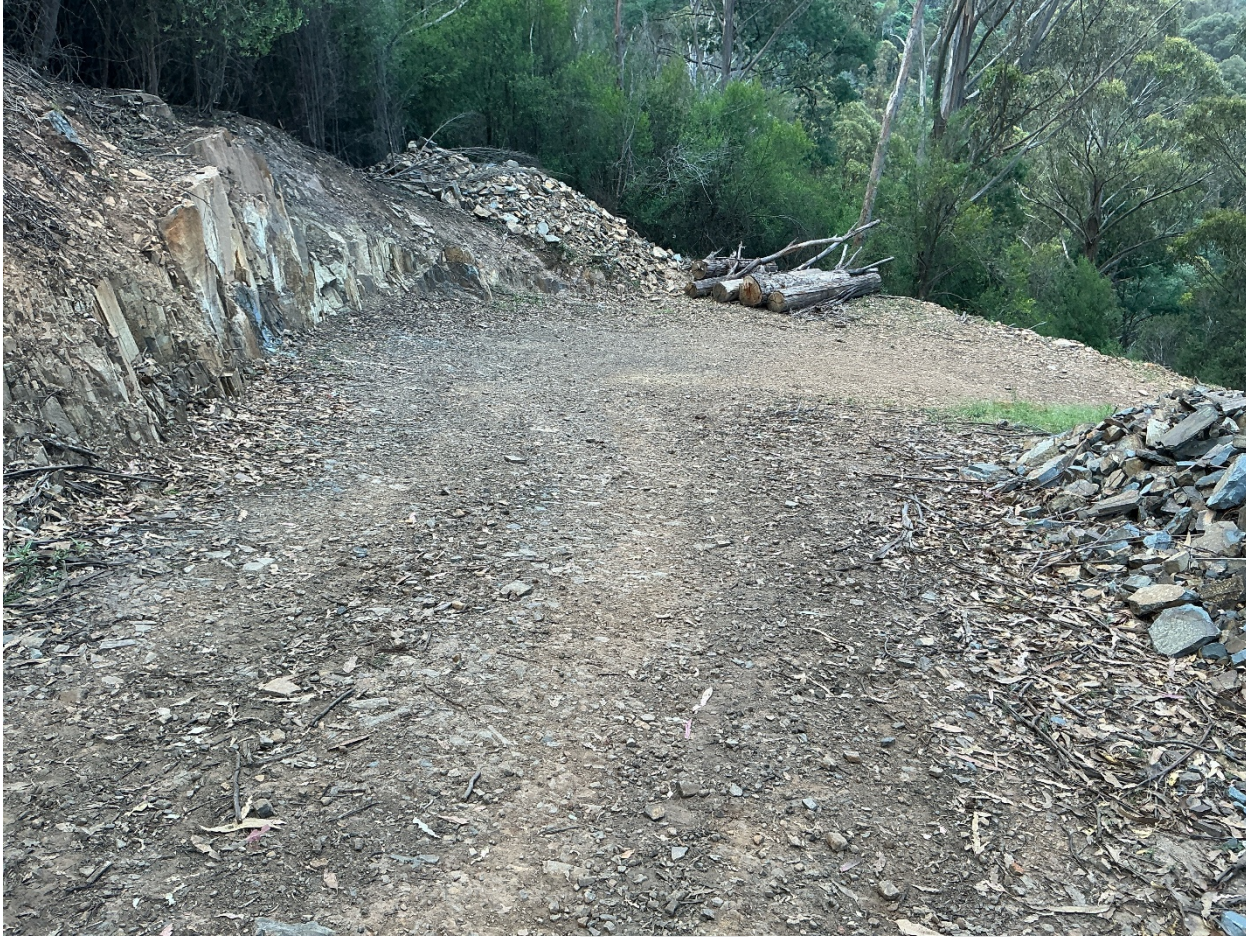
**Photo 5 Evidence of exposed slightly weathered dolerite bedrock on the northern section of the driveway**

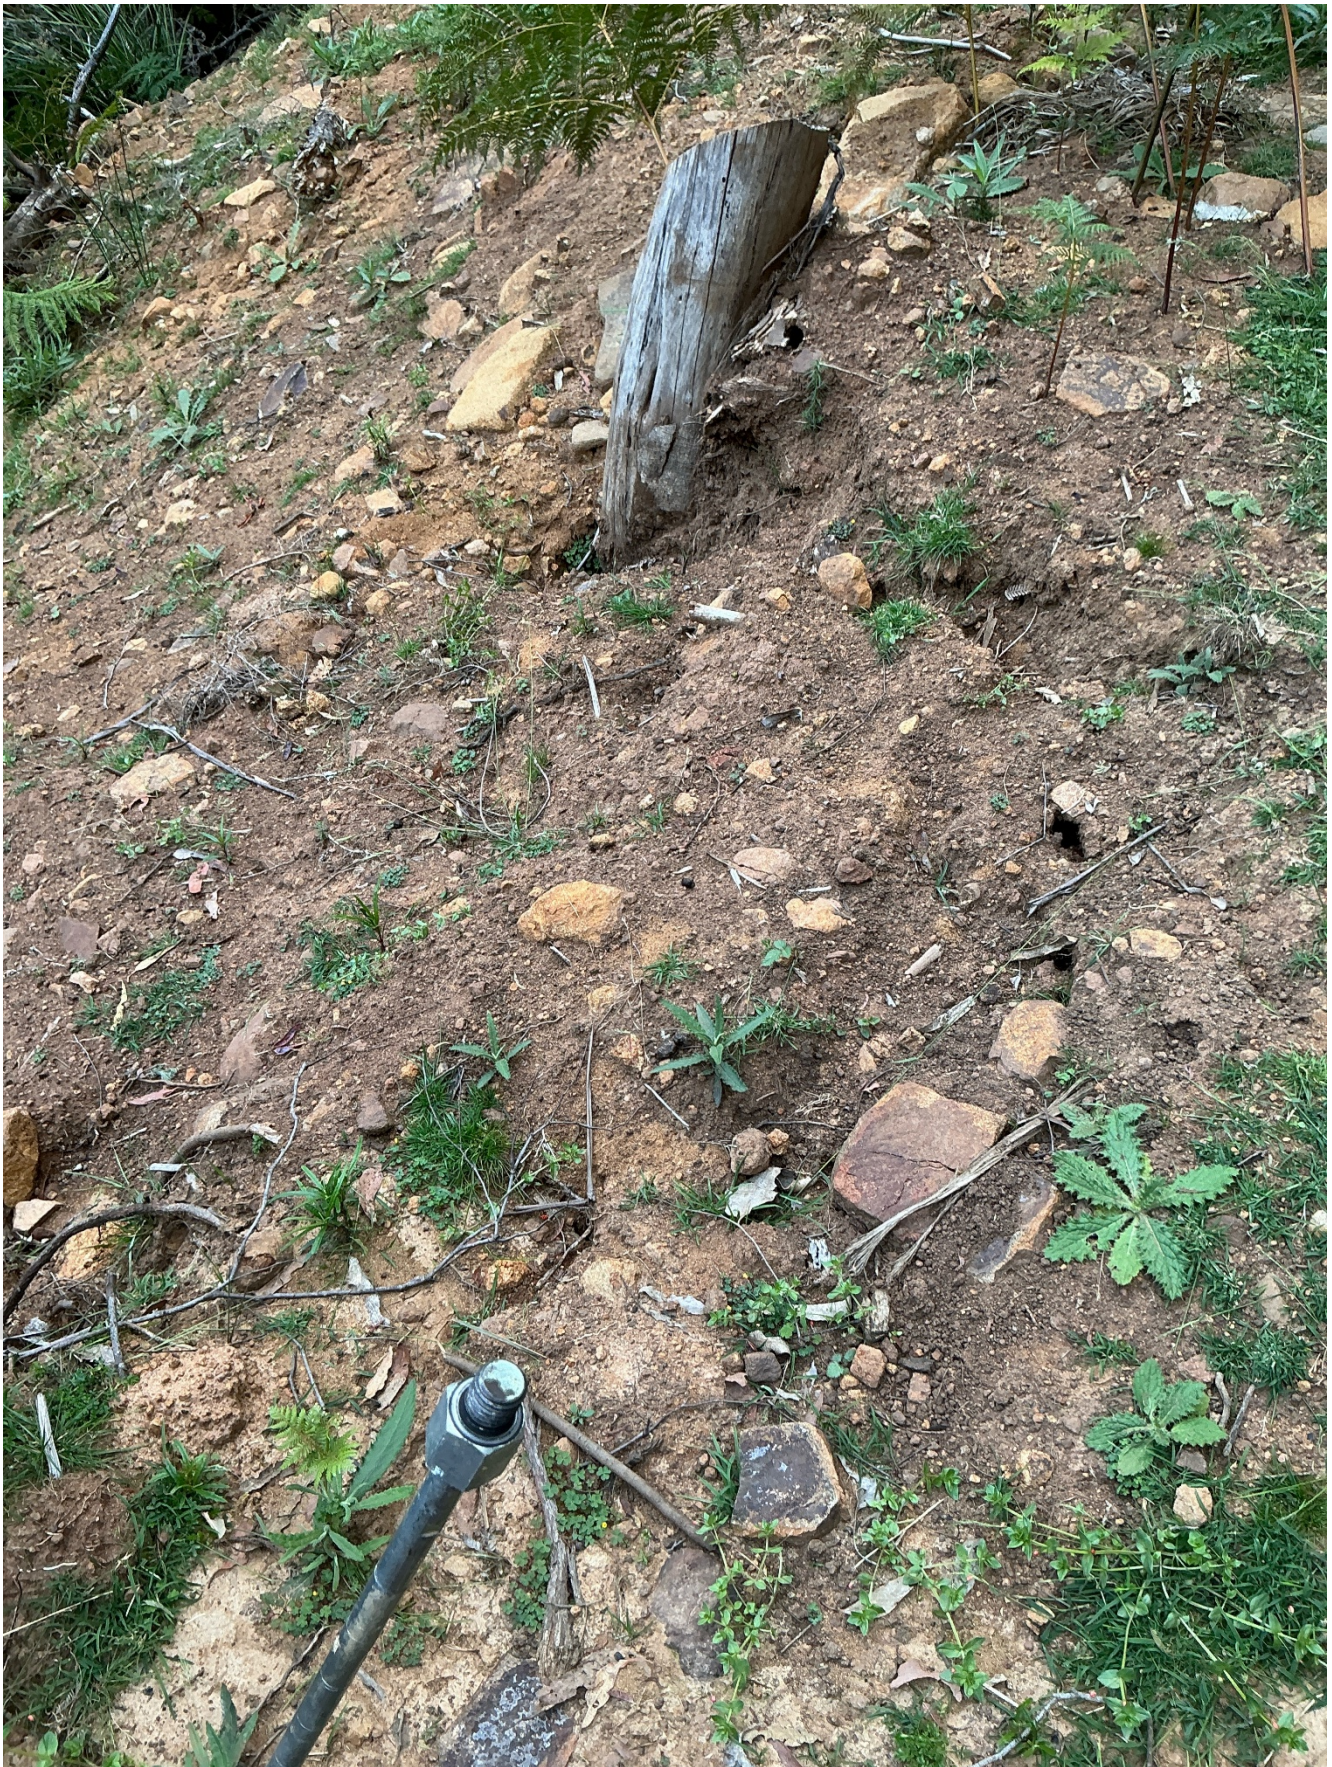
- The existing cut batter reaches up to 50° in some parts of the driveway with an average slope angle of 40°.
- Localised rockfall of cobbles and small boulders at the base of the road cut were observed.
- Steep angles are also used for the existing driveway fill where batter angles up to 40° are observed.
- There is evidence of localise slope instability (tension cracks) in some parts of the existing driveway fill (Photo 6, Photo 7).

**Photo 6 Evidence of tension cracks within the road fill in this section of the driveway.**

Shallow seated rotation or translational failure through road fill in section with steep fill batter angles (40°) near cross Section A and near test pit TP2. Assessed risk to the driveway.

- Road widening by 0.5 m in the cut near Section A and test pit TP2 (Map 5) but not in the fill (fill must not be used).
- Provision of roadside guideposts 1.0m from the crest of the widened sections
- Ensuring the cuts do not exceed 1H:1V.
- Fill management including preventing water infiltration and slope stabilisation if not cost prohibitive

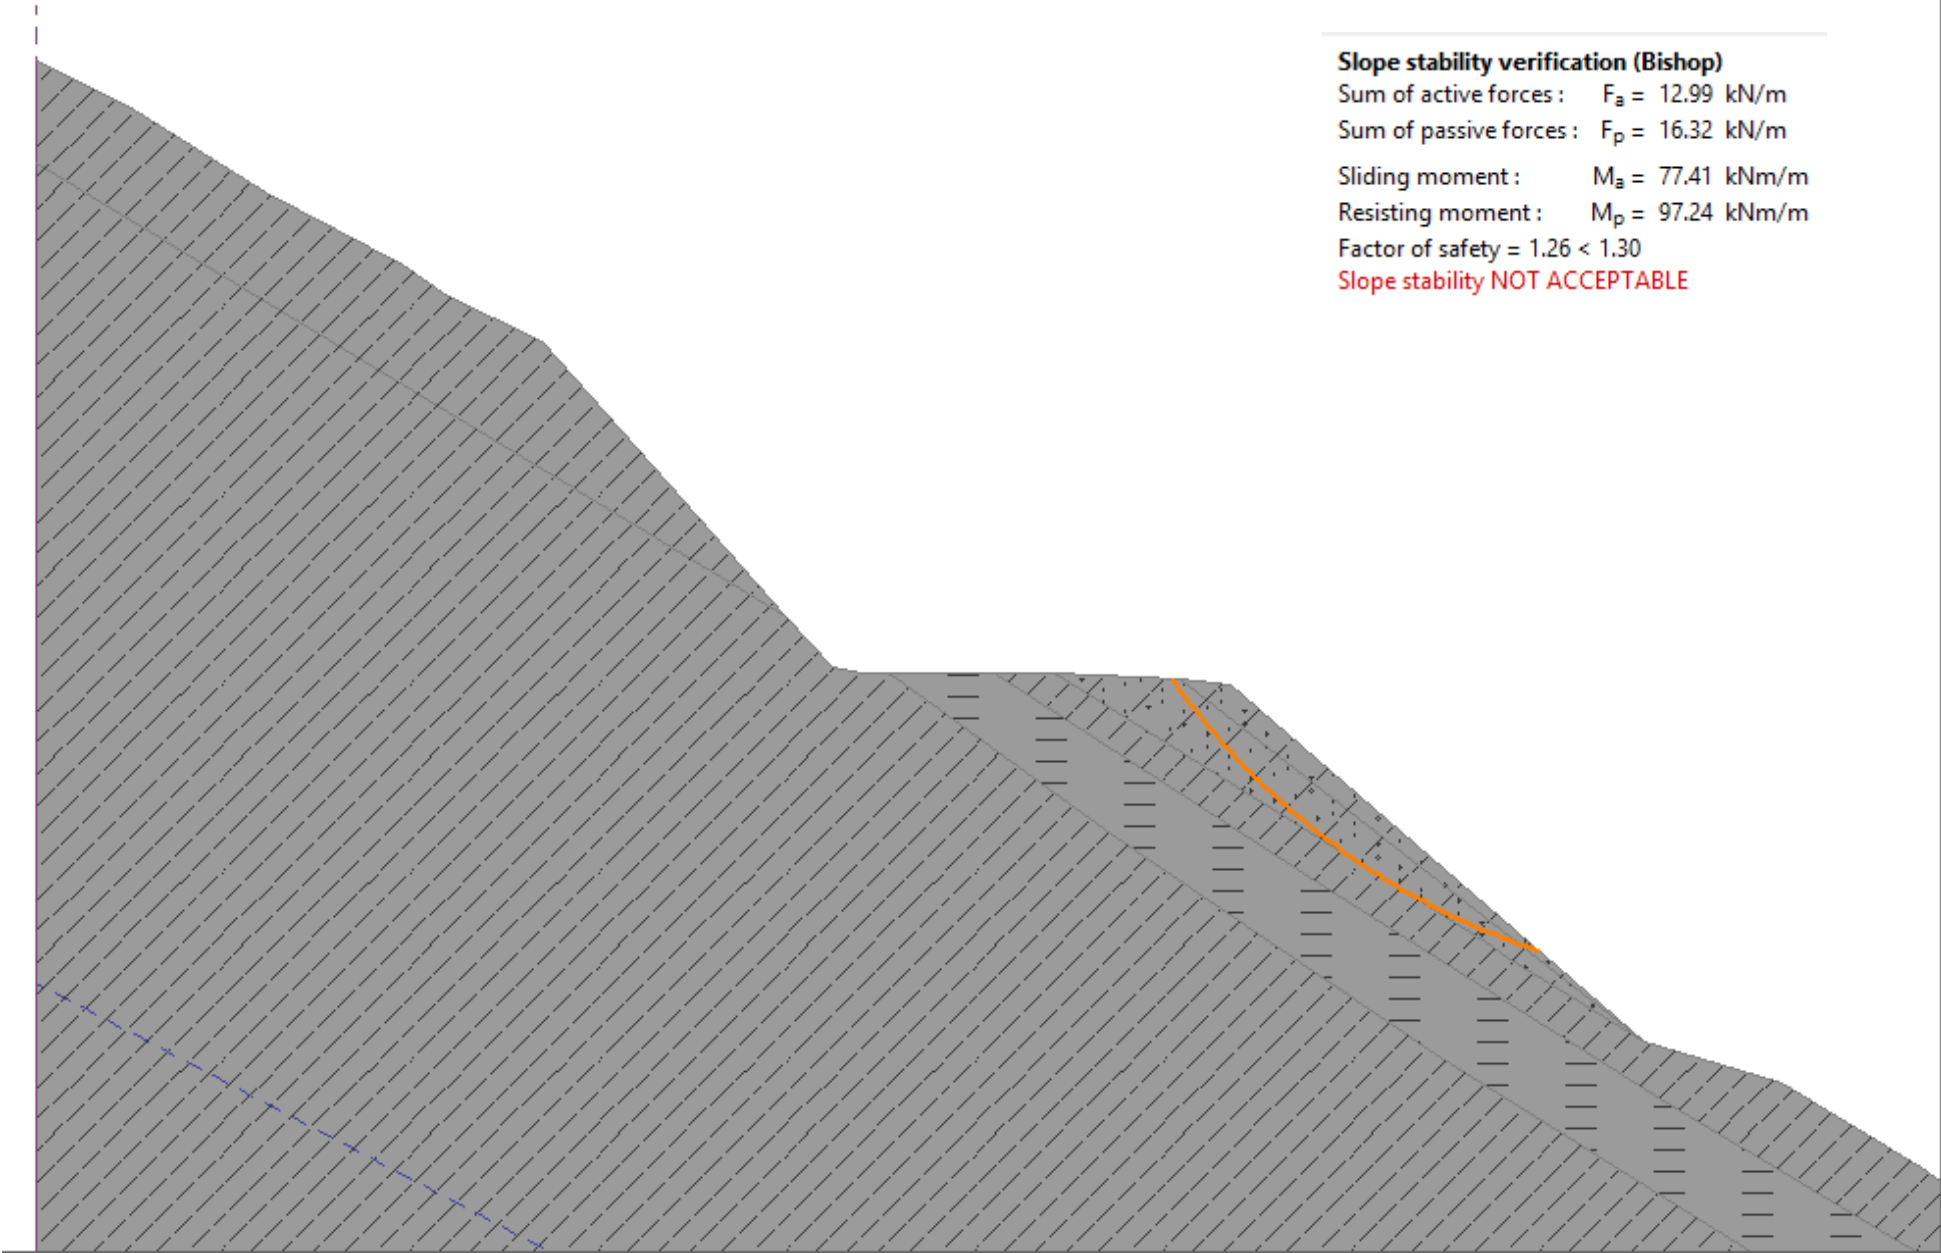
- Based on present conditions, a safety factor of 1.3 is not met (1.26) with rotational failure predicted on the margin of the road.
- The cut is projected to have a safety factor exceeding 1.3.
- If the road margins are loaded as indicated above, a factor of safety of 1.05 is modelled which is below the acceptable limits
- Management is recommended for Scenario 3 and required for Scenario 4.

Factor of safety =  $1.26 < 1.30$

**Slope stability NOT ACCEPTABLE**
