Arboricultural Report

Joscon Tasmania Pty Ltd

**224 Longmans Road, Margate,
7054, TAS**

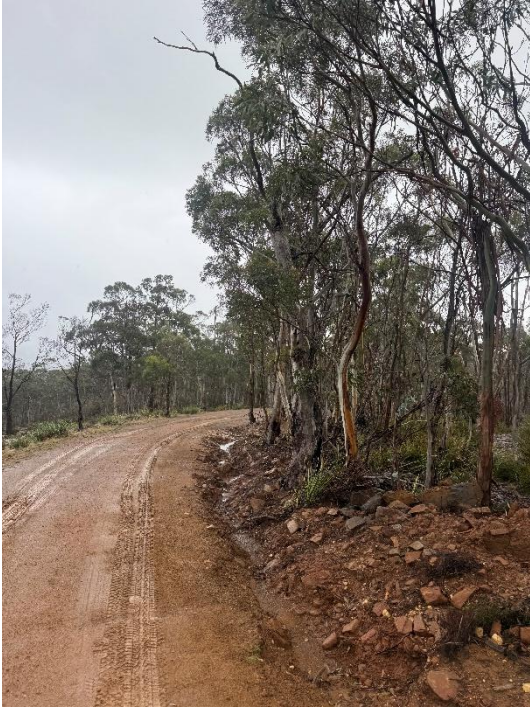
The site has an existing above grade access road. This road has been installed well. There are existing drains and walls between the trees on site and the road. There are differences in topography throughout the site making it unlikely for any roots to be near the roadway.

Figure 3. Image of above grade access road.

- A gravel access road can be extended in the same fashion it has been developed. That is above grade and semi permeable construct. This development must be undertaken sensitively to avoid damage to the roots. An example would include a larger rock (ballast rock) as a base and smaller rocks as a finish on top.

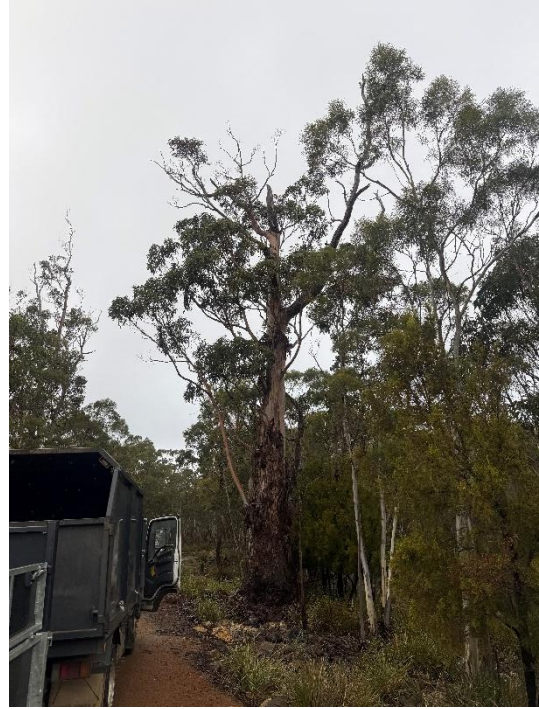
Figure 4. Image of Tree 16.

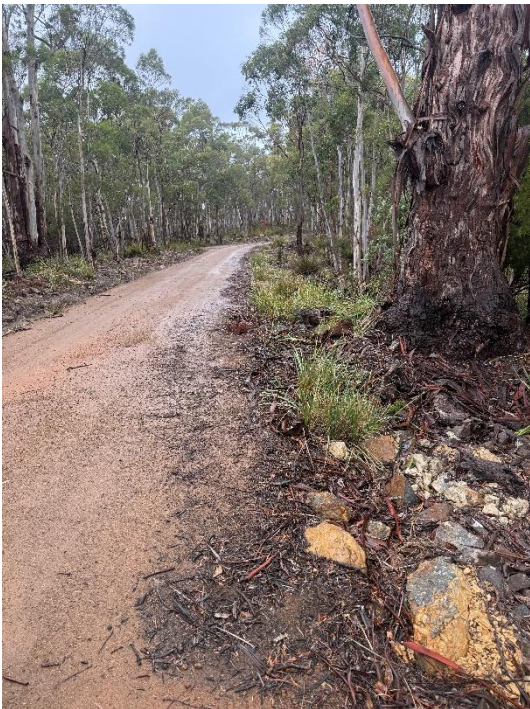
Figure 5. Image of above grade access road.

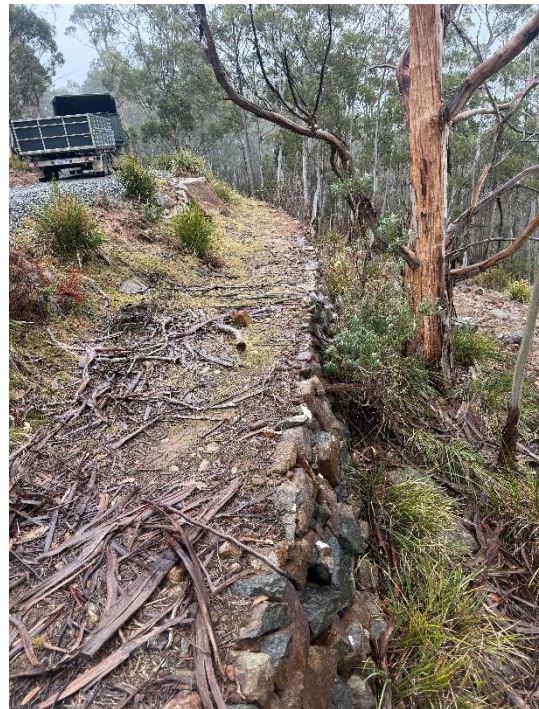
Figure 6. Image of old stone wall separating trees and access road.

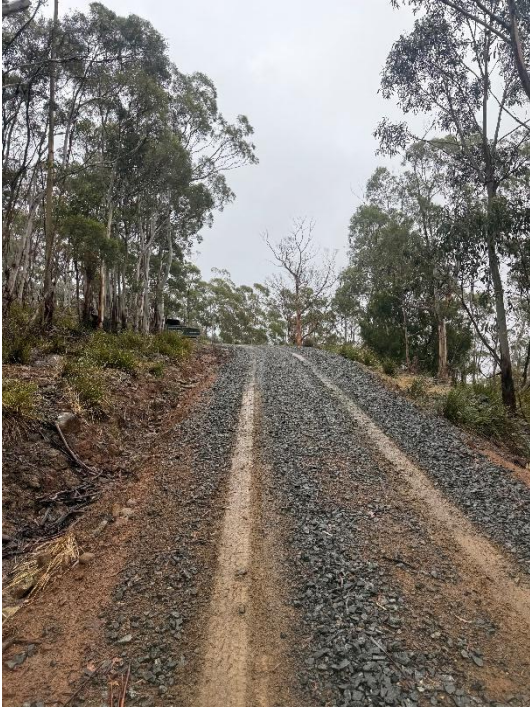
Figure 7. Image of above grade access road.

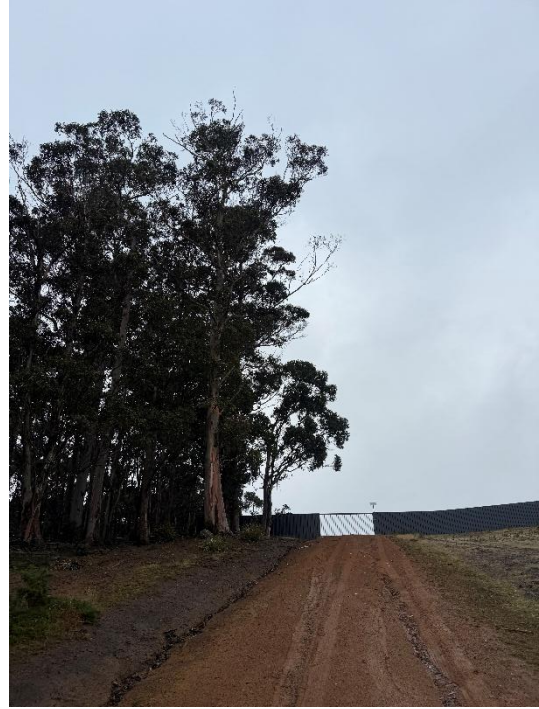
Figure 8. Image of front gate with large trees beside it.
