## GEOTECHNICAL SITE INVESTIGATION

### **4571 BRUNY ISLAND - MAIN ROAD PROPOSED VISITOR ACCOMMODATION**

**Client: Nic Danger**

**Investigation Date: 01/05/2026**

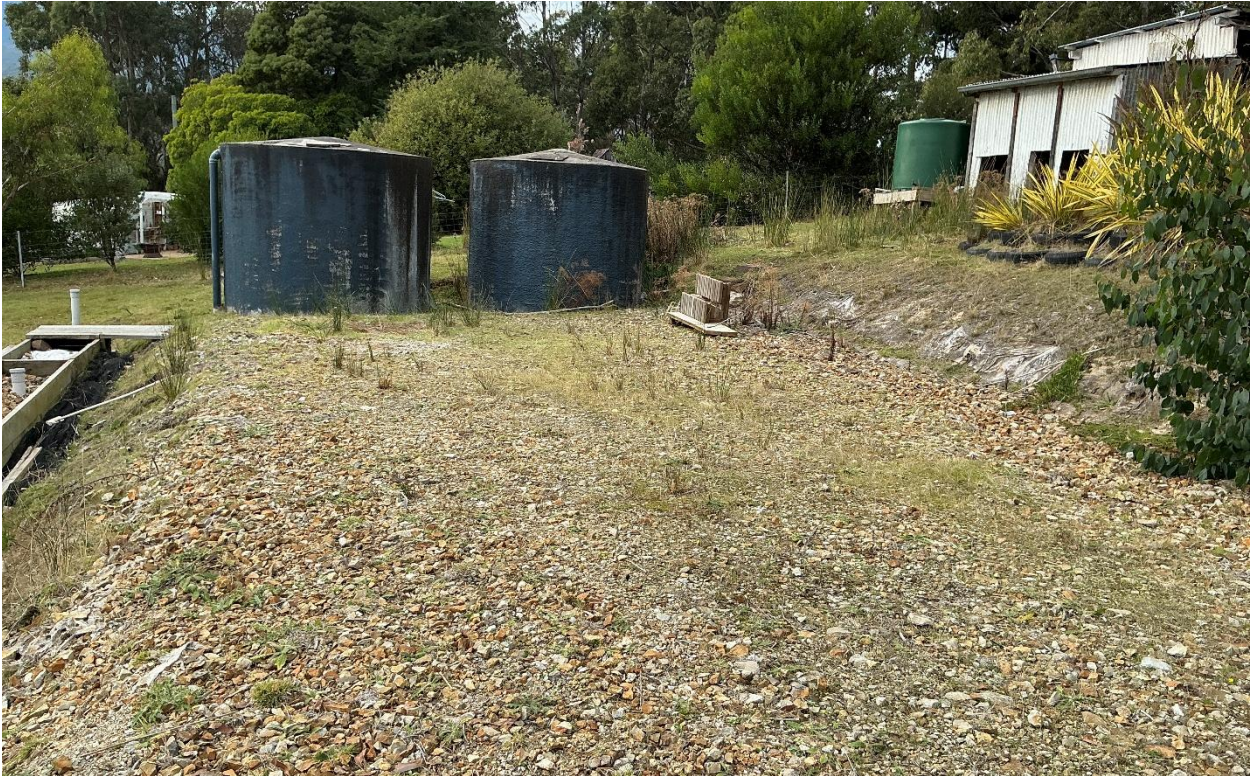
*Photo 1 Gravelled lower/middle bench area with water tanks visible downslope. The photograph shows the relatively level pad area and provides context for the cut/fill transition located upslope toward BH01.*

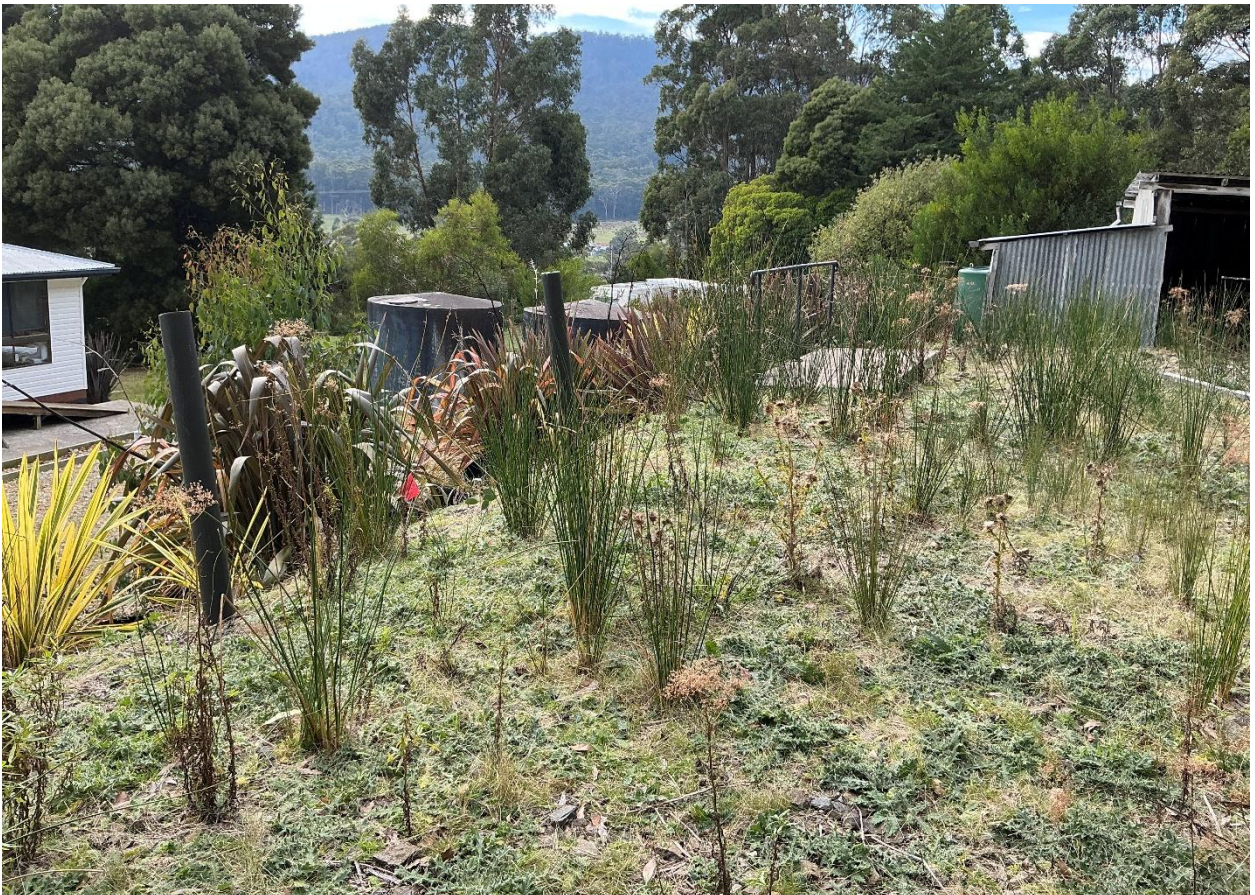
*Photo 2 Upper bench area looking downslope across vegetation and existing Site features. The photograph shows the stepped nature of the Site, with the visitor accommodation area located nearby but not directly shown. BH01 is indicated by the red flag near the crest of the batter.*

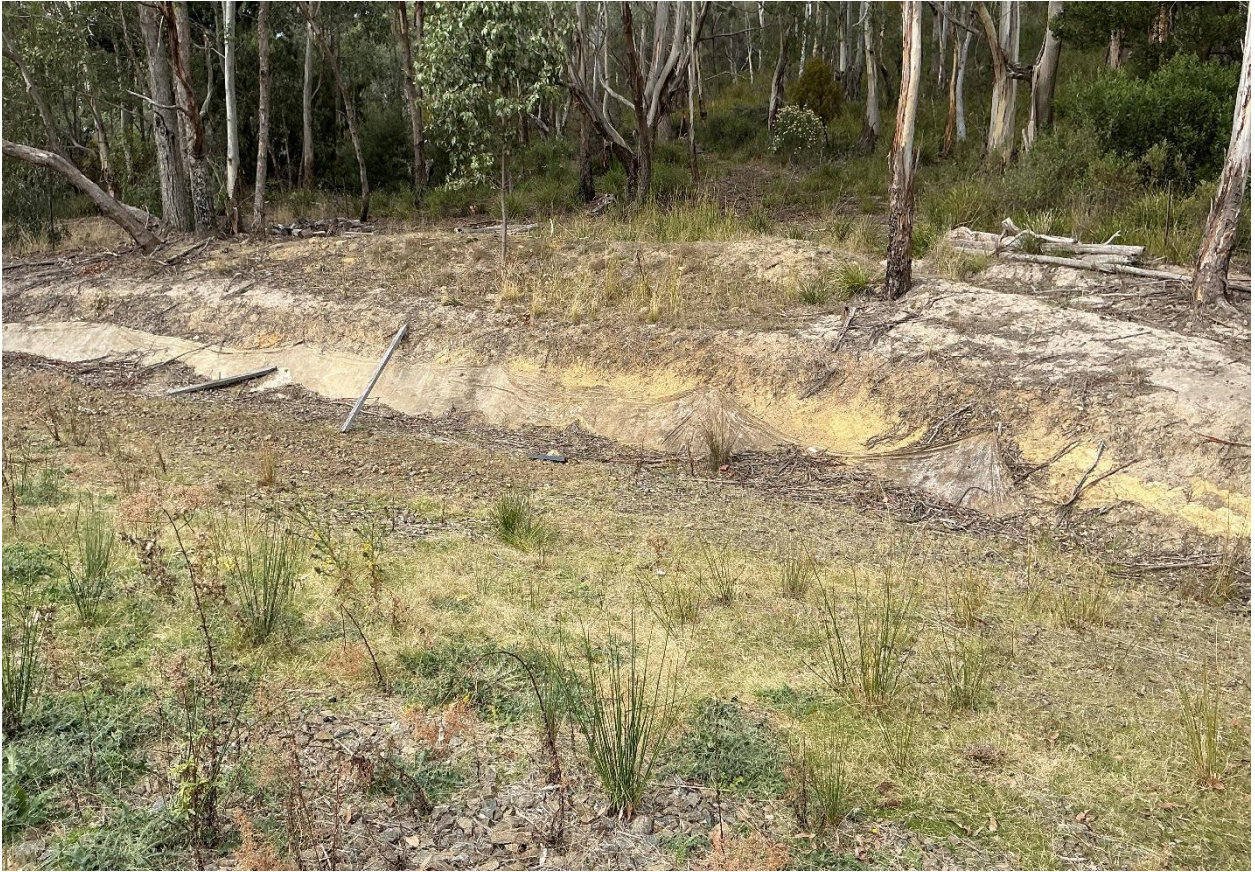
| Scenario | Description | Landslide / erosion mechanism | Scale of feature | Likelihood | Consequence | Risk level | Management required |
|---|--|---|--|---|---|---|---|
| Scenario 2 – Instability of upper cut batter | Localised instability of the upper cut batter above the upper bench area. This cut exposes weathered dolerite-derived soils and highly to extremely weathered material. | Shallow cut-face instability, minor slumping, erosion, or localised ravelling from the exposed cut face. | Small-scale cut batter instability only. Not representative of a deep-seated landslide mechanism. | Rare to Unlikely | Minor | Low | No, for slope stability under current conditions. |

*Photo 3 Exposed cut batter at the rear of the upper bench, showing previous excavation into soil/weathered material. This cut forms part of the uncontrolled earthworks assessed for stability.*

- Disturbed areas should be revegetated as soon as practicable following any future earthworks.
- No tunnel erosion was observed at the time of inspection; however, exposed dispersive soils should not be left untreated, particularly on the upper cut batter.

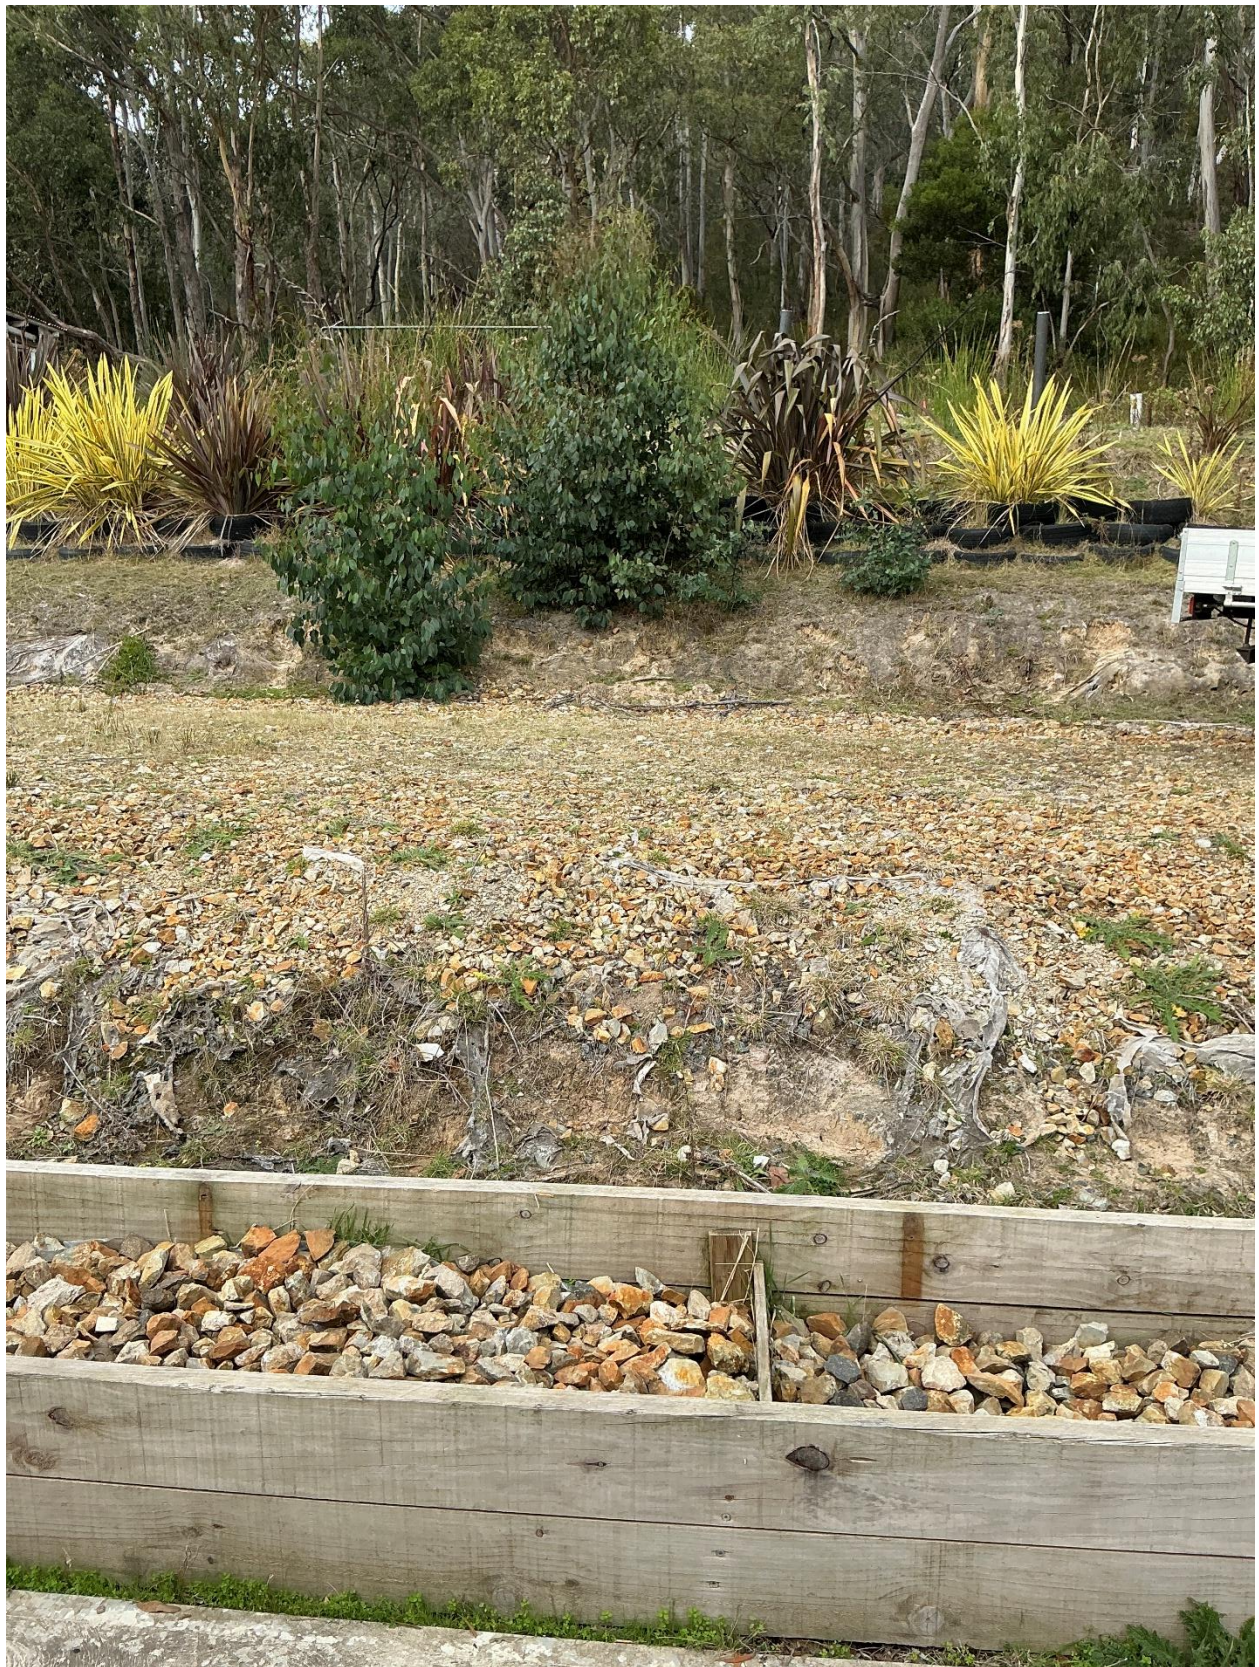
| Scenario | Description | Landslide / erosion mechanism | Scale of feature | Likelihood | Consequence | Risk level | Management required |
|---|--|---|--|---|---|---|---|
| Scenario 1 – Instability of lower cut/fill batter | Localised instability of the cut/fill batter between the lower and middle bench areas. This area includes historical fill and modified ground associated with the existing terraced Site layout. | Shallow slumping, ravelling, or localised movement of fill or near-surface soil on the existing batter. | Small-scale, localised batter instability only. Not representative of a deep-seated landslide mechanism. | Rare to Unlikely | Minor | Low | No, for slope stability under current conditions. |

*Photo 4 View of the cut/fill face between the upper and lower bench areas, with the lower retained gravel area in the foreground. The photograph shows the earthworks and batter geometry upslope of the lower bench.*

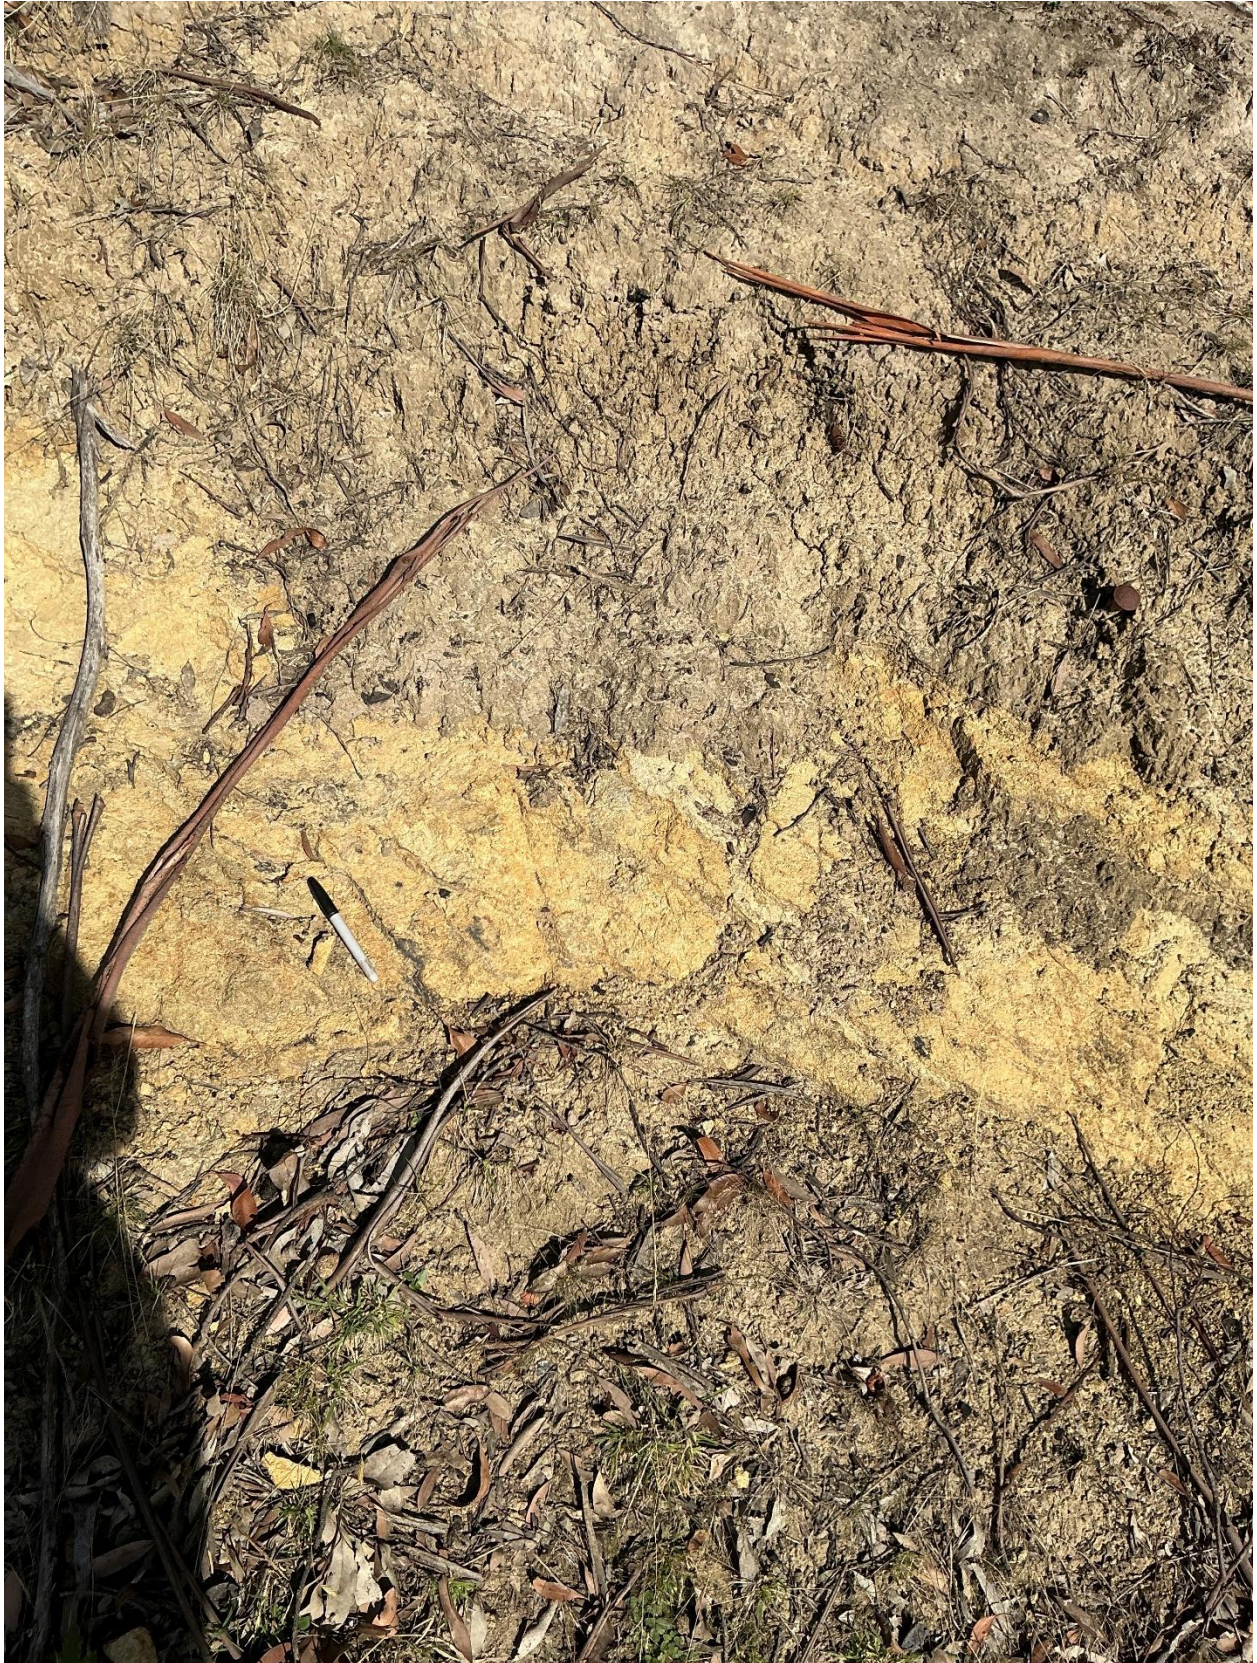
*Photo 5 Close-up of exposed soil/weathered material within the cut batter of the upper bench, showing the nature of the near-surface materials encountered in the historical earthworks area.*
