Preliminary Arboricultural Report

Homes Tasmania

**47 Summerleas Road,
Kingston, 7050, TAS**

Tree Pioneers Pty Ltd
ABN: 15 687 986 876
Franklin,
Tasmania, 7113

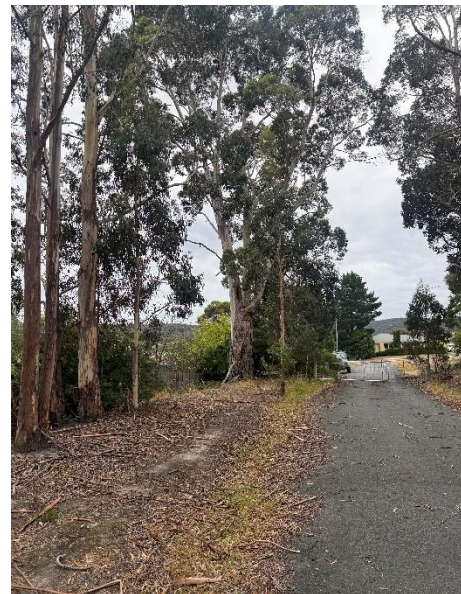
Tree 16 is a large specimen with fungal fruiting bodies present. This is typical for the species. This tree appears to have the best health and vigour of all the specimens onsite. The tree appears to be adapting to the feature well with sounds reactive growth. Further investigation is required to quantify the extent of decay. This will need to be inspected

and monitored annually. This requires a picus or arbortom test which maps the density of timber at

Figure 4. Tree 16 and bitumen roadway.

the fungal fruiting bodies. Compare data sets annually to determine the rate of decay and inform the management plan.

- Management plans are required for Trees 16 and 45.
- Tree 16 requires further investigation.
- Tree 6 and 7 are to be removed to make way for the car park. These trees have poor health and safety issues in an urban environment.
- Trees 1, 2, and 3 are not compatible with the new direction of the driveway and are to be removed to make way for the development.
- Construction sensitive methods to install car park and upgrade driveway.
- Any services required on site can be trenched in through the center of the driveway. Any sections of driveway that overlap significantly with a TPZ are required to be excavated with hydro-vac. This is non-invasive digging to locate roots and thread services underneath. Roots need to be viewed as assets/services such as water/power or telecommunications.

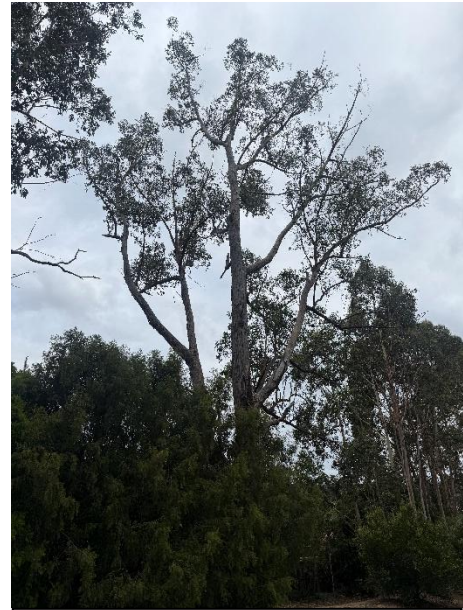
There is a visitors car park proposed along the driveway. A potential location could be within Tree 6 and Tree 7s TPZ. Tree 6 is declining and has a short life expectancy. Tree 7 is a dead tree and not compatible in a public space over roadways and buildings. These trees appear to not be suitable for the urban environment. Installation of the car park would still require construction sensitive measures and arborist supervision.

Figure 5. Tree 6 showing thin canopy and dieback present.

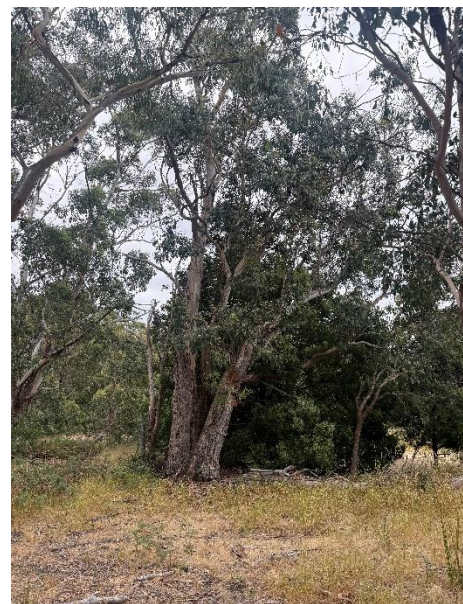
Tree 45 is large specimen at the edge of the development and may experience some encroachment. The tree is a poorly structured specimen with multiple failures and extensive decay. This tree can be retained with the development. However, it is dependent on whether the trees' risk can be managed. Exclusion zones and heavy pruning are required.

Figure 6. Tree 45. The tree has large hollow sections and failures.

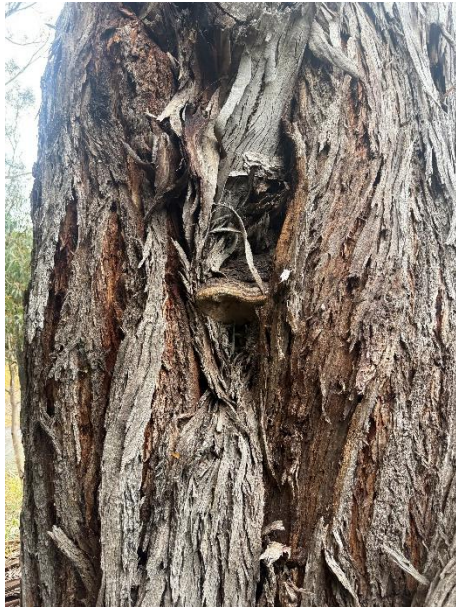
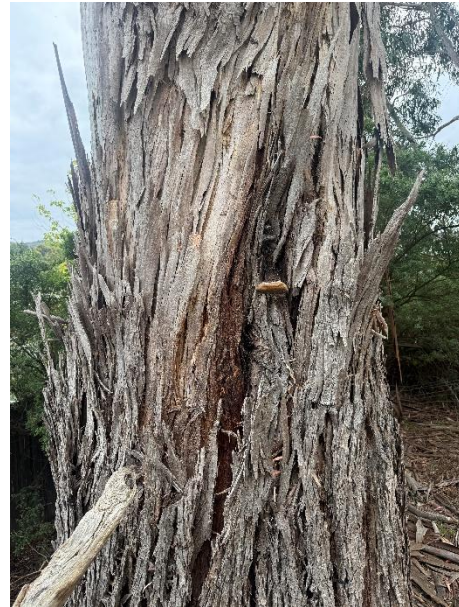
Figure 7. Tree 16. Image showing fungal fruiting bodies that require further investigation.

Figure 8. Tree 16. Image showing fungal fruiting bodies that require further investigation.

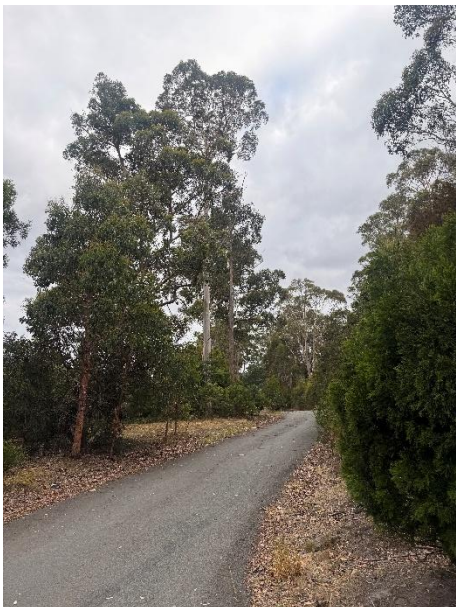
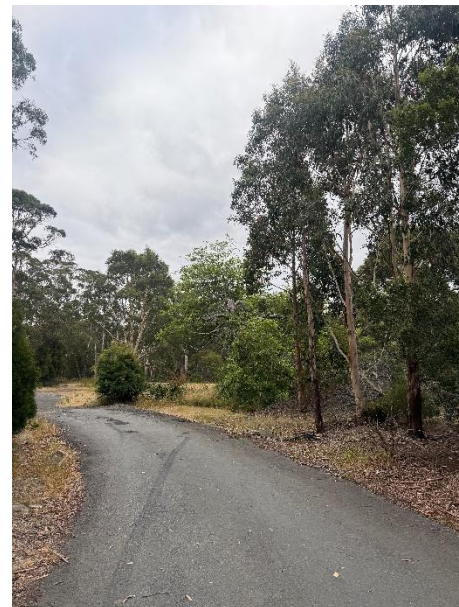
Figure 8. Image of pre-existing roadway.

Figure 9. Image of pre-existing roadway.
