## Arboricultural Report

**Joscon Tasmania Pty Ltd**

**224 Longmans Road, Margate,  
7054, TAS**

**Tree Pioneers Pty Ltd**  
**ABN: 15 687 986 876**  
Franklin,  
Tasmania, 7113

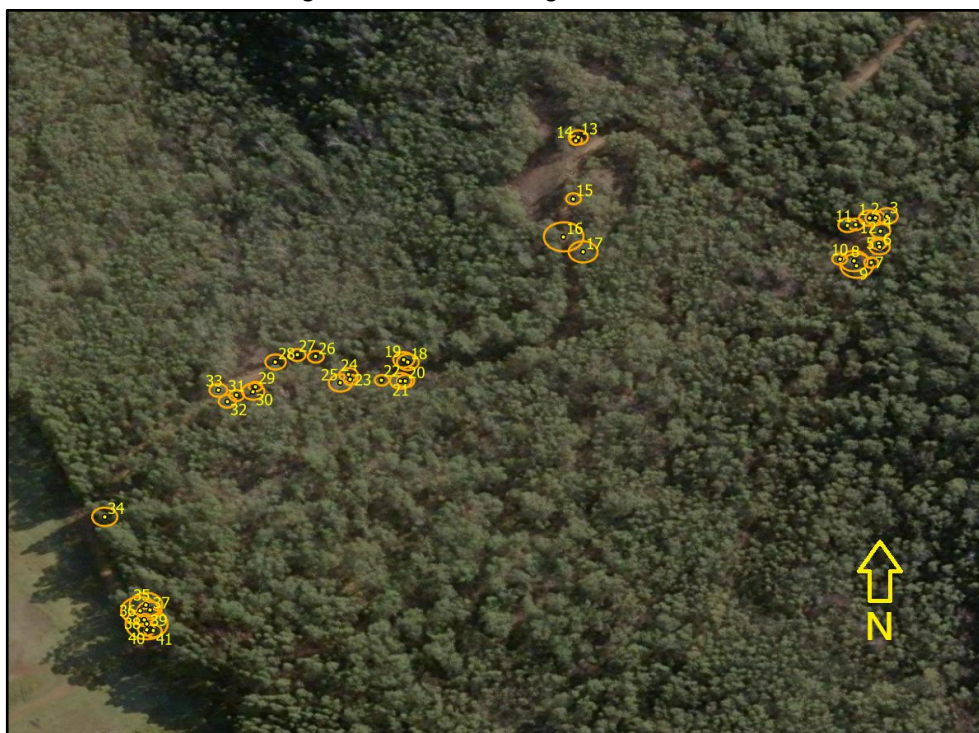
Figure 2. Trees within 15m of the access road upgrade and there TPZ.

- A) Map with tree locations (Figure 2) and tree data (Table 1) provided in report.
- B) No trees to be removed
- C) Trees can be retained with above grade installation of the access road extension for bushfire compliance.

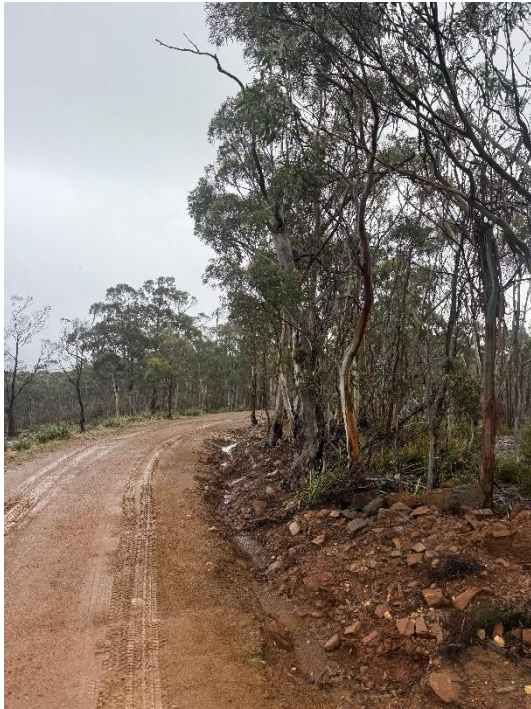
The site has an existing above grade access road. This road has been installed well. There are existing drains and walls between the trees on site and the road. There are differences in topography throughout the site making it unlikely for any roots to be near the roadway.

**Figure 3.** Image of above grade access road.

- A gravel access road can be extended in the same fashion it has been developed. That is above grade and semi permeable construct. This development must be undertaken sensitively to avoid damage to the roots. An example would include a larger rock (ballast rock) as a base and smaller rocks as a finish on top.

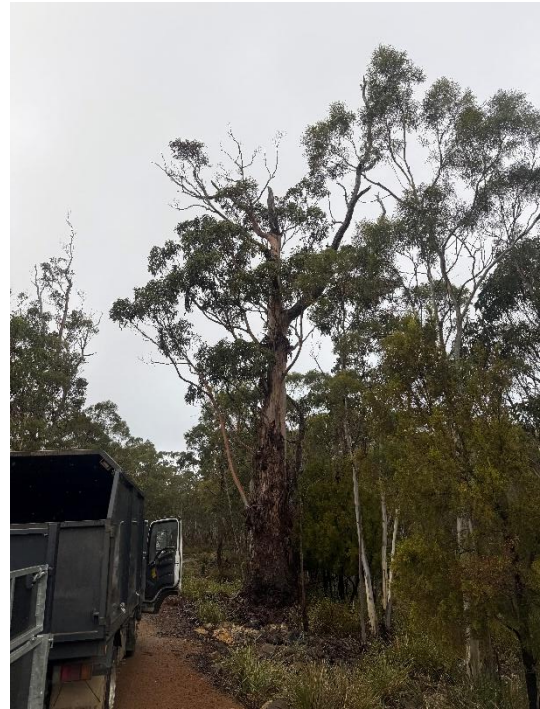
**Figure 4.** Image of Tree 16.

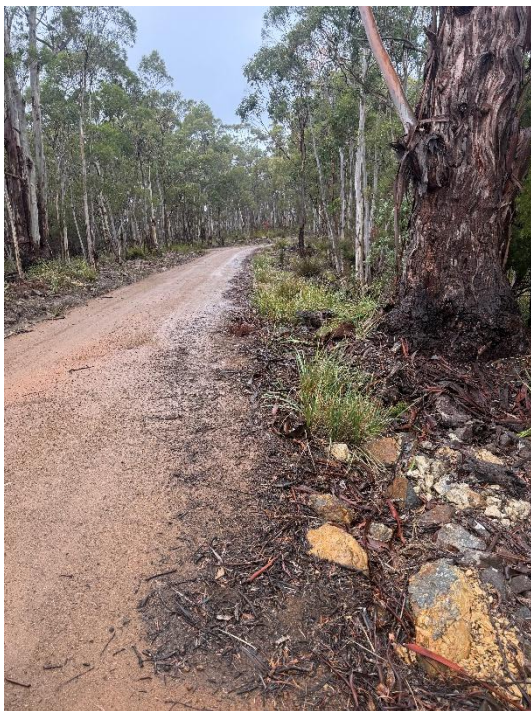
**Figure 5.** Image of above grade access road.

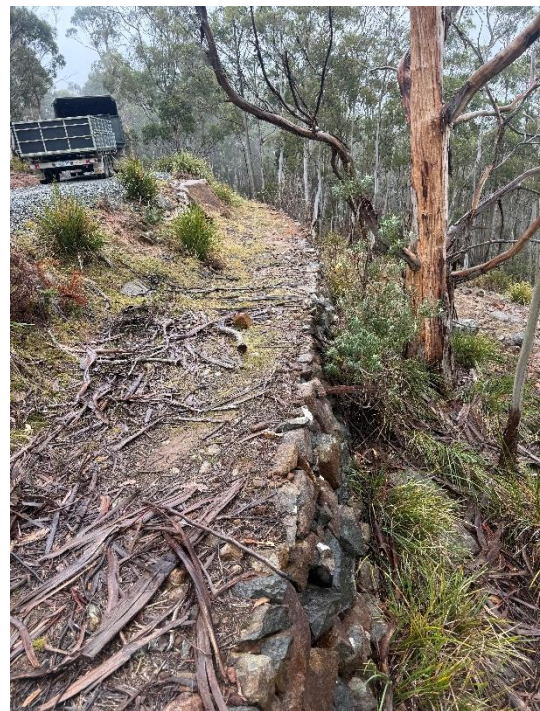
**Figure 6.** Image of old stone wall separating trees and access road.

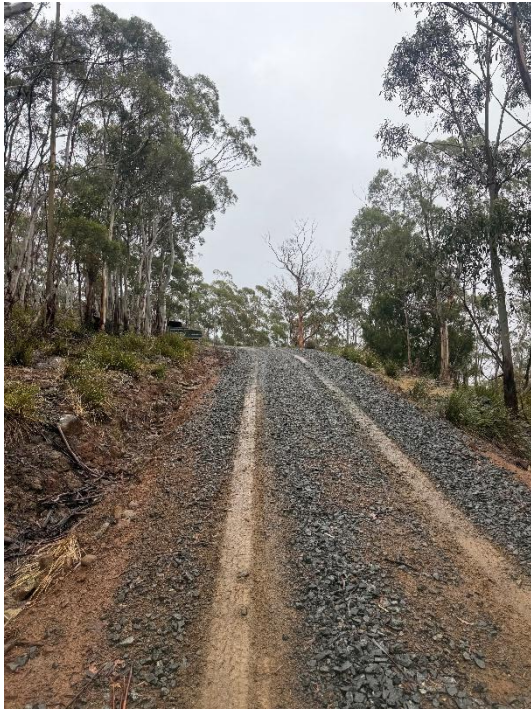
**Figure 7.** Image of above grade access road.

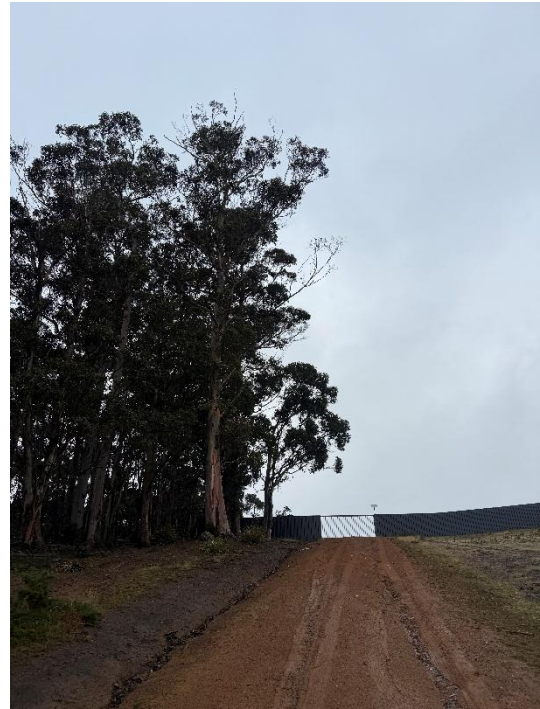
**Figure 8.** Image of front gate with large trees beside it.
