ARBORICULTURAL IMPACT ASSESSMENT

UPGRADE OF EXISTING VEHICLE ACCESS

BULK EARTH WORKS IN TREE ROOT ZONES

283 SANDFLY ROAD  
MARGATE 7054

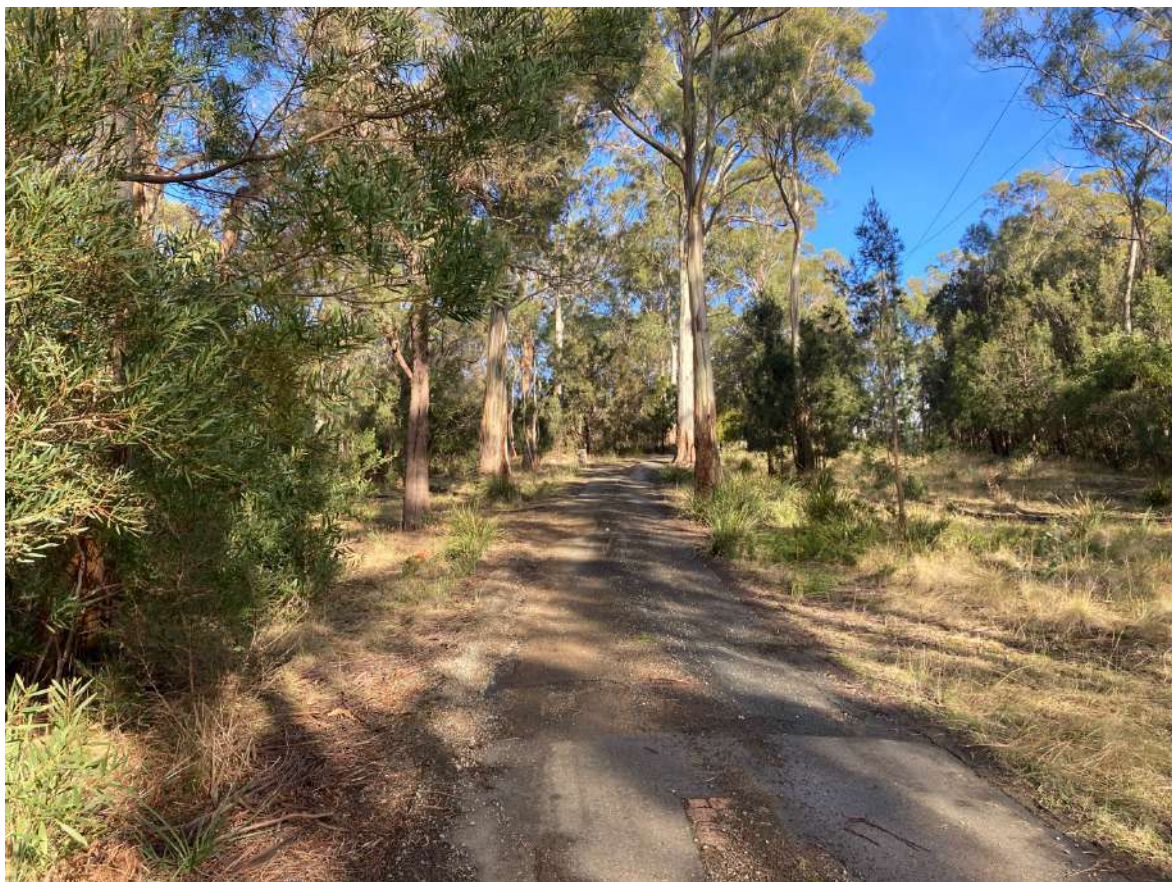
**Figure 2:** The existing access lower section looking southwest from the start of the survey area at chainage ~65m to chainage 120m (approx.)

- 5.2.2.1 The proposed upgrade of the existing access will result in a notionally **unacceptable** level of encroachment on the NRZ area of HCV tree **8** as well as trees **3, 5, 16, 17, 18, 22, 23 & 31** including works within their Structural Root Zones (SRZ). Surface disturbance, excavation & compaction associated with typical vehicle access demolition, upgrade & sealing works will likely sever/damage significant absorbing & structural roots resulting in an **unacceptable** adverse impact & potential instability of these trees. However it is likely that the proposed works can be successfully achieved with tolerable long term impact if appropriate protective measures are properly implemented and controlled in accordance with the tree protection measures outlined in with **sub-item 6.4.2 & item 6.6** of the **Tree Protection Specification (TPS)** presented in **Section 6** of this document.

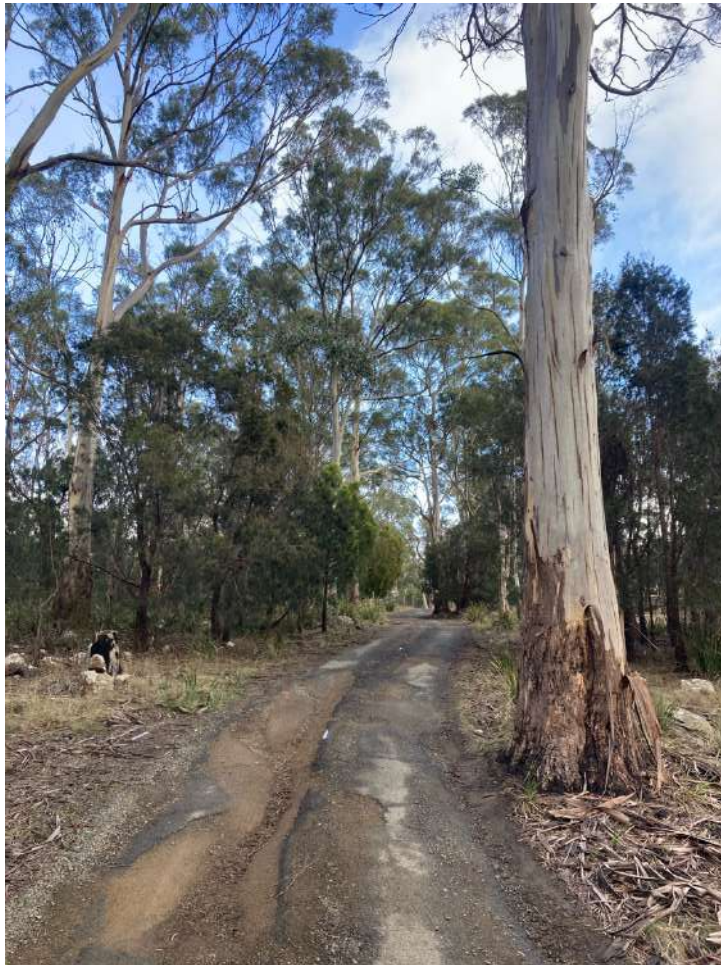
**Figure 3:** The existing access upper section looking southwest from chainage ~120m to the end of the survey Route at chainage 186.4m

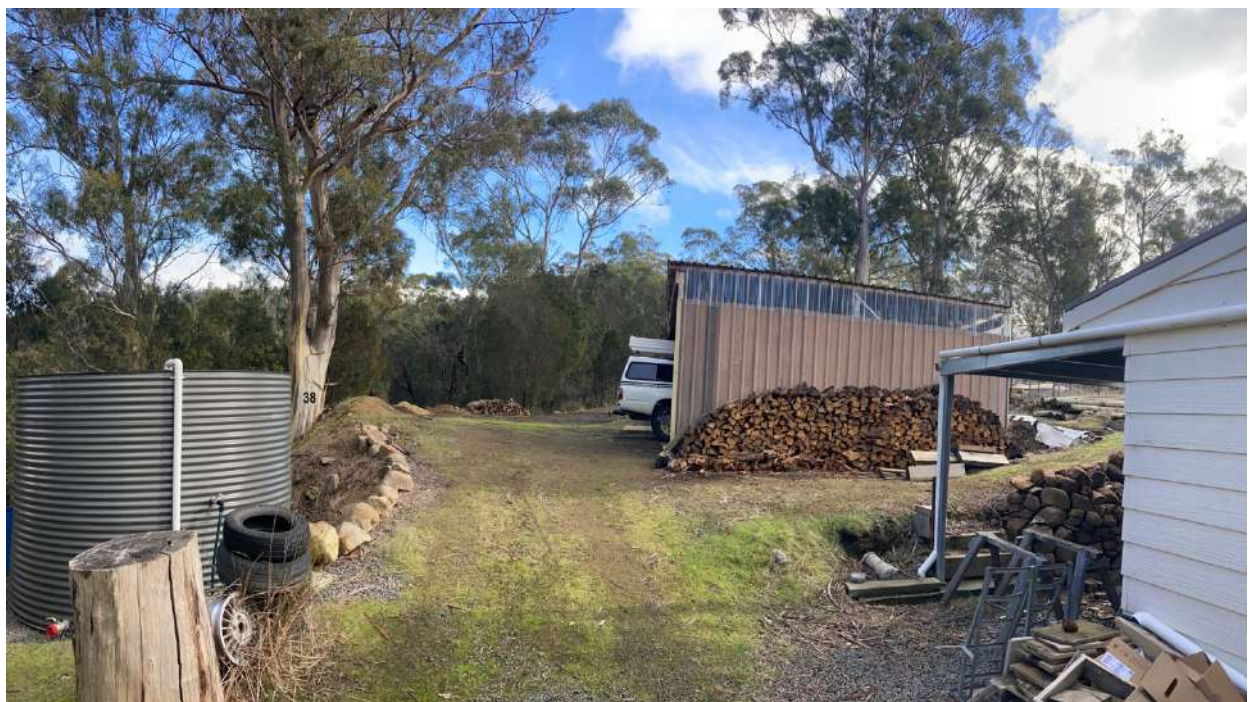
**Figure 4:** The area of bulk earthworks associated with the subject outbuilding/lean-to in the root zone of tree 38

- 5.2.3.1 The bulk cut & fill earth works conducted in association with the construction of the new outbuilding has resulted in a major (>40%) encroachment on the NRZ/SRZ area of HCV tree **38** including deposition of fill approx. 1.5m up its western trunk face (figure 7 below). In addition the fill deposition resulted in a moderate (~15%) encroachment on the NRZ area of tree **40**. Compaction of the existing soil surface by the bulk fill will undoubtedly have had an adverse impact on the subject trees by direct load force damage of absorbing root mass as well as reducing water infiltration & aeration/oxygen exchange to the roots. In addition the covering of the trunk base of tree 38 will have resulted in increasing likelihood of its infection by decay causing fungal pathogens. However, due the amount of fill and the time since deposition (2021) the practicable benefit of its removal without causing further possible damage to the trunk and structural roots of tree 38 is questionable. As the subject trees have unimpeded access to open free soil to their south in which to undertake root expansion I consider the most practicable action would be to leave the fill to remain in situ as is.

- 5.3.4 Leave the fill deposits in the NRZ of trees **25, 26, 38 & 40** to remain in situ as is.
- 5.3.5 Create the proposed bushfire Hazard Management Area within the **TPZ** of trees to be retained in accordance with items **6.2 & 6.5** of the **TPS**.

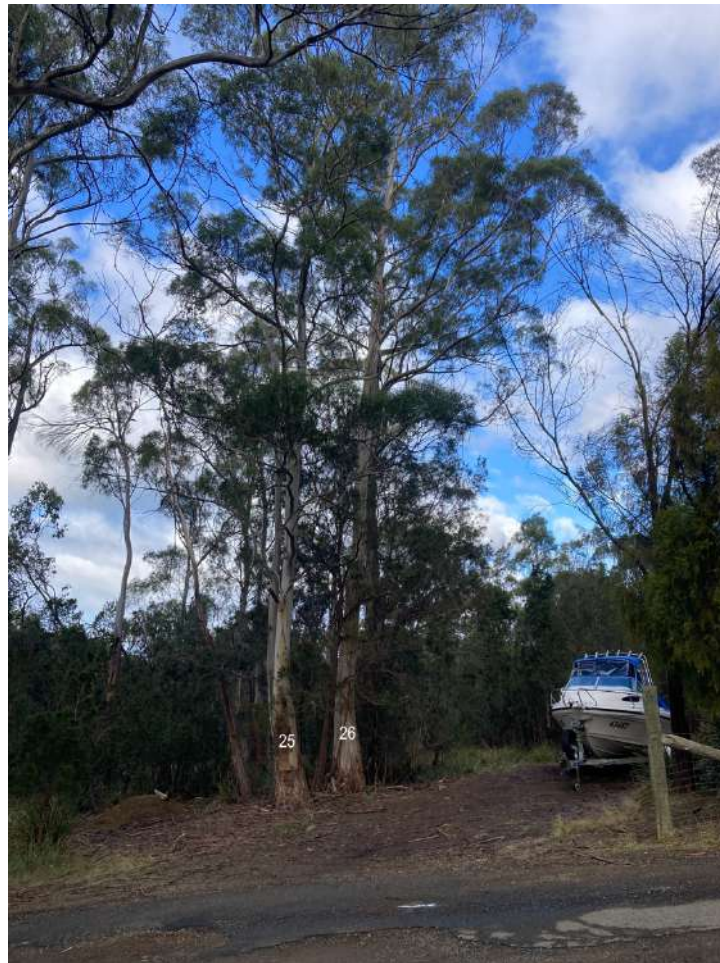
**Figure 5:** The fill deposit & compaction for construction of the boat parking/storage area in the root zones Of trees 25 & 26

- 5.2.4.1 The fill deposition & compaction conducted in association with construction of the boat parking/storage area has resulted in major encroachment (30% & 26%) on the NRZ areas of trees **25 & 26**. This level of encroachment with compacted fill will likely have had some adverse impact on these trees through direct shear force damage & alteration of the water infiltration & gaseous exchange potential. However it is also feasible that new absorbing roots of the subject trees have migrated into the fill material in the interim since its installation and, as such, its removal may be more damaging to the trees than leaving it in situ. Accordingly I consider that it would be most practical to leave the fill to remain in situ as is.

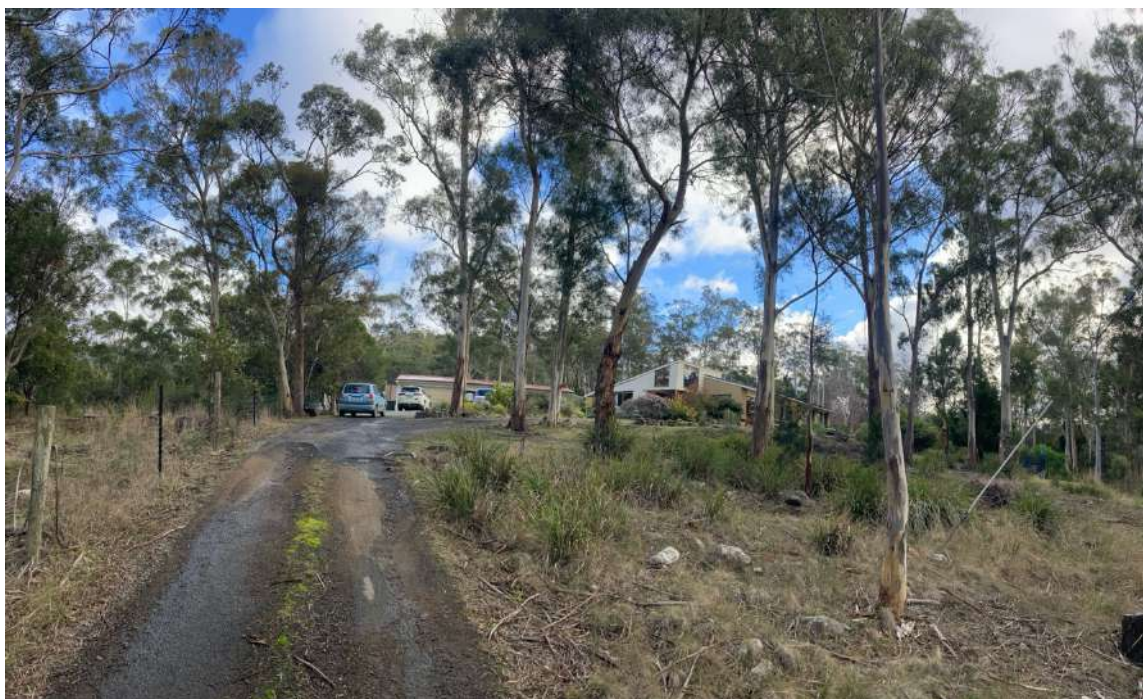
**Figure 6:** The general area included in the proposed Bushfire Hazard Management Area including the site dwelling & access terminus turning circle.

- 5.2.5.1 Creation of the proposed bushfire Hazard Management Area (G.J. Williams, 2023) will occur with the NRZ of trees **28-40, 42 & 43**. These works will have a **minimal/tolerable** impact on the subject trees so long as they are conducted in accordance with items **6.2 & 6.5** of the **TPS**.

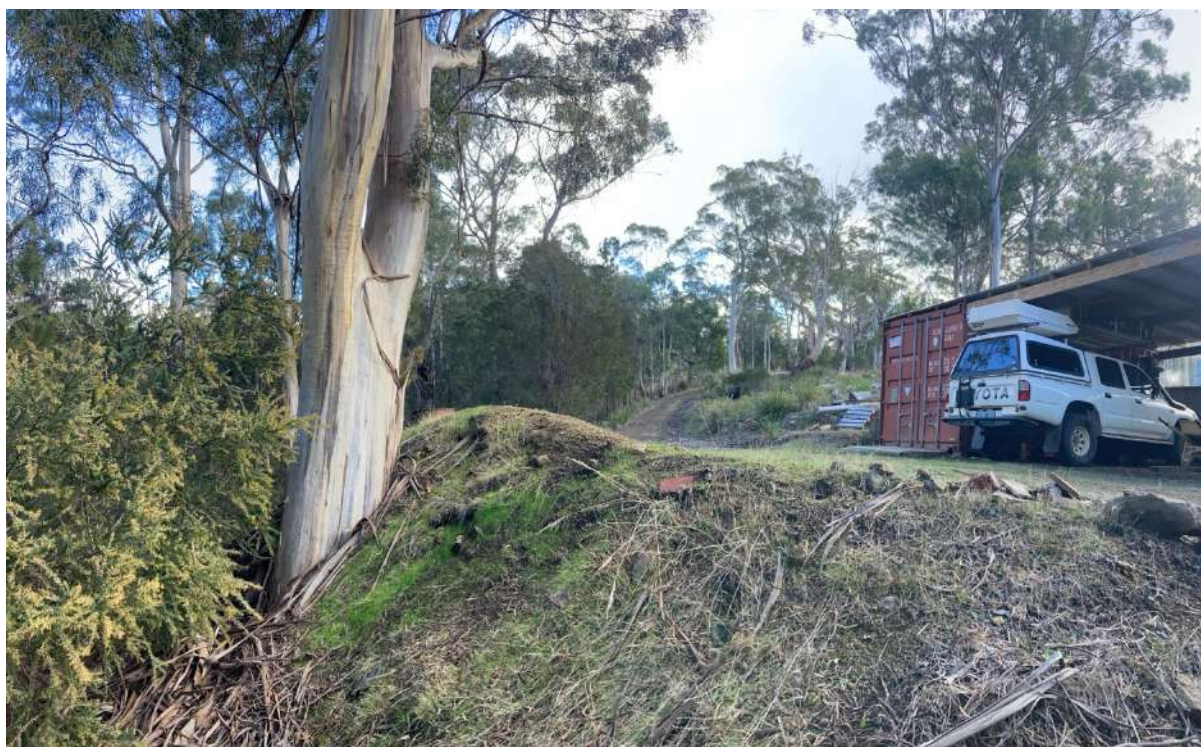
**Figure 7:** Bulk fill covering the western face of tree 38

| Identifier | Species | Age Class(m) | Height (m) | Spread (m) | DSH (m) | DAB(m) | Overall Vitality | Overall Structure | Life expectancy | Conservation Value | NRZ(m) | SRZ(m) | NRZ/SRZ Encroachment | Likely Impact | Recommendation | Comments |
|---|---|---|---|---|---|---|---|---|---|---|---|---|---|---|---|---|
| 38 | <b>White Peppermint</b><br>( <i>Eucalyptus pulchella</i> ) | M | 16-20m | 10 | 0.80 | 0.88 | P | F | S | VH | 9.6 | 3.1 | Ma<br>(40%)+ SRZ | Likely <b>adverse</b> impact from soil deposition due to compaction & burying of trunk base | Rt | Tree stressed with canopy thinning and dieback. Fill Placed ~1.5m up western trunk face. <b>Leave fill in situ as removal may cause further trunk &amp; root damage.</b> |
