# **PRELIMINARY LANDSLIDE RISK ASSESSMENT**

**283 Sandfly Road, Margate, TAS, 7054**

**02 June 2024**

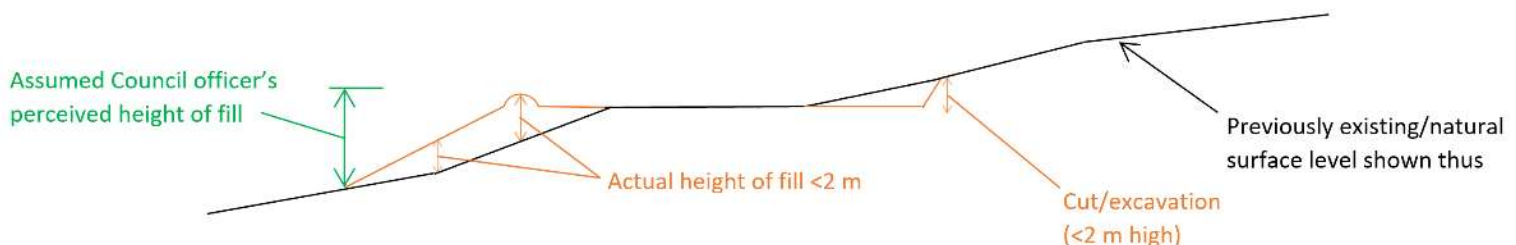
**Figure 2** – Explanatory fill height diagram – nominal cross section through centre of subject cut and fill area.

- 3.7 The southern batter of the placed fill is approximately 1H:1V. The height of the fill varies, as the natural ground below is moderately sloped toward the south to south-east. As such, the apparent height on the southernmost edge of the fill appears greater than the actual height of the fill, which was estimated to be a maximum of 1.5 m vertically above the previously existing/natural ground surface. Refer Figure 2 below.

Given the site observations noted above, it is contended that the fill does not exceed 2 m in height as suggested by Council. A sketch diagram is provided in Figure 2 below to assist in illustrating the effect of placing fill over the naturally sloping ground, with the perceived height of fill tending to appear much greater than the actual height of the fill. The subject fill, is in no location, estimated to exceed 2 m in height above the natural ground level. The subject excavations in the local area also do not, in any location, exceed 2 m in depth from the natural ground level. This being the case, the works are deemed to comply with acceptable solution clause 26.4.3 A3, and the performance criteria clause 26.4.3 P3 (c) is therefore irrelevant.

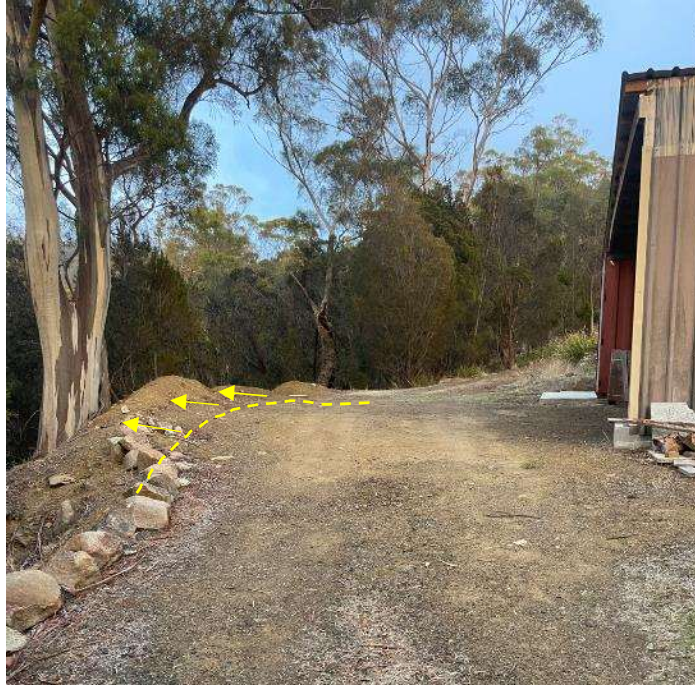
- 3.3 The only fill in the vicinity of the subject works is to the south of the shipping container and lean-to where spoil from the adjacent cut excavation has been placed.

- 3.4 The subject fill has been placed on the southern side of a previously existing access track, running approximately east-west, to the immediate south of the shipping container structure. Neither the access track nor any of the adjacent structures are supported by the placed fill.

**Photo 1:** Looking west along the southern elevation of the shipping contain/lean-to structure (and access track). Note subject fill to left side of picture.

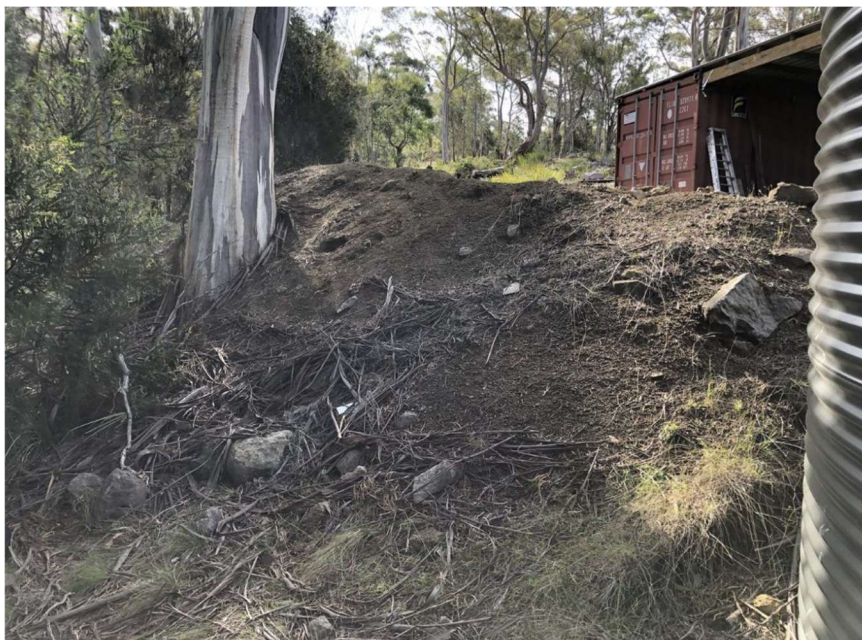
- 3.5 No failure or slumping of the fill was observed, and vegetation has started to establish on parts of the fill embankment.
- 3.6 The fill material, where observed, is doleritic clayey gravel with fragments of extremely weathered dolerite rock and occasional hard rock cobbles.

**Photo 2:** Eastern end of subject fill viewed from downslope.

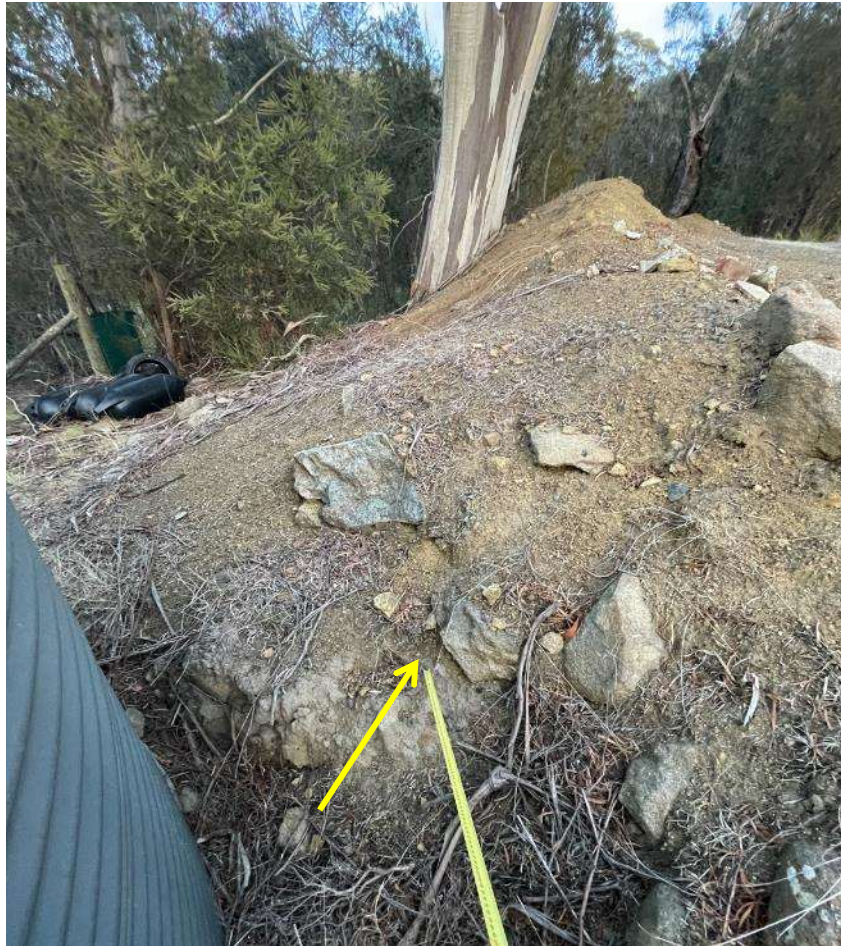
**Photo 3:** Eastern end of fill looking west. Previously existing/natural ground can be observed.

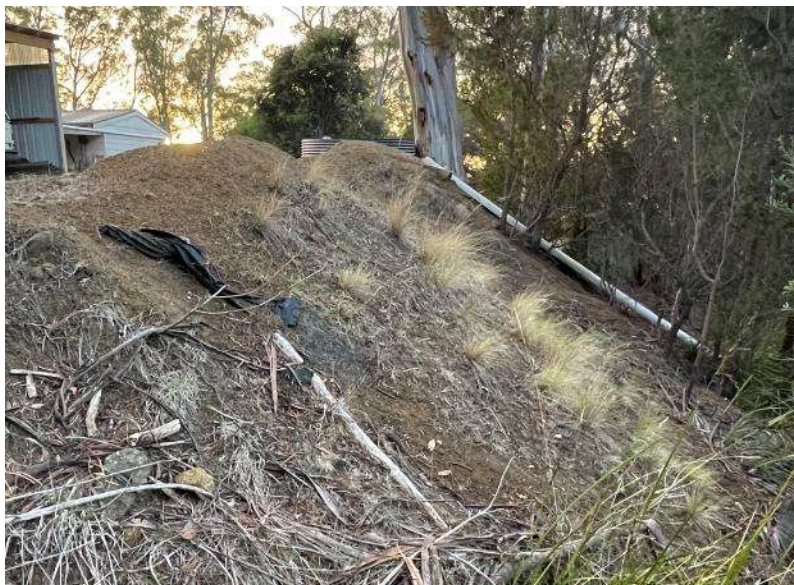
**Photo 4:** Western end of fill looking east.

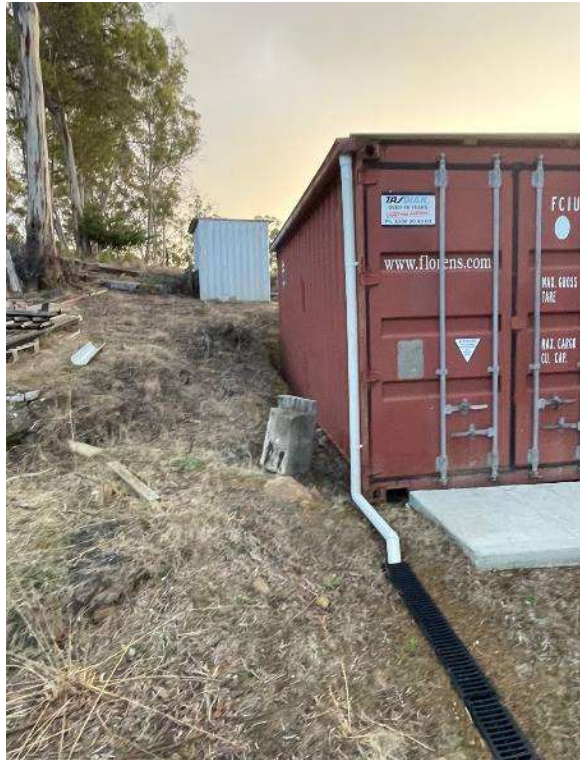
- 3.11 The roof of the subject structure is drained via a roof gutter and down pipe which is connected to a grated drain which outfalls to the south of the subject area. Generally, surface water appears to be able to drain away from the area of fill via the grated drain, which the surrounding area is generally graded towards. Given the sloped nature of the site, other general surface rainfall runoff would tend to freely drain down the slope to the south/south-east.

**Photo 5:** Looking north along western elevation of subject structure. Note excavation, roof drainage, and grated surface drain.

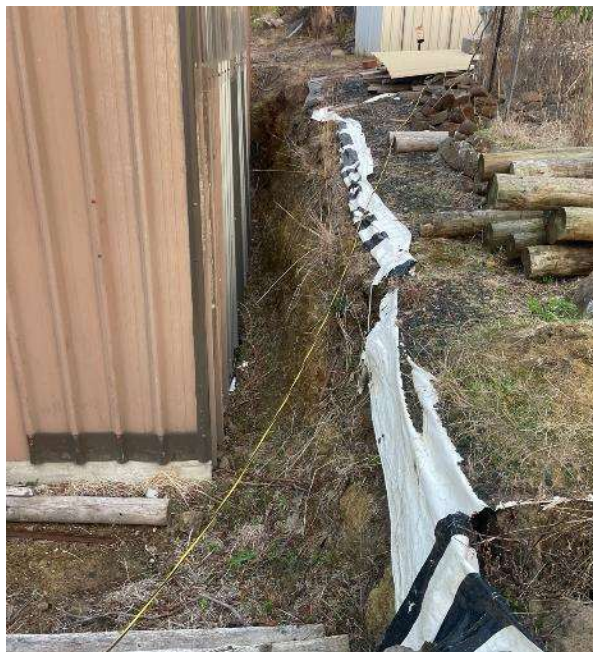
- 3.12 The excavation that has occurred at the site of the subject structure is a maximum of approximately 1.2 m in height (along the northern elevation). The excavation was observed to contain a slight backslope from the vertical and has occurred into natural ground, generally being, weathered dolerite rock, doleritic gravels, and clay.

**Photo 6:** Looking west along northern elevation of shipping container/lean-to. Note excavation.

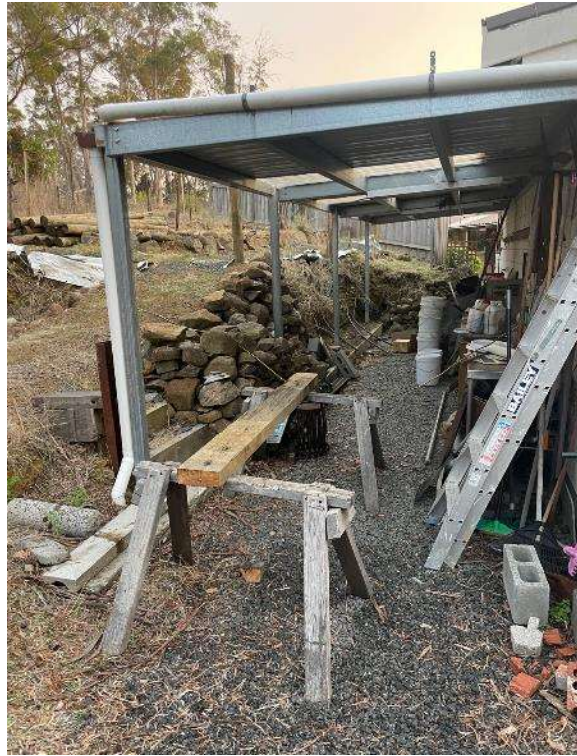
- 3.13 A secondary nearby excavation, similar in nature to that noted above, was observed to the western side of the existing shed/garage. It was estimated to be approximately 1.5 m maximum in height. A dry stone wall partially covers the excavated face.

**Photo 7:** Nearby excavation along western elevation of adjacent shed/garage.
