BUSHFIRE HAZARD REPORT

Proposed residential dwelling
13 Coop Court
Kingston, 7050

Dated 20th May 2026
Report by David Lyne BFP-144
Version 3.0

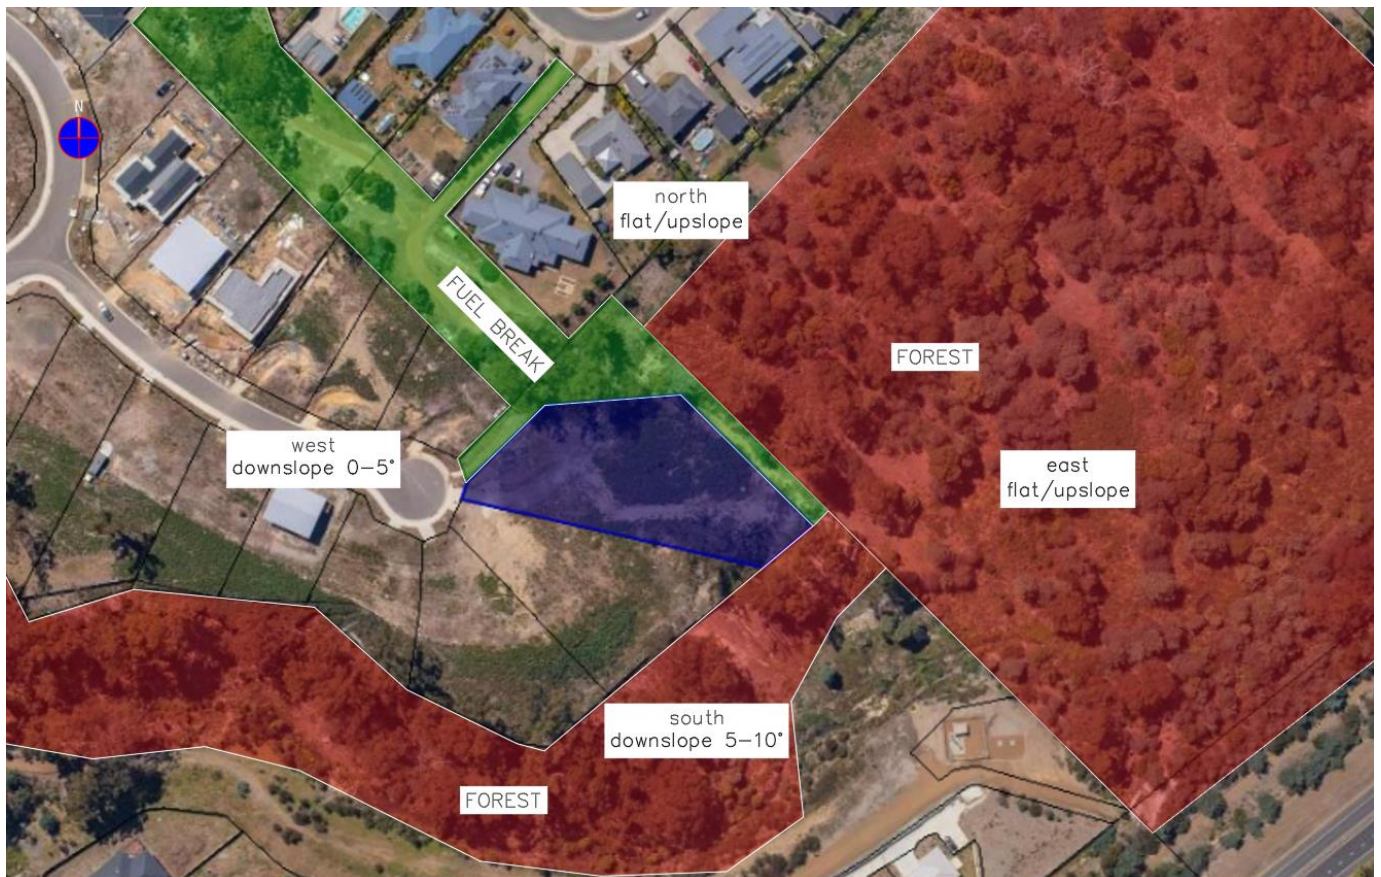
Photo 1 – Site analysis with Cadastral Overlay – Subject site highlighted blue.

Note: in a bushfire there is a possibility of fire attack from any direction, not just the direction of the highest hazard. Photo 1, above indicates the Bushfire Prone Vegetation described. Refer to Appendix B for current conditions as at time of inspection.

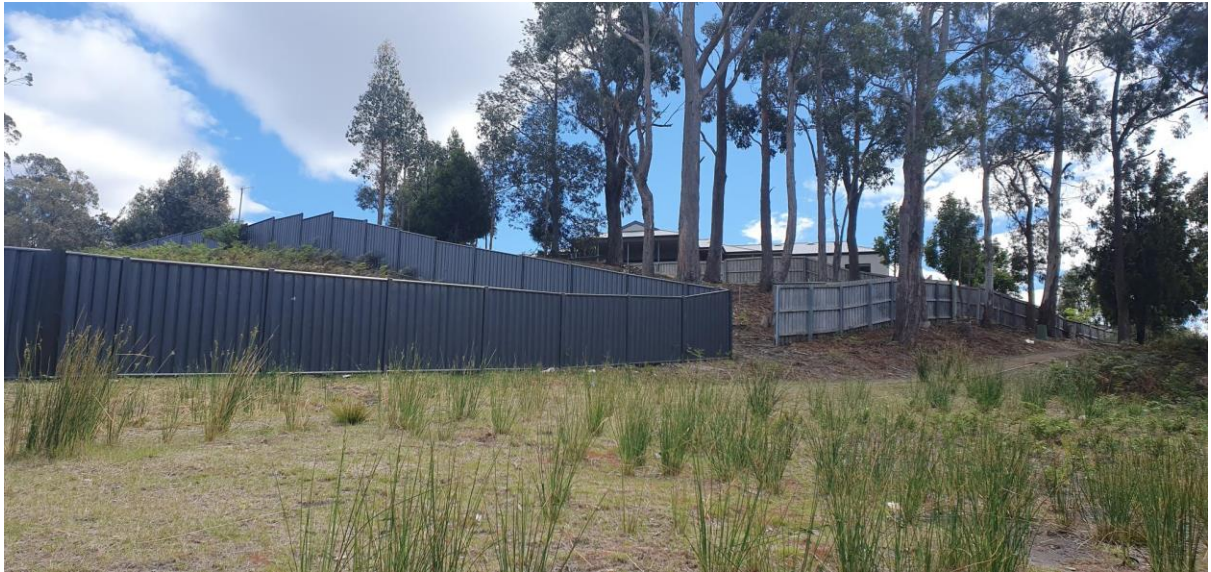
Looking North

The Council maintained pathway and reserve interface located to the north and north-west of the allotment presents a modified fuel environment compared to the unmanaged forest vegetation to the east and south of the site. The understory vegetation within this area has been observed to be periodically maintained in accordance with Council reserve management practices, resulting in a reduced surface fuel hazard and increased separation between the proposed dwelling site and unmanaged vegetation.

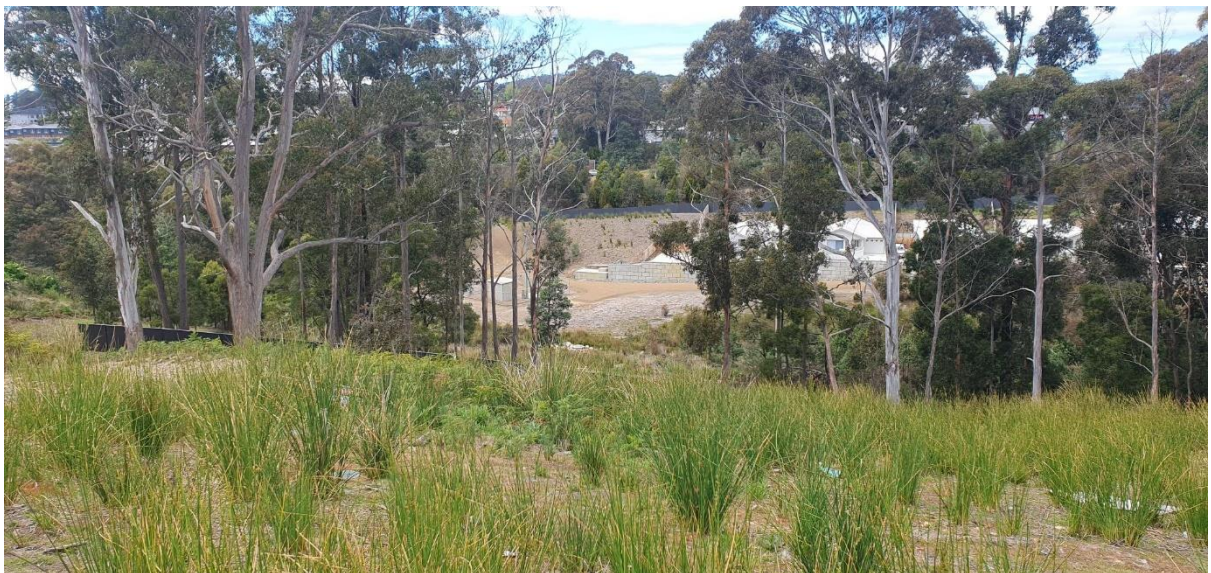
Looking South

From the proposed dwelling site a 360° survey has been conducted to determine the vegetation type, proximity and slope under the vegetation which is of the highest hazard rating. In this case the **Forest** to the south and to the east is the highest hazard vegetation surrounding the dwelling.

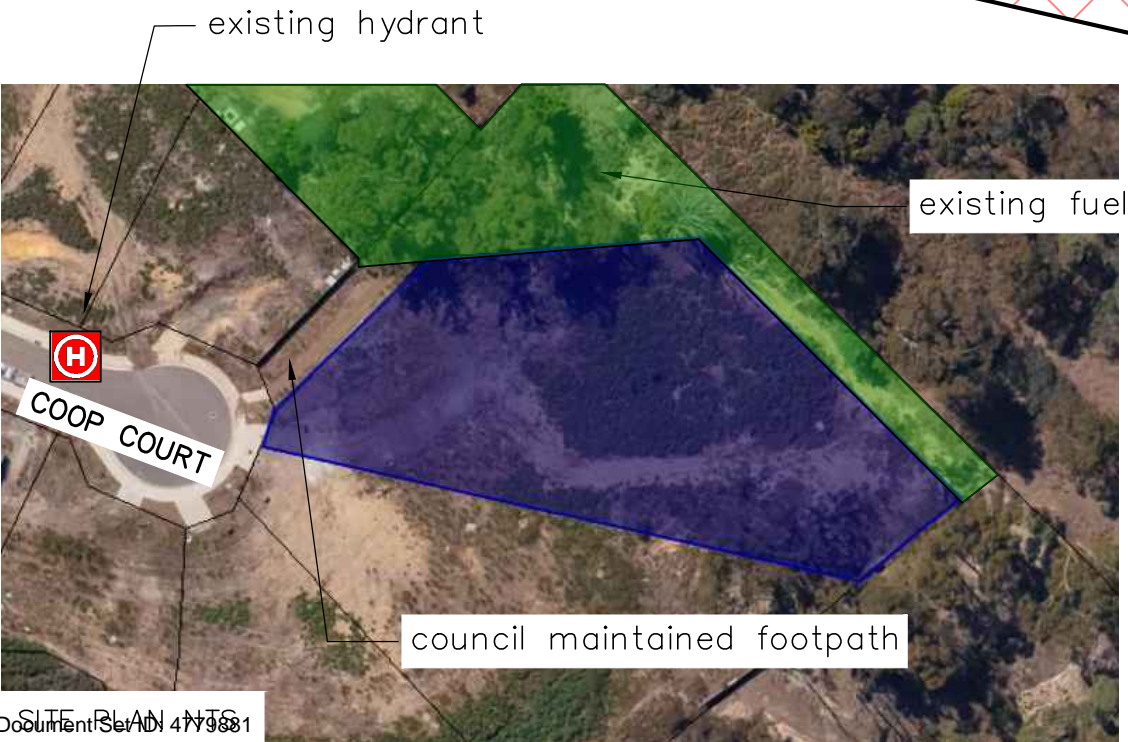
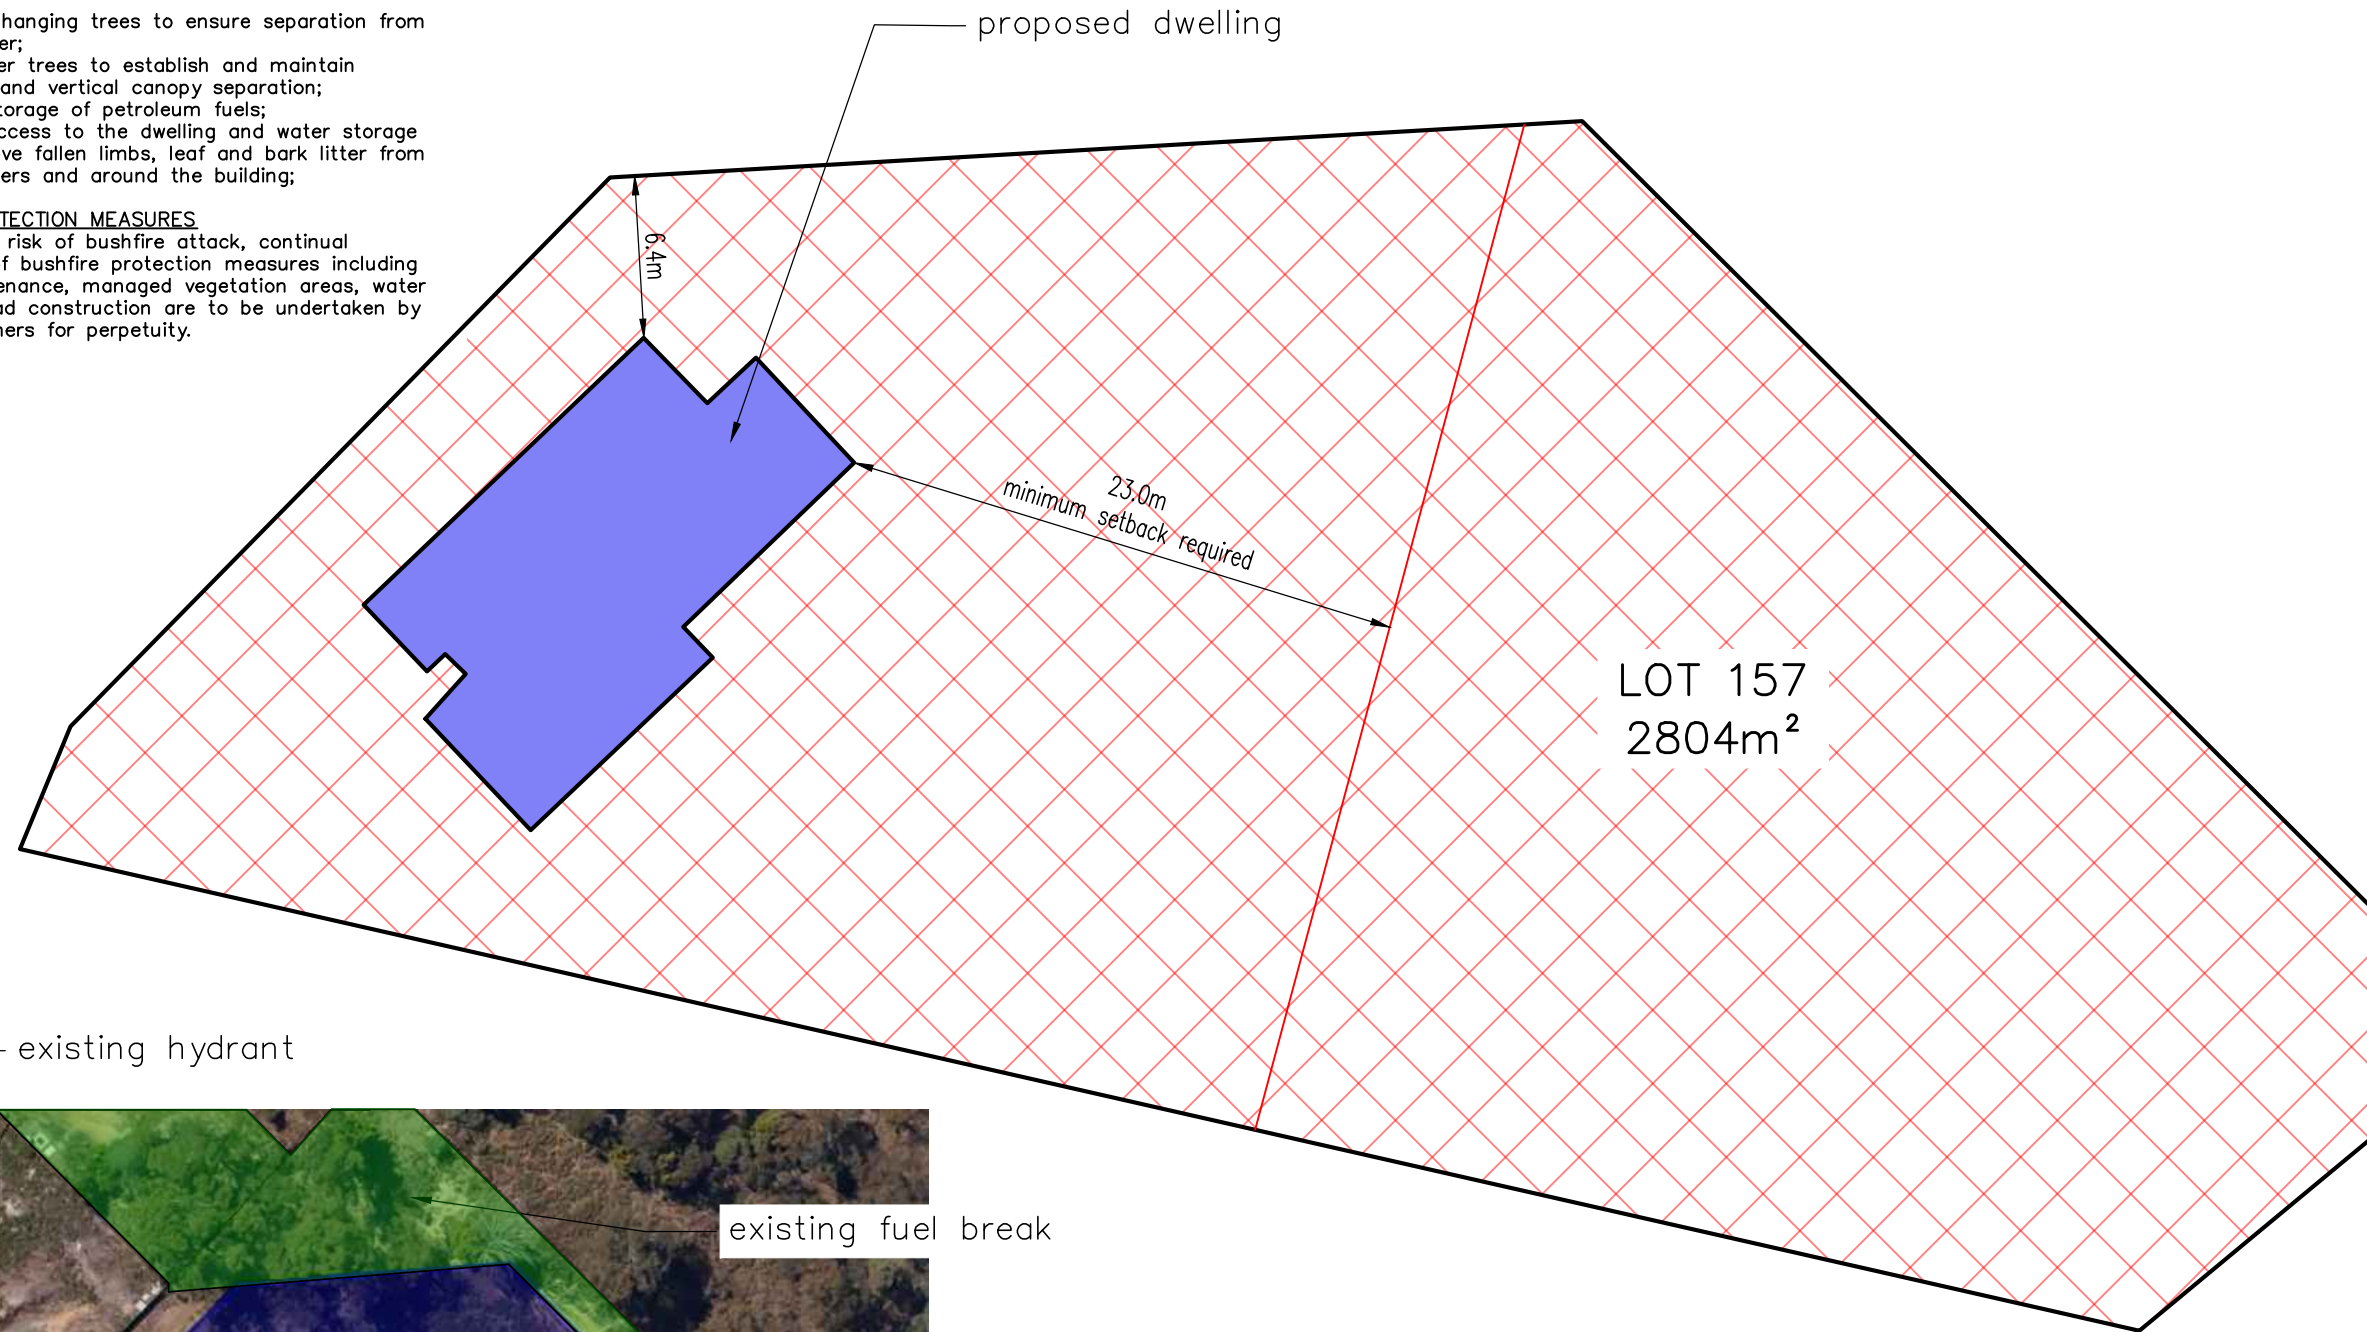
BHMP
 SCALE 1:200

HAZARD MANAGMENT AREA
 Low threat, maintained vegetation in accordance with AS 3959 – Clause 2.2.3.2 (e) & (f). Building is to be constructed to meet BAL-19

Hazard Management Area includes the area to protect the Building as well as the access and water supplies. The entirety of this allotment should be treated as HMA. Vegetation in the Hazard Management area is to be managed and maintained in a minimum fuel condition. The HMA is determined from the unmanaged vegetation on neighbouring allotments, and should the level of the unmanaged vegetation increase the BHMP and HMA should be reviewed to determine the ongoing suitability of the BHMP and HMA associated with the development.

- Removal of fallen limbs, leaf and bark litter;
- Cut lawns short (less than 100mm) and maintain;
- Remove pine bark and other garden mulch;
- Complete under-brushing and thin out the under storey;
- Prune low hanging trees to ensure separation from ground litter;
- Prune larger trees to establish and maintain horizontal and vertical canopy separation;
- Maintain storage of petroleum fuels;
- Maintain access to the dwelling and water storage area Remove fallen limbs, leaf and bark litter from roofs, gutters and around the building;
