SITE AND SOIL EVALUATION REPORT **FOUNDATION AND WINDLOADING ASSESSMENT**

12 Streamside Way

Kingston

June 2025

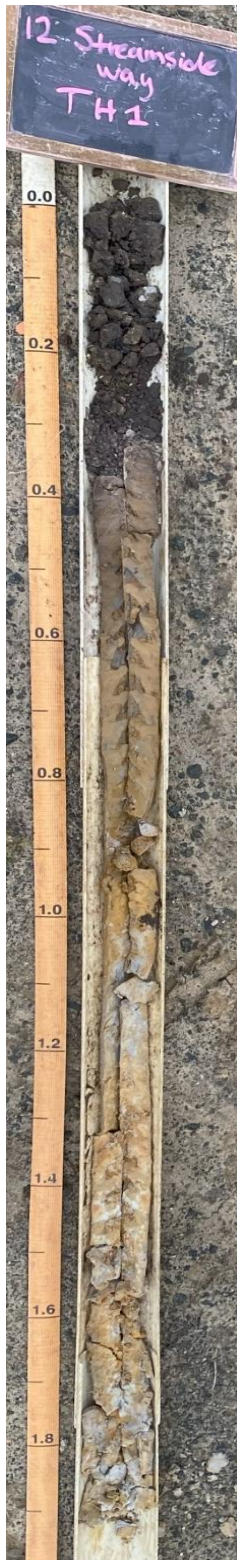
SOIL PROFILES – Test Hole 1

Depth (m)	Horizon	Description and field texture grade	USCS Class
0.0 – 0.3	FILL	Uncontrolled FILL	
0.3 – 0.4	A1/A2	Very dark greyish brown (2.5Y 3/2) grading to grey (10YR 6/1), Loamy Fine Sand , weak fine polyhedral structure, dry loose consistency	SM
0.4 – 1.0	B2 _{1g}	Brownish yellow (10YR 6/6) with grey (10YR 5/1) mottles, Fine Sandy Medium Clay , massive, very moist soft consistency, Fe oxides down root channels.	CH
1.0 – 1.5	B2 _{2g}	Mottled light grey (2.5Y 7/1) and yellow (10YR 7/6), Sandy Silty Light Clay , massive, moist soft consistency	CH
1.5 – 1.9	B2 ₃	Mottled light grey (2.5Y 7/1) and yellow (10YR 7/6), Sandy Light Clay , weak coarse angular blocky structure, slightly moist firm to soft consistency, sand down cracks <u>No Refusal</u>	SC/CL

Layers of uncontrolled fill are present on the site to maximum observed depths of 0.5 m.

The soil profiles are formed from windblown sands over clayey colluvium derived from Triassic sandstone. The profiles are deep with effective refusal occurring at approximately 2.4 m. The field textures of the soil profile are dominated by clay, which is highly reactive, weakly structured and mildly dispersive. The clays are poorly drained, evidenced by iron oxides down root channels deep in the soil profile. The DCP indicates a low bearing capacity to at least 2.1 m. Founding on the deeper more competent materials, at or below approximately 3.2 m depth, is recommended.
