ARBORICULTURAL IMPACT ASSESSMENT
UPGRADE & EXTENTION OF EXISTING VEHICLE
ACCESS FOR A PROPOSED RESIDENTIAL
DWELLING

**218 TALBOTS ROAD
SANDFLY 7150**

MARCH 2026

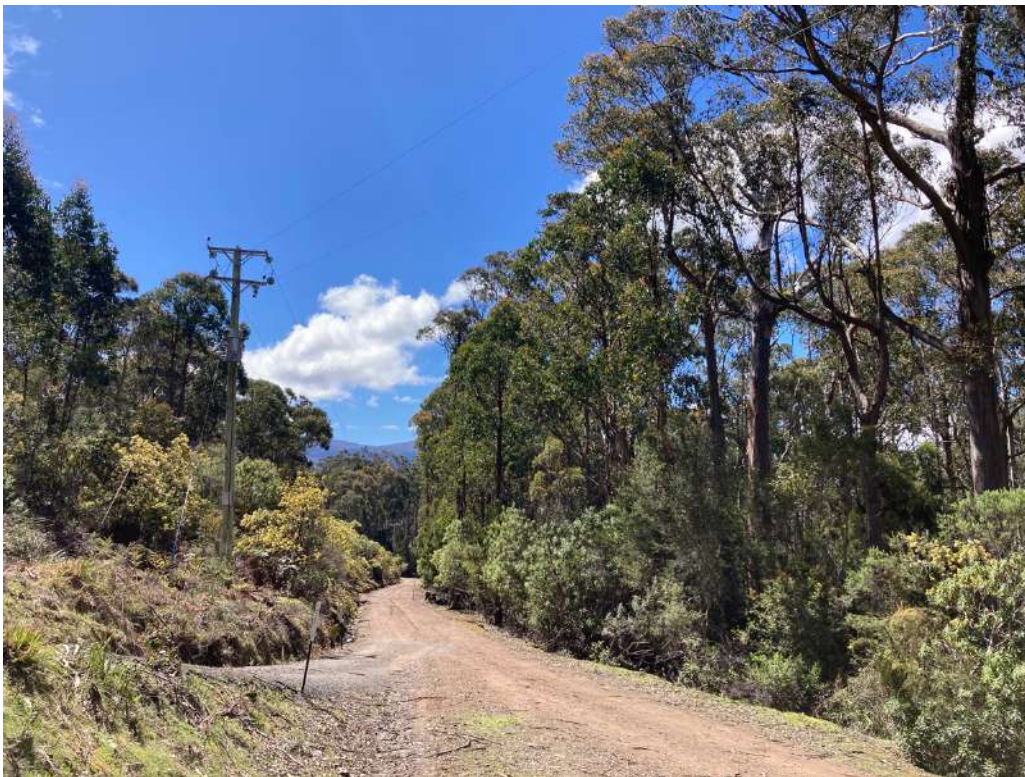
Figure 2: The 'shared' section of Talbots Rd looking north to the terminus of the Council maintained section of Talbots Rd.

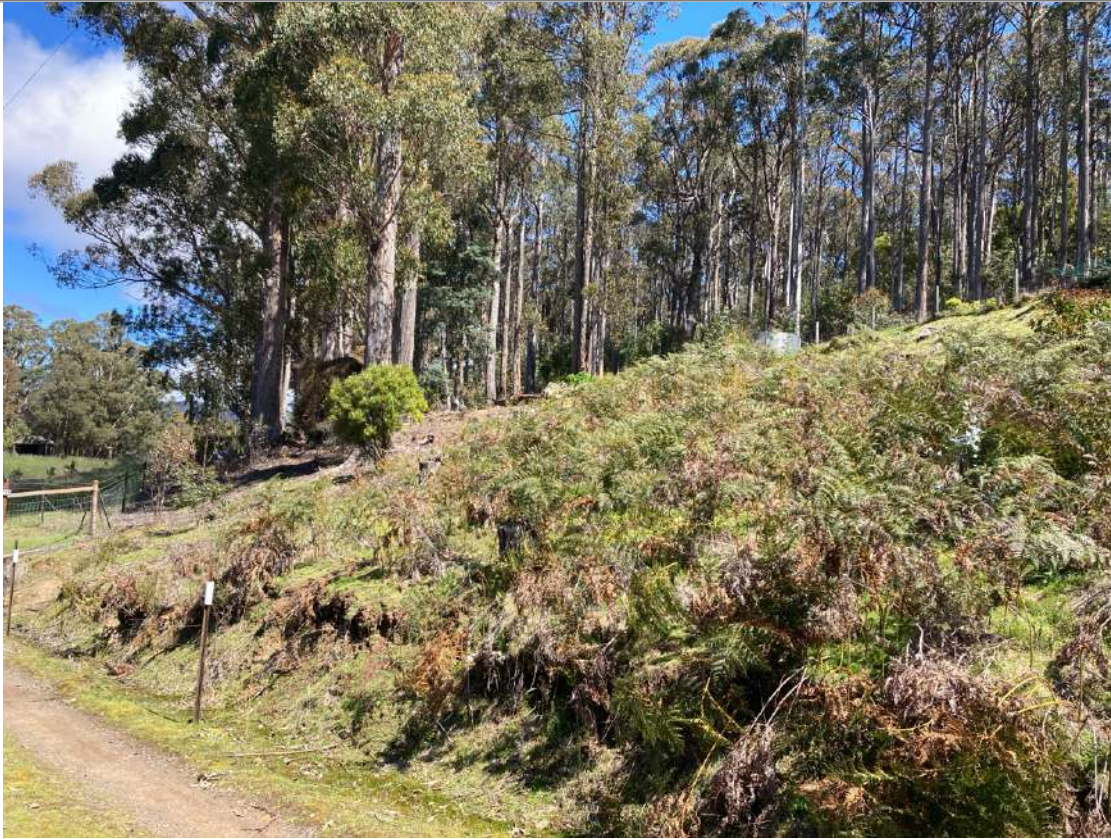
Figure 3: The proposed existing track extension route to meet with the 'shared' section of Talbots Rd

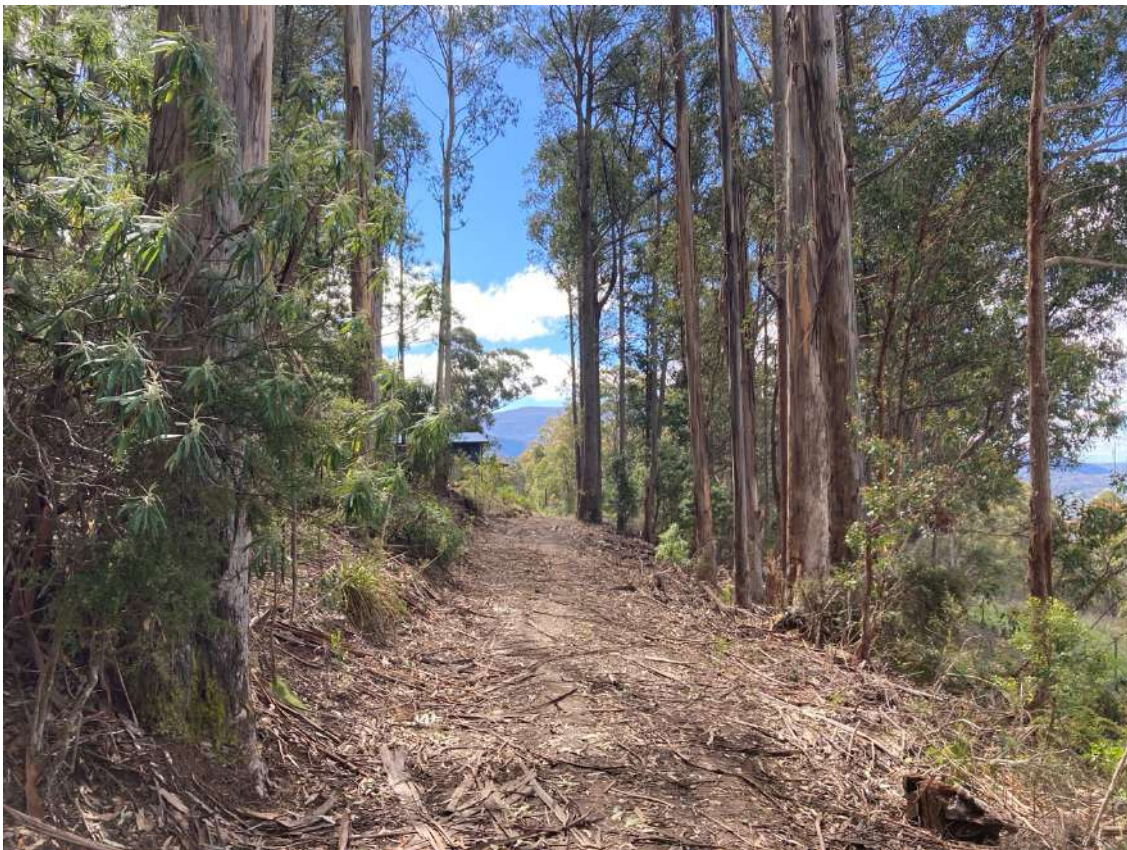
Figure 4: The northern terminus of the existing track looking north

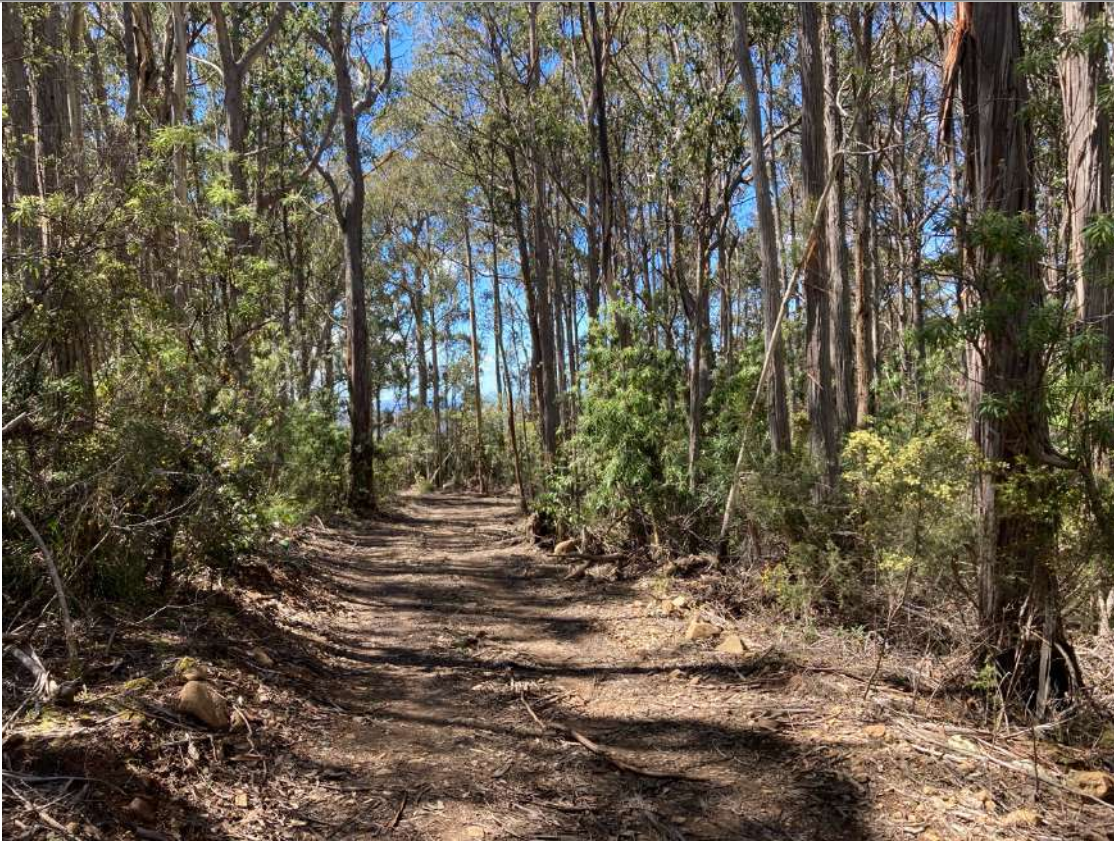
Figure 5: *Representative mid-section of the existing track looking north*

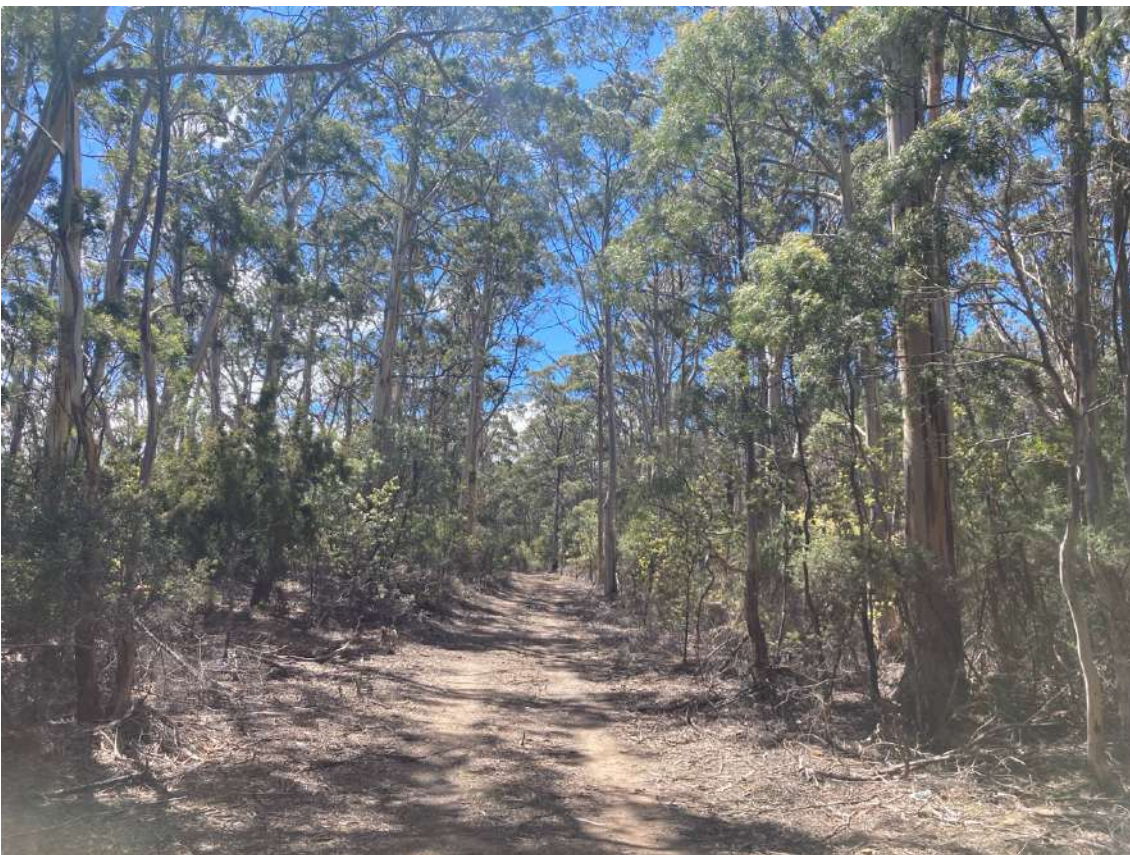
Figure 6: *Representative upper-section of the existing track looking north*

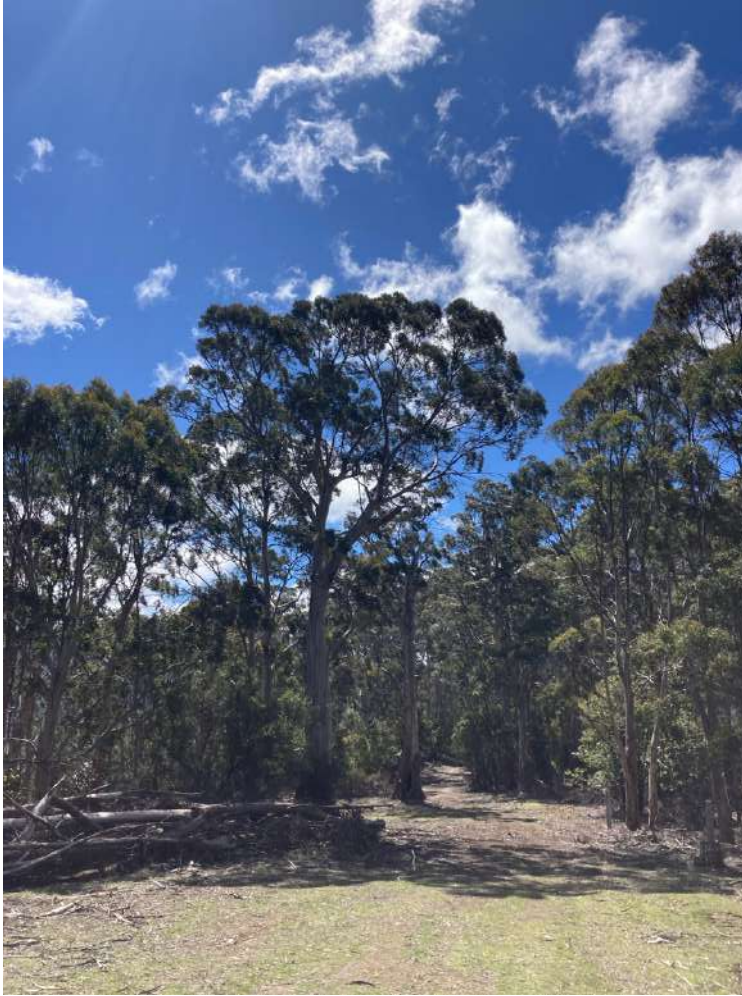
Figure 7: Southern terminus of the existing track looking north

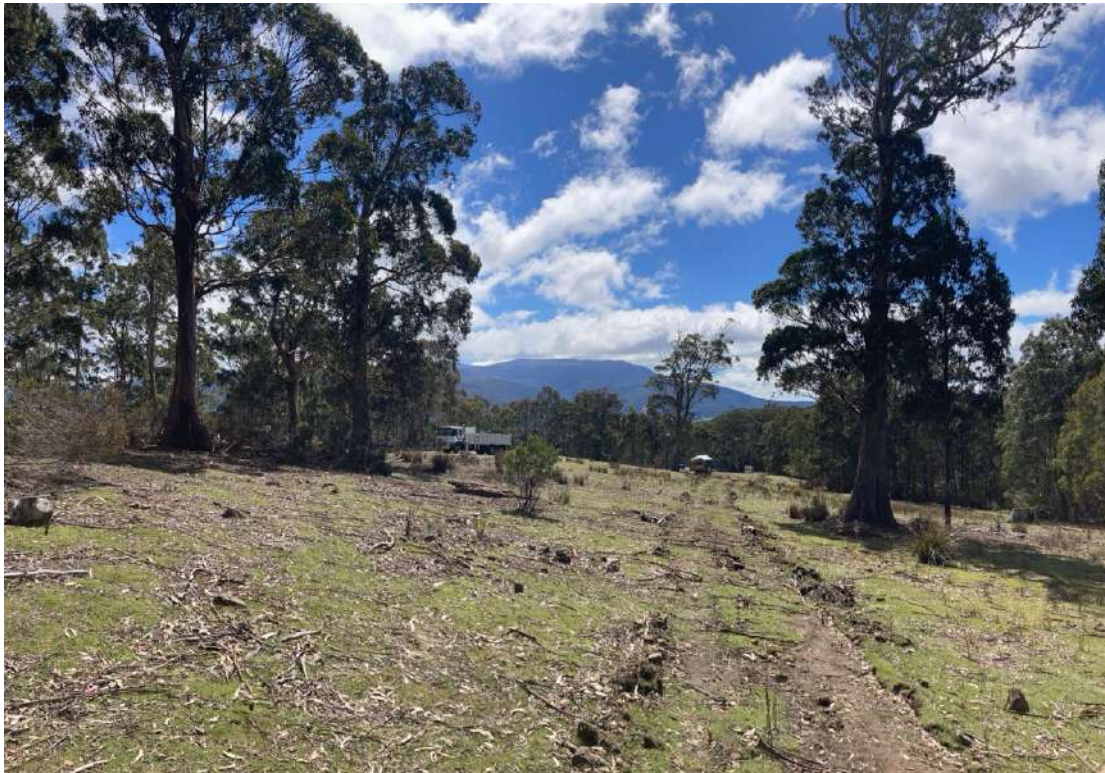
Figure 8: Proposed extension route of the existing track looking north

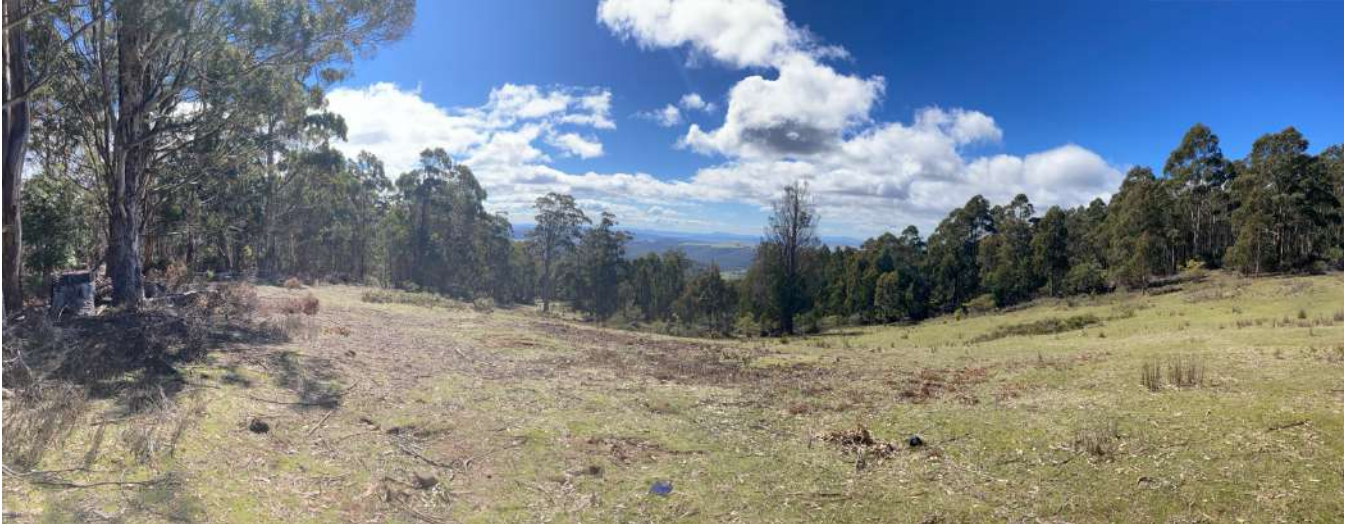
Figure 8: The dwelling site looking north along the proposed track extension route

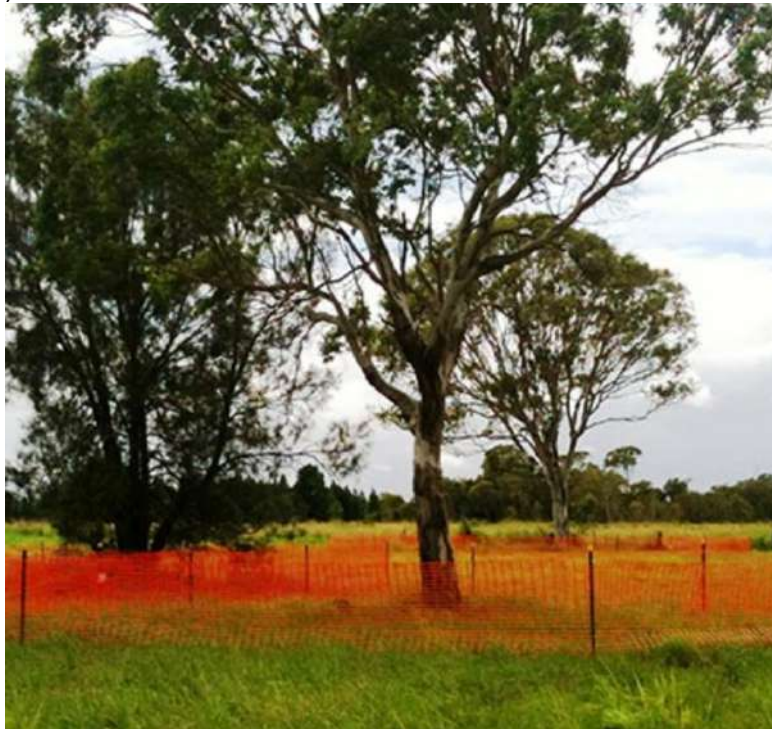
Figure 10- Tree Protection Fencing constructed with barrier mesh.

6.3.2 Tree Protection Fencing: Protective fencing shall be installed at the locations shown on the Tree Protection Plan in **Appendix 1** by a **blue line**. Where Tree Protection Zones merge a single fence encompassing the area is deemed to be adequate. The actual form of the fencing can vary, provided it is fit for purpose in that it *effectively physically restricts access and damaging activities within the TPZ/SRZ that it encloses for the duration of the proposed works* and it is approved by the Project Arborist. **In the context of the proposed works it is appropriate to construct the fencing from medium duty (160 gsm minimum) barrier mesh attached to star pickets (droppers) at 5m minimum spacing.** In order to maintain tension 2mm fencing wire should be run through the top of the barrier mesh & droppers (see figure 10 below).

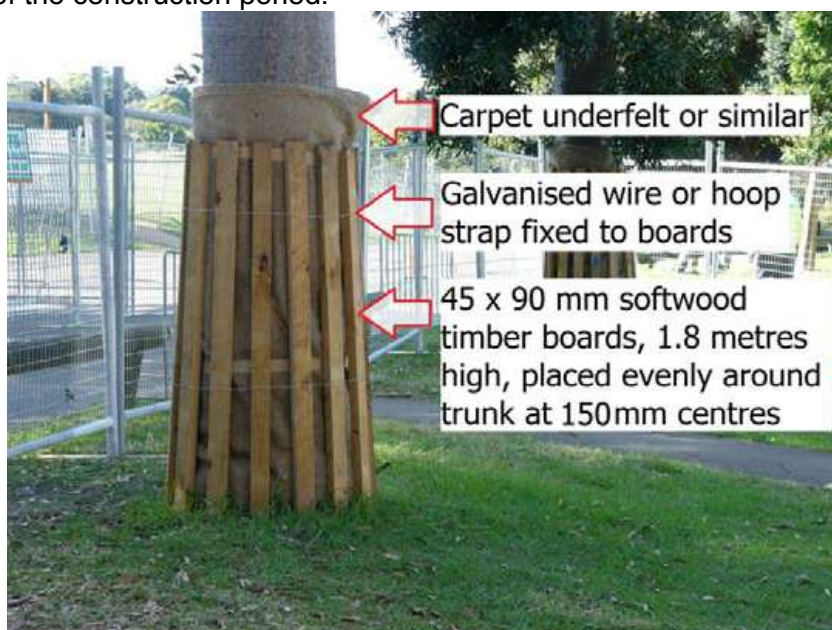
Figure 12- Example of tree trunk protection

6.3.4 **Trunk Protection:** Where provision of tree protection fencing is impractical due to its proximity to the proposed construction footprint, trunk protection shall be erected around nominated trees to avoid accidental damage, as indicated by a pink circle on the Tree Protection Plan (Appendix 1). The trunk protection shall consist of a layer of carpet underfelt (or similar) wrapped around the trunk, followed by 1.8 metre lengths of softwood timbers (90 x 45mm in section) aligned vertically and spaced evenly around the trunk at 150mm centres (i.e. with a 50mm gap) and secured together with 2mm galvanised wire or galvanised hoop strap as shown in Figure 12 below. Recycled timber (such as demolition waste) may be suitable for this purpose, subject to the approval of the Project Arborist. The timbers shall be wrapped around the trunk (over the carpet underfelt), but not fixed to the tree to avoid mechanical injury or damage to the trunk. Trunk protection should be installed prior to any site works and maintained in good condition for the duration of the construction period. Carpet underfelt (alone) is sufficient for trees with a trunk diameter of less than 200mm. Trunk protection should be installed prior to any site works and maintained in good condition for the duration of the construction period.
