**Application for Sewerage Main Works at Lot 2 Nautilus Grove and Road Reserve (CT 114677/102),  
Huntingfield – Response to further information request**

**Arboricultural Impact Assessment  
Report**

**Preliminary Arboricultural  
Assessment Report**

<b>Project name</b>	Rising Main – Huntingfield Subdivision
<b>Document title</b>	Huntingfield Rising Main - Construction Environmental Management Plan
<b>Project number</b>	12634561
<b>File name</b>	12634561-GHD-RPT-PL-Rising Main CEMP

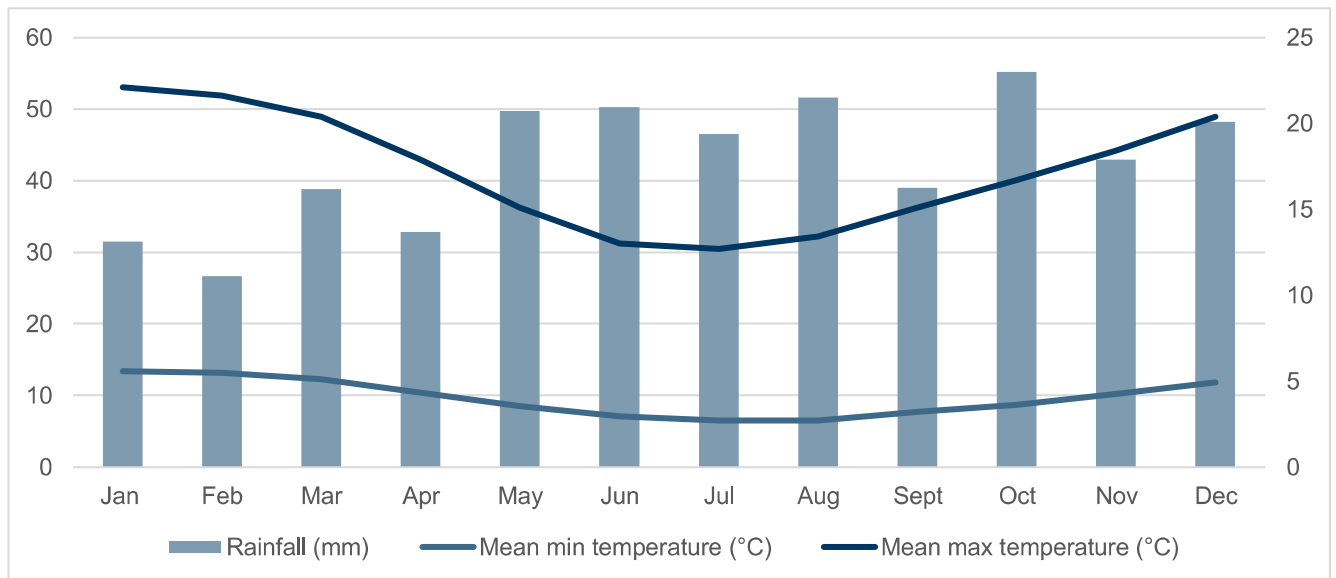
Figure 1 Mean rainfall and mean maximum and minimum temperature data from Bureau of Meteorology (BOM) monitoring site at Dennes Point for the period of 2012-2025

The nearest Bureau of Meteorology weather station of similar geographical setting capturing current weather data is Dennes Point (ID number: 094255). The mean annual maximum and minimum temperature for this station is 17.2 °C and 9.7 °C respectively, and the mean annual rainfall is 512.7mm<sup>1</sup> (Figure 1).

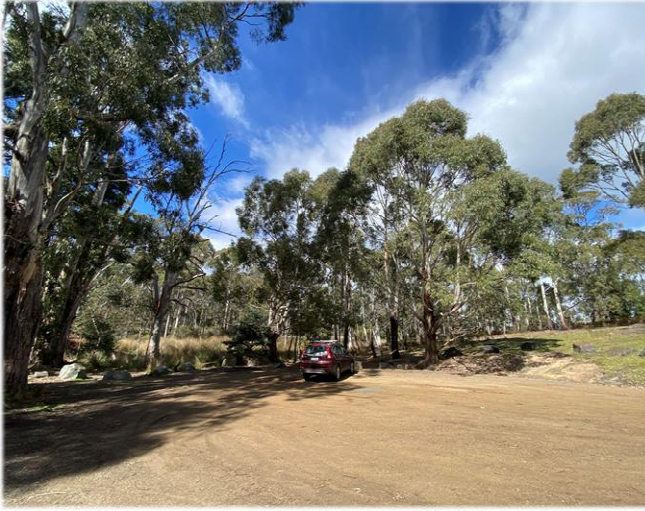
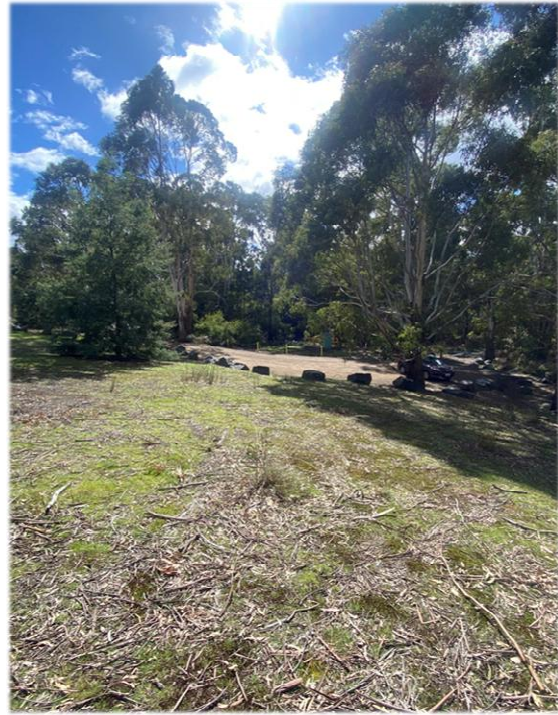
Plate 1 & 2: Area proposed for installation of new SPS – compacted gravel carpark bordered by mature *E. viminalis*. Heavily grazed/modified groundcover representative of much of the rising main alignment.

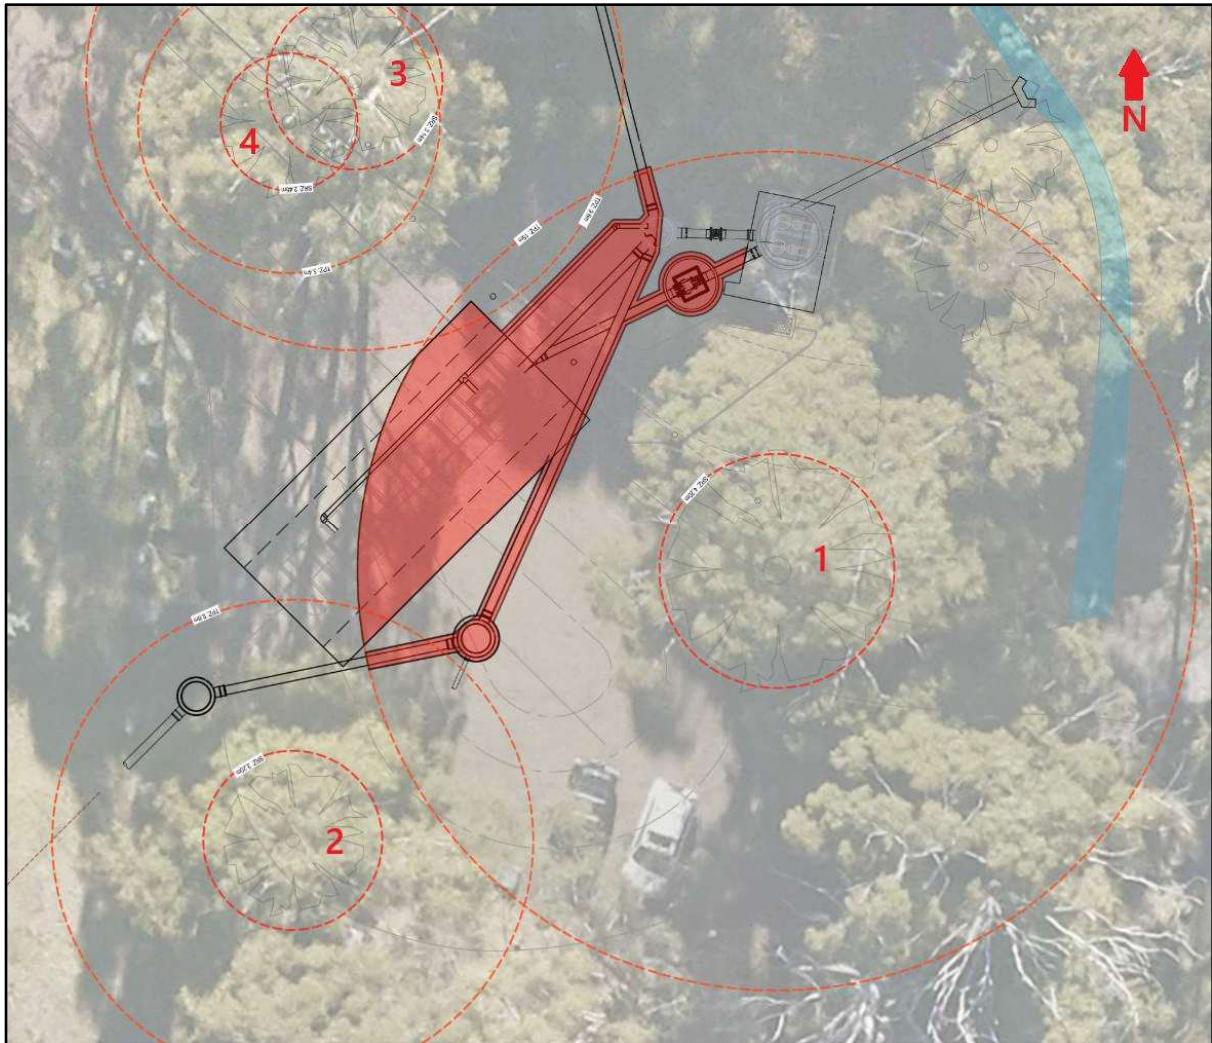
**Figure 2.** Site plans provided by Claire Austin showing plans overlaid on the site.

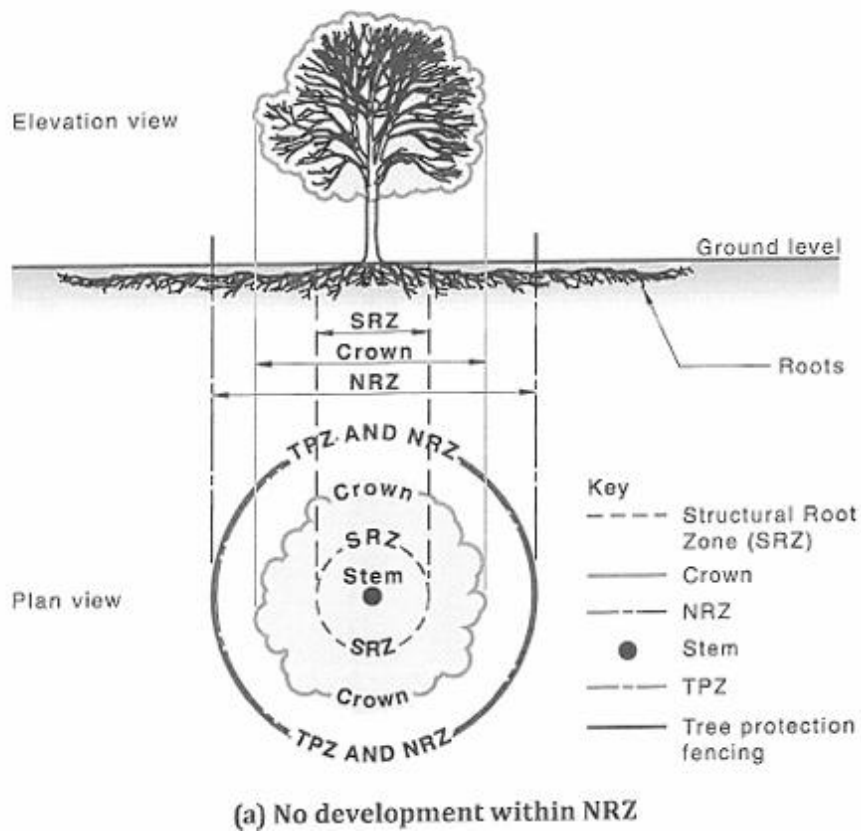
**Figure 3.** Image of a tree with no encroachment showing all the requirements. Image source from Australian Standard 4970-2025.

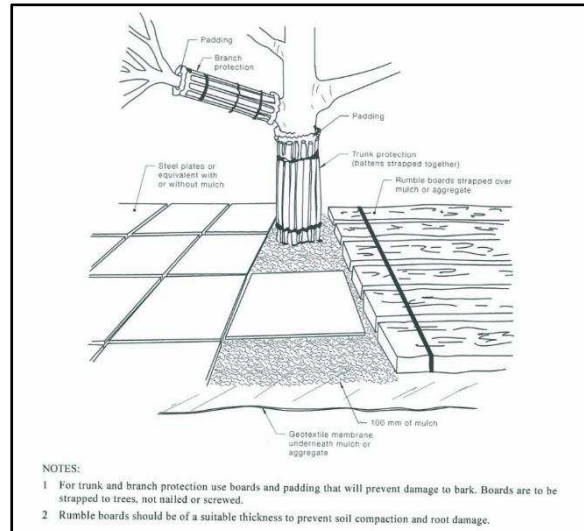
**Figure 6.** Trunk Protection and ground protection. Imaged sourced from the Australian Standard 4970-2025.

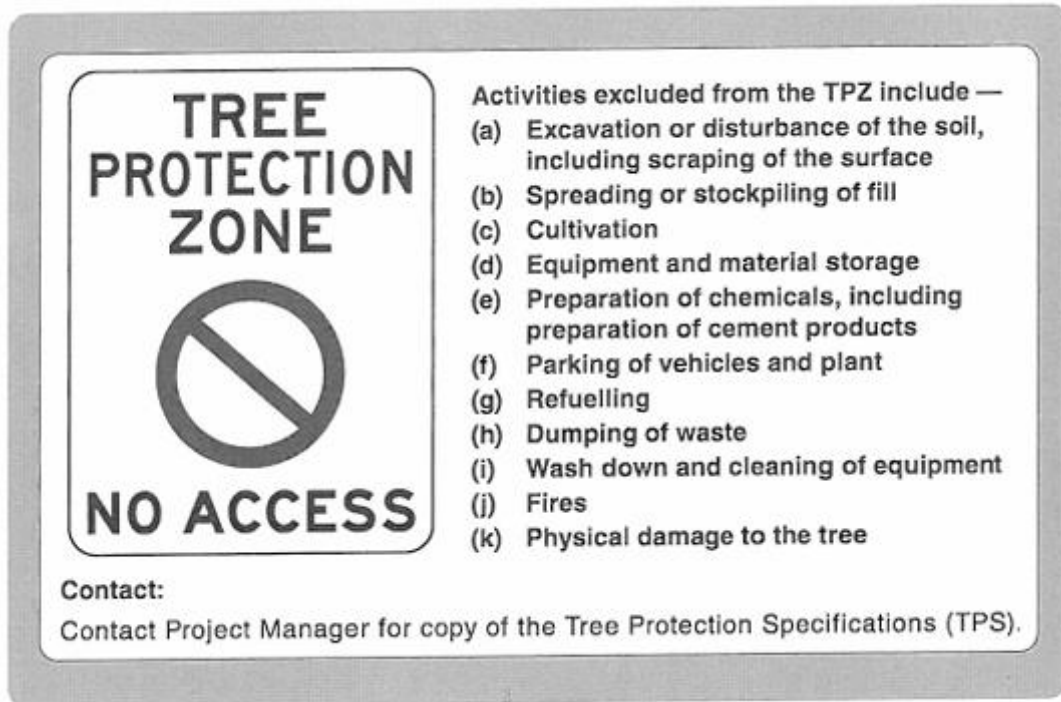
**Figure 7.** An example of a Tree Protection Zone Sign. Imaged sourced from the Australian Standard 4970-2025.

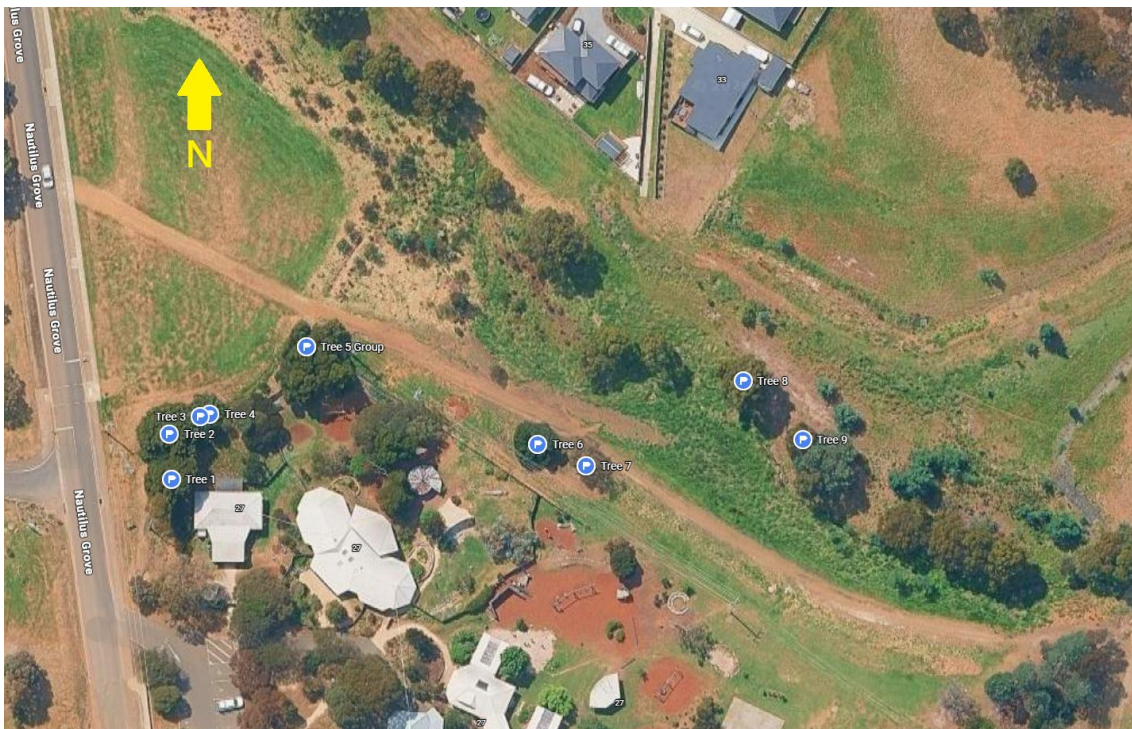
Figure 1. Map of site with tree locations (Source Google Maps).

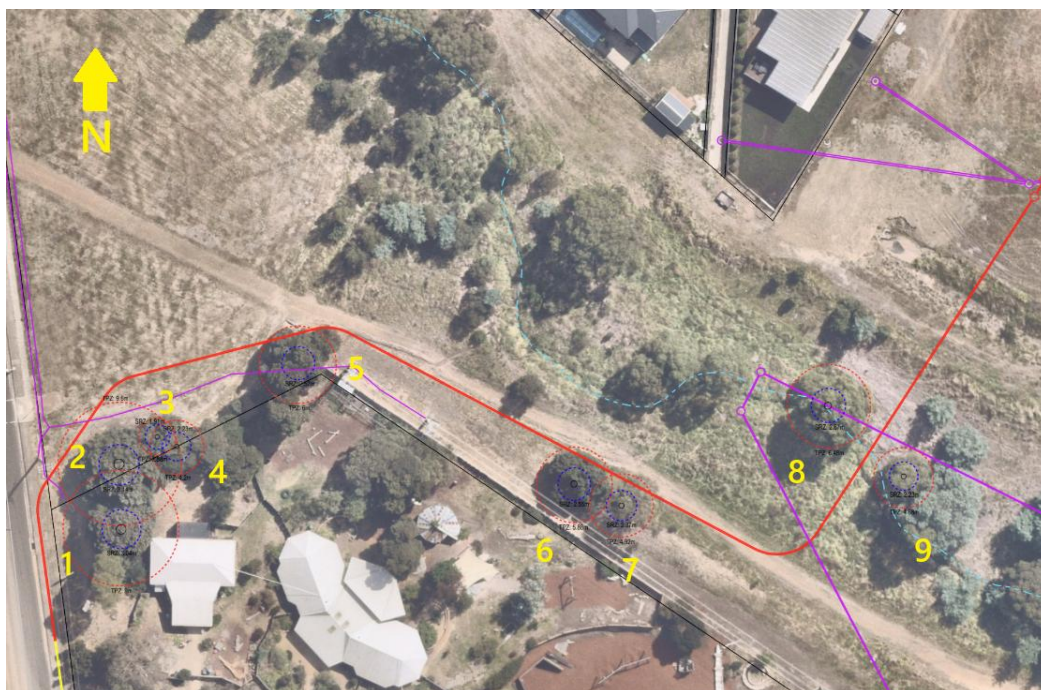
Figure 2. Map of site with tree locations and TPZ. (Source. Provided by Claire Austin).

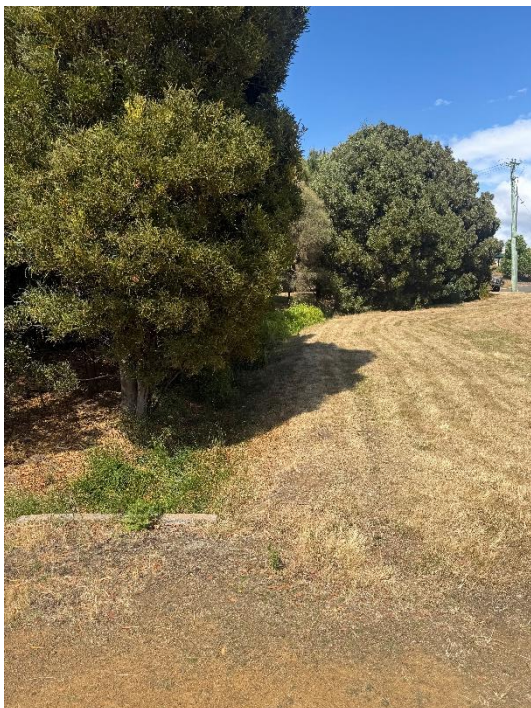
**Figure 3.** Image of Tree 5 in the fore ground and Trees 1-4 in the background. The covert is visible under the trees.

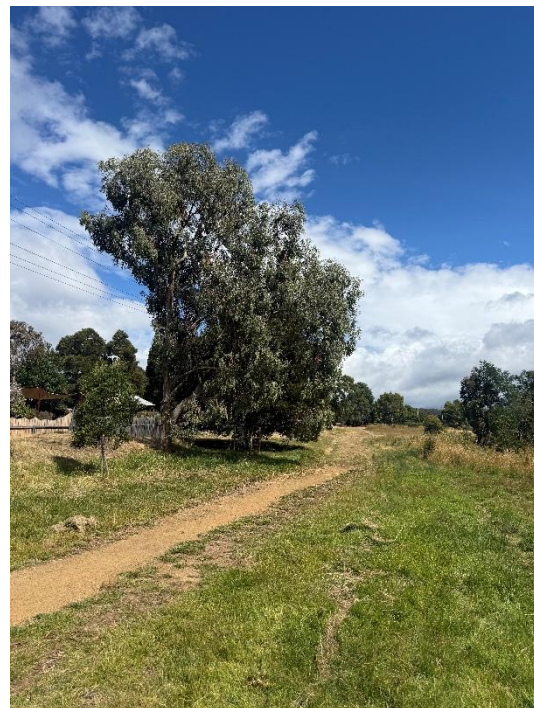
**Figure 4.** Image of Trees 6 and 7 along the path. Both trees experience minor encroachment to one side of the TPZ.

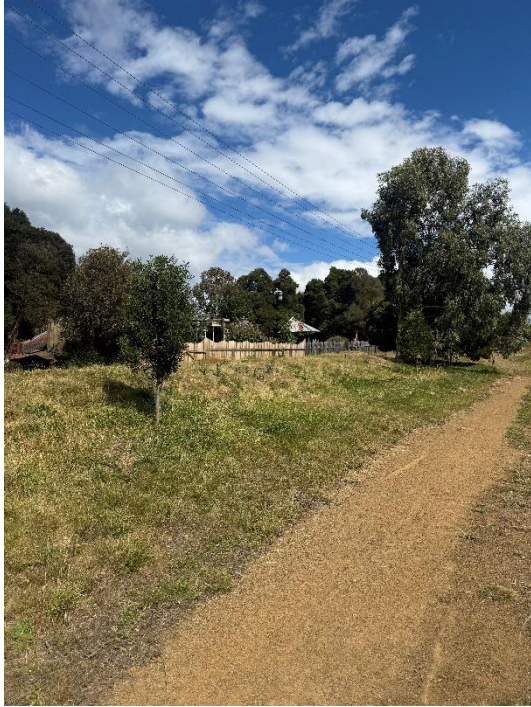
**Figure 5.** Image of Tree 6 and 7 in the background. New planting in the foreground near where the pipeline turns to cross the creek.

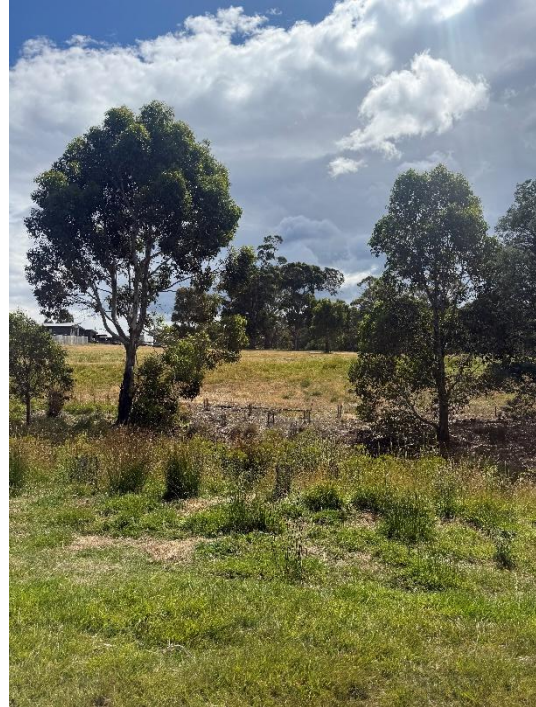
**Figure 6.** Image of Trees 8 and 9 in a creek.

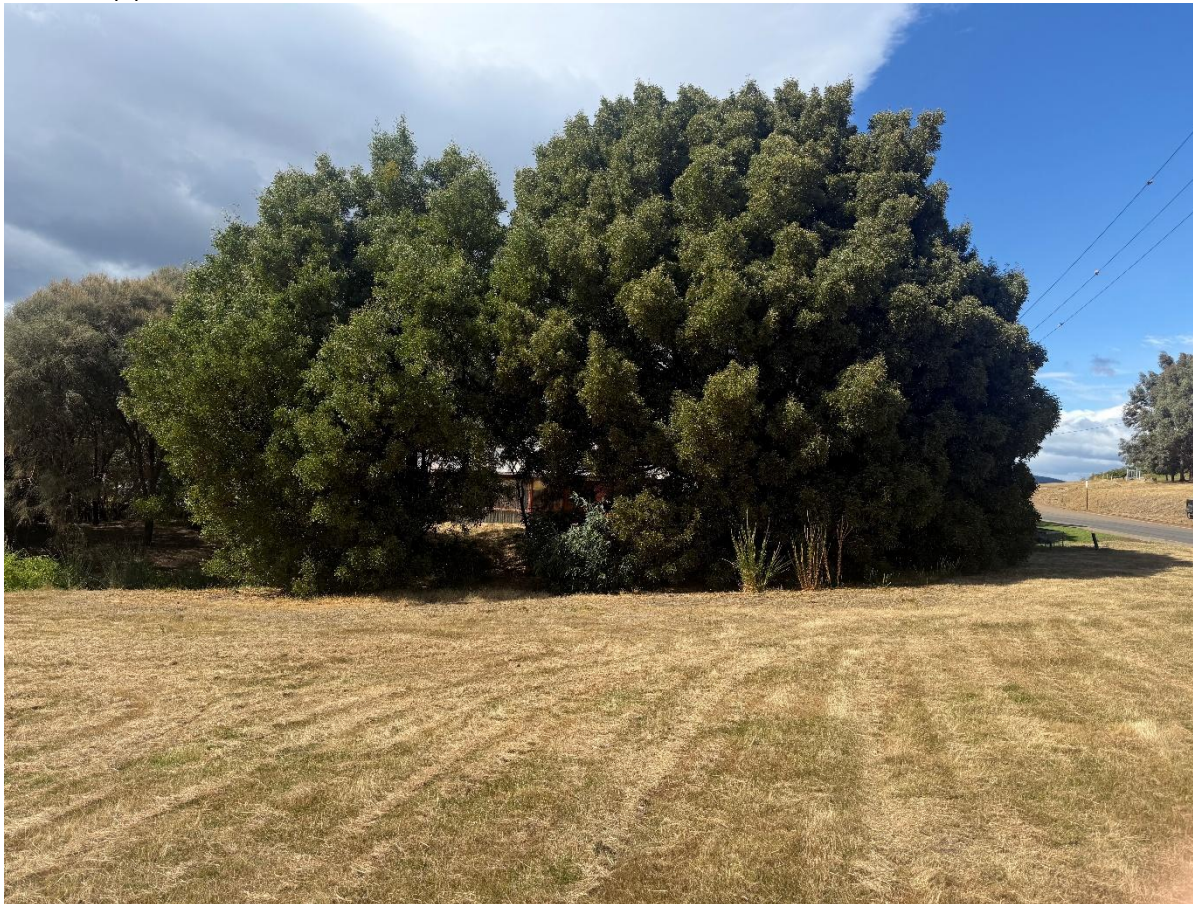
**Figure 7.** Image of Trees 1, 2, 3, and 4.

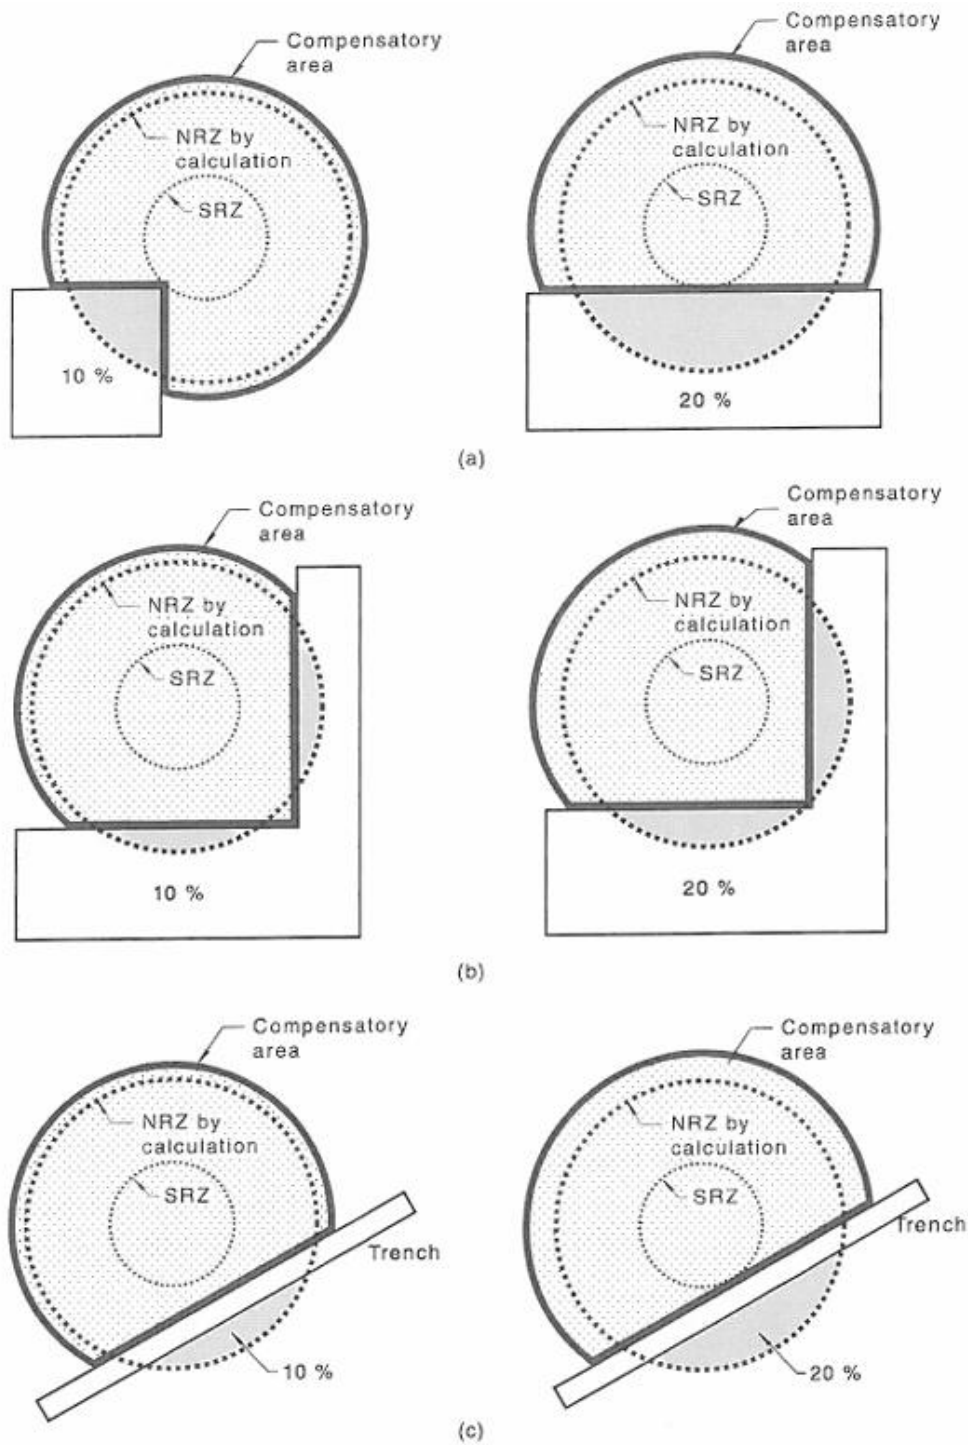
NOTE These examples are not to scale and are for illustrative purposes. The proposed encroachment is considered minor if it is less than or equal to 10 % of the area of the NRZ, has not had recent TPZ encroachments and is outside of the SRZ (see [Clause 3.4](#)). The proposed encroachment is considered moderate if it is greater than 10 % and less than or equal to 20 % of the area of the NRZ and is outside of the SRZ (see [Clause 3.4](#)).

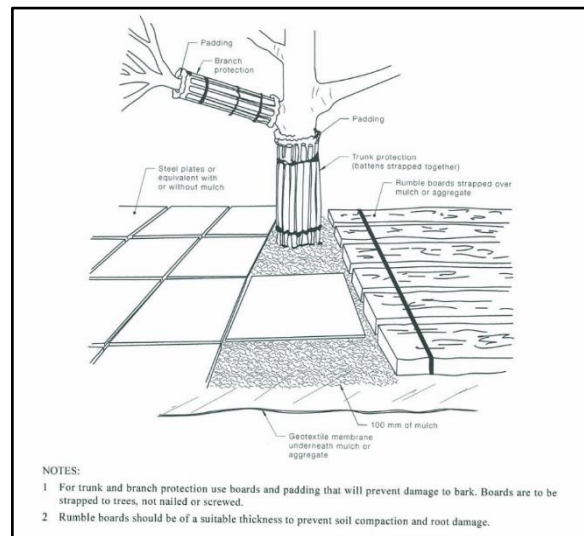
**Figure 7.** Trunk Protection and ground protection. Imaged sourced from the Australian Standard 4970-2025.

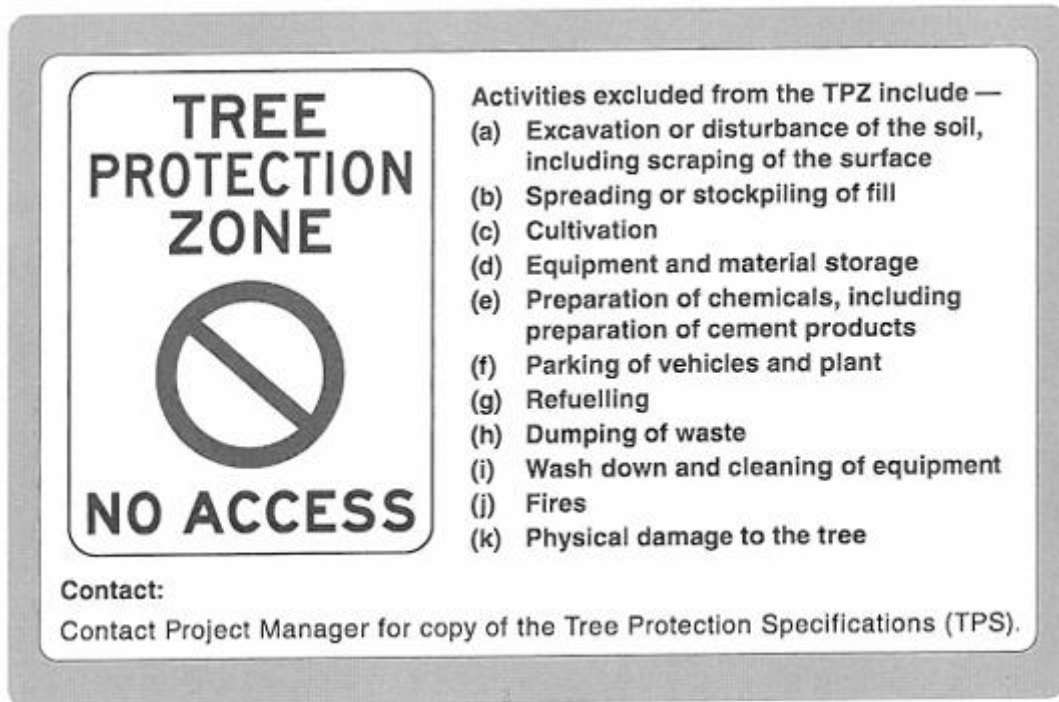
**Figure 8.** An example of a Tree Protection Zone Sign. Imaged sourced from the Australian Standard 4970-2025.
