ROCK SOLID GEOTECHNICS PTY LTD

Geotechnical Assessment - 16 Victoria Avenue, Dennes Point (C.T.23731/4)

INTRODUCTION

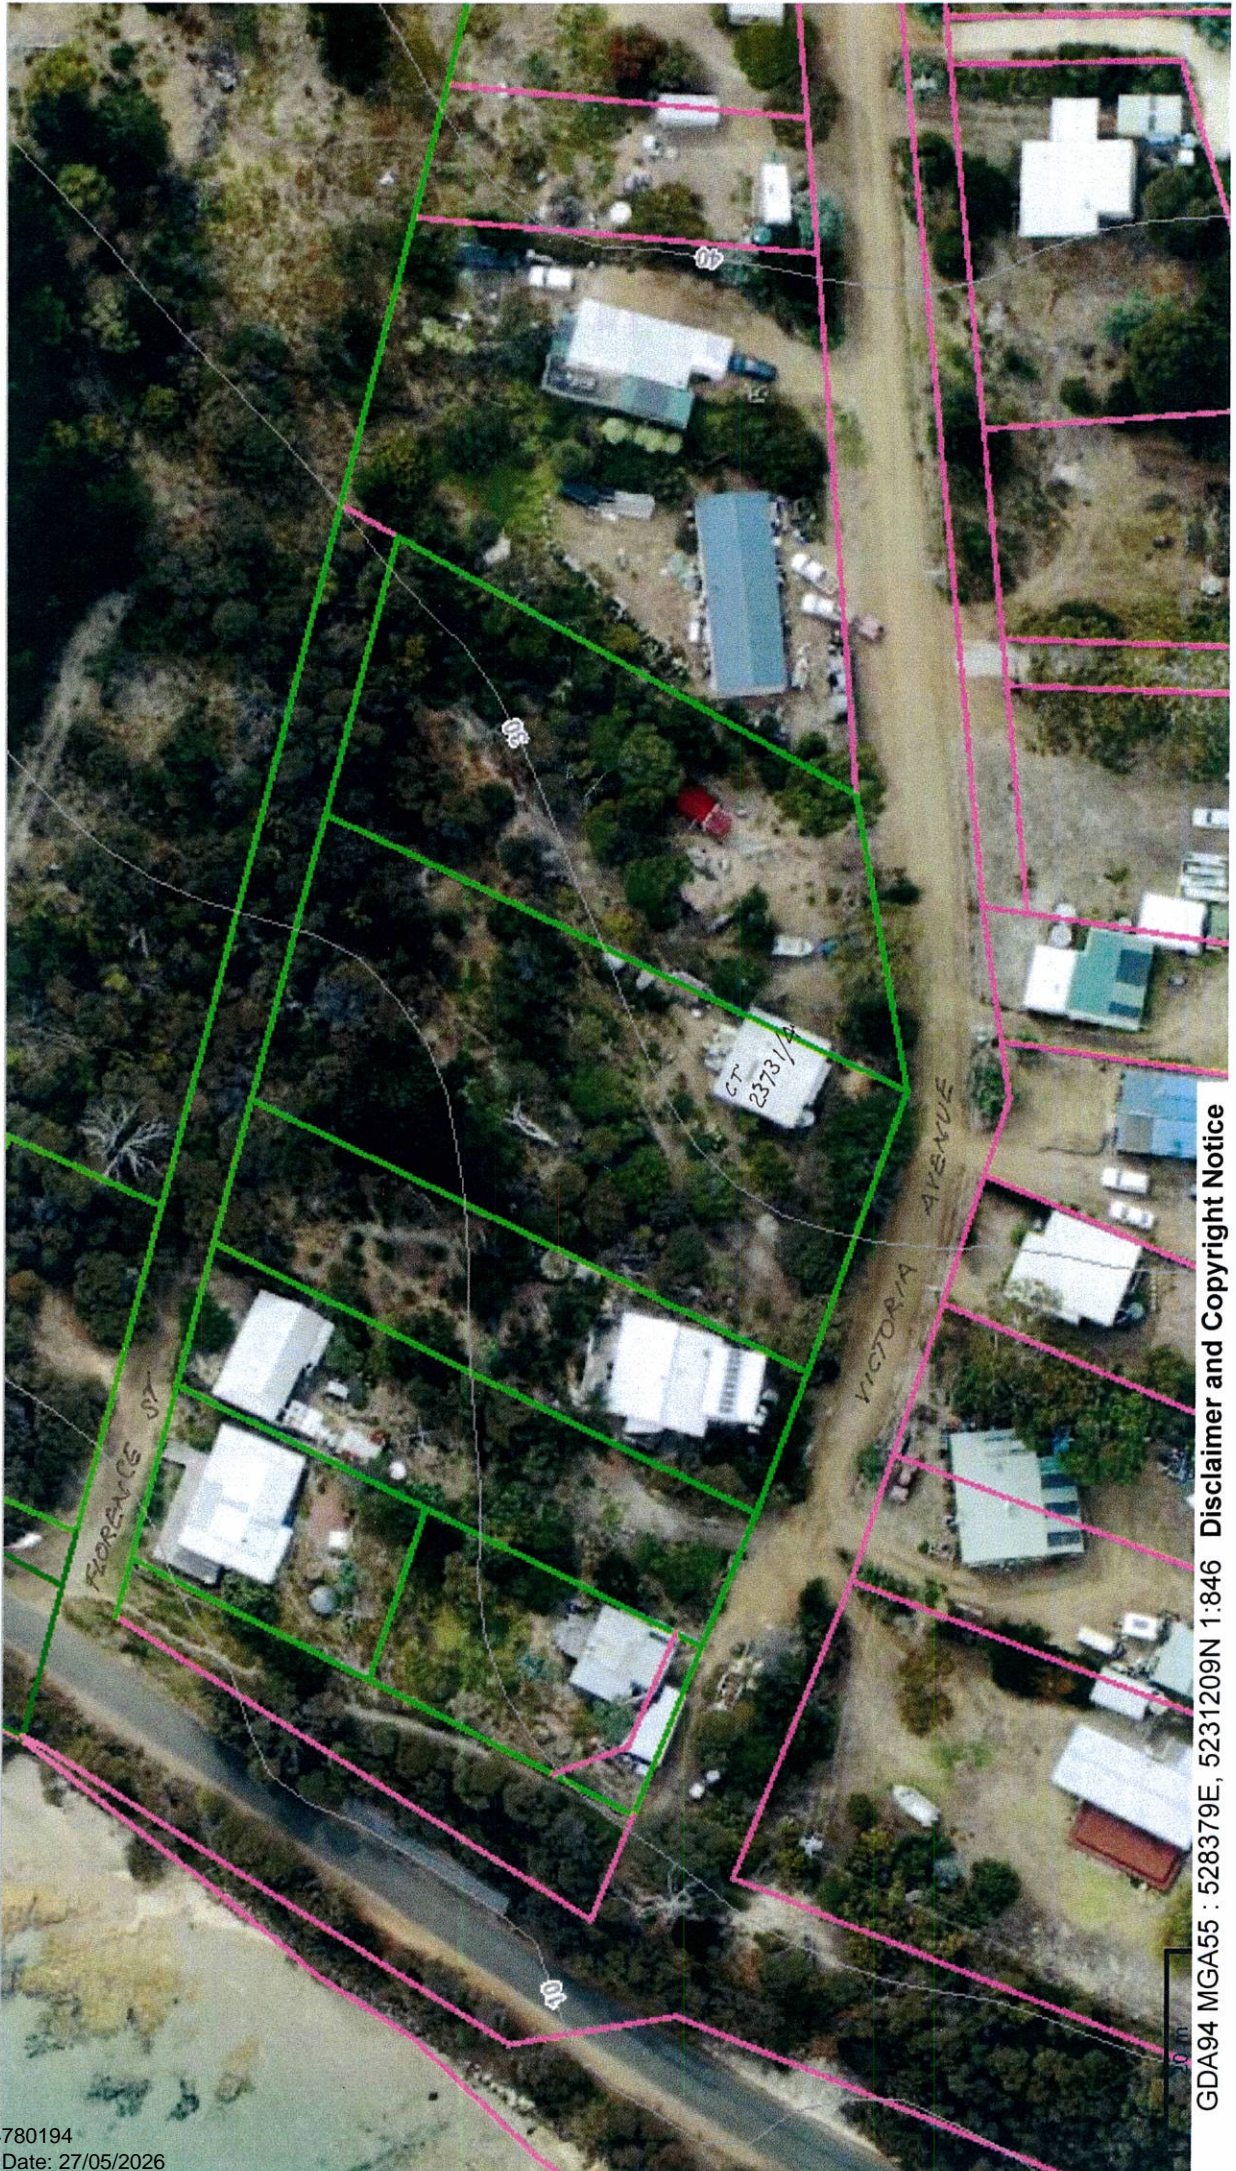
FIGURE 1

The property runs between Victoria Avenue and Florence Road. The residence is located to the immediate north of Victoria Avenue (Figure 1). The current residence lies over the boundary with the property upslope and to the east (Figure 2), and is the subject of a boundary adjustment application.

The residence is situated in the upper, southeastern portion of the property, with the onsite wastewater system located downslope from the dwelling in the centre of the block. No portion of the residence and associated services are located within the defined Low Landslide Hazard Area.

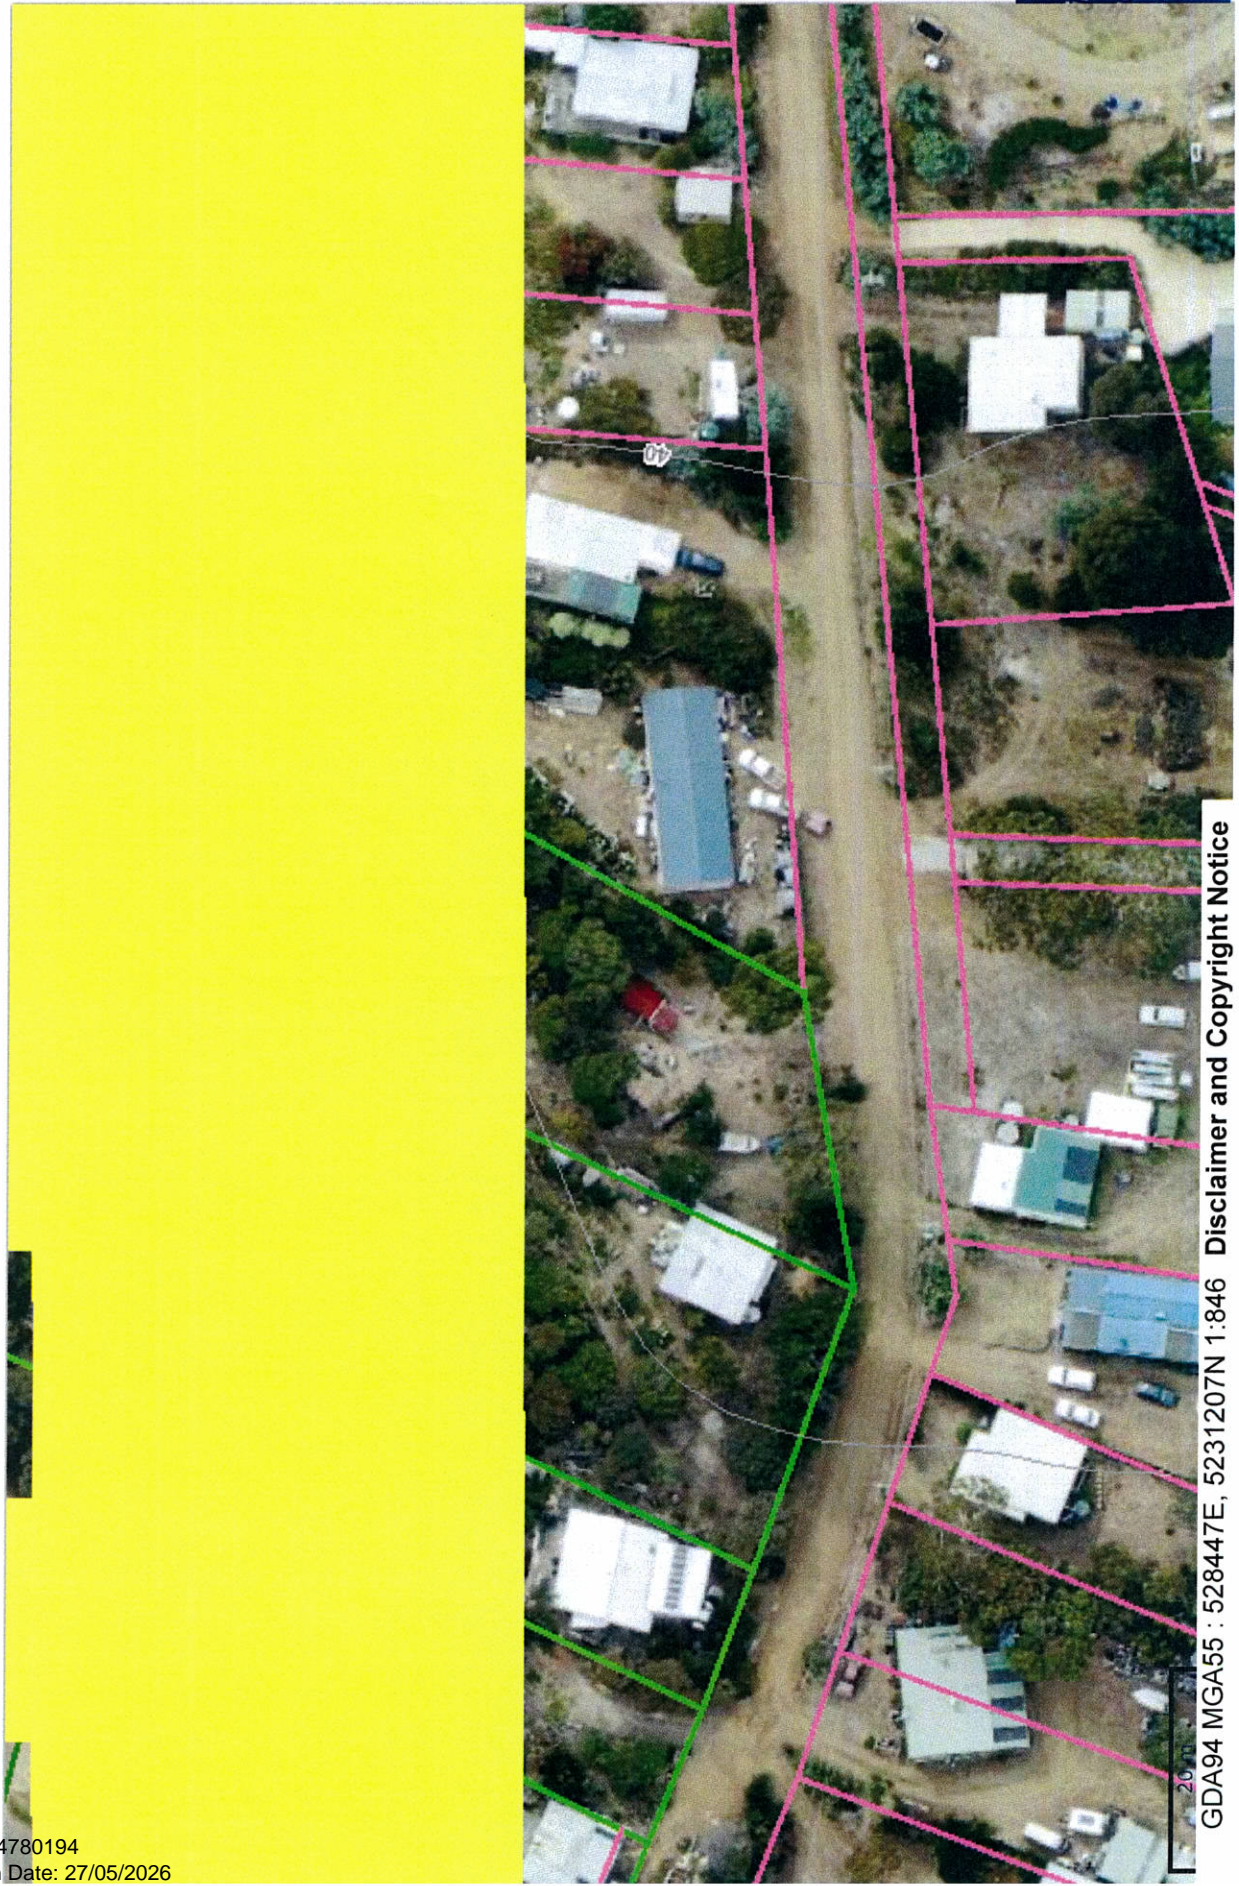
The planning scheme maps, Low Landslide Hazard Area, and Landslide Polygon Area are presented as Figures 3 & 4.

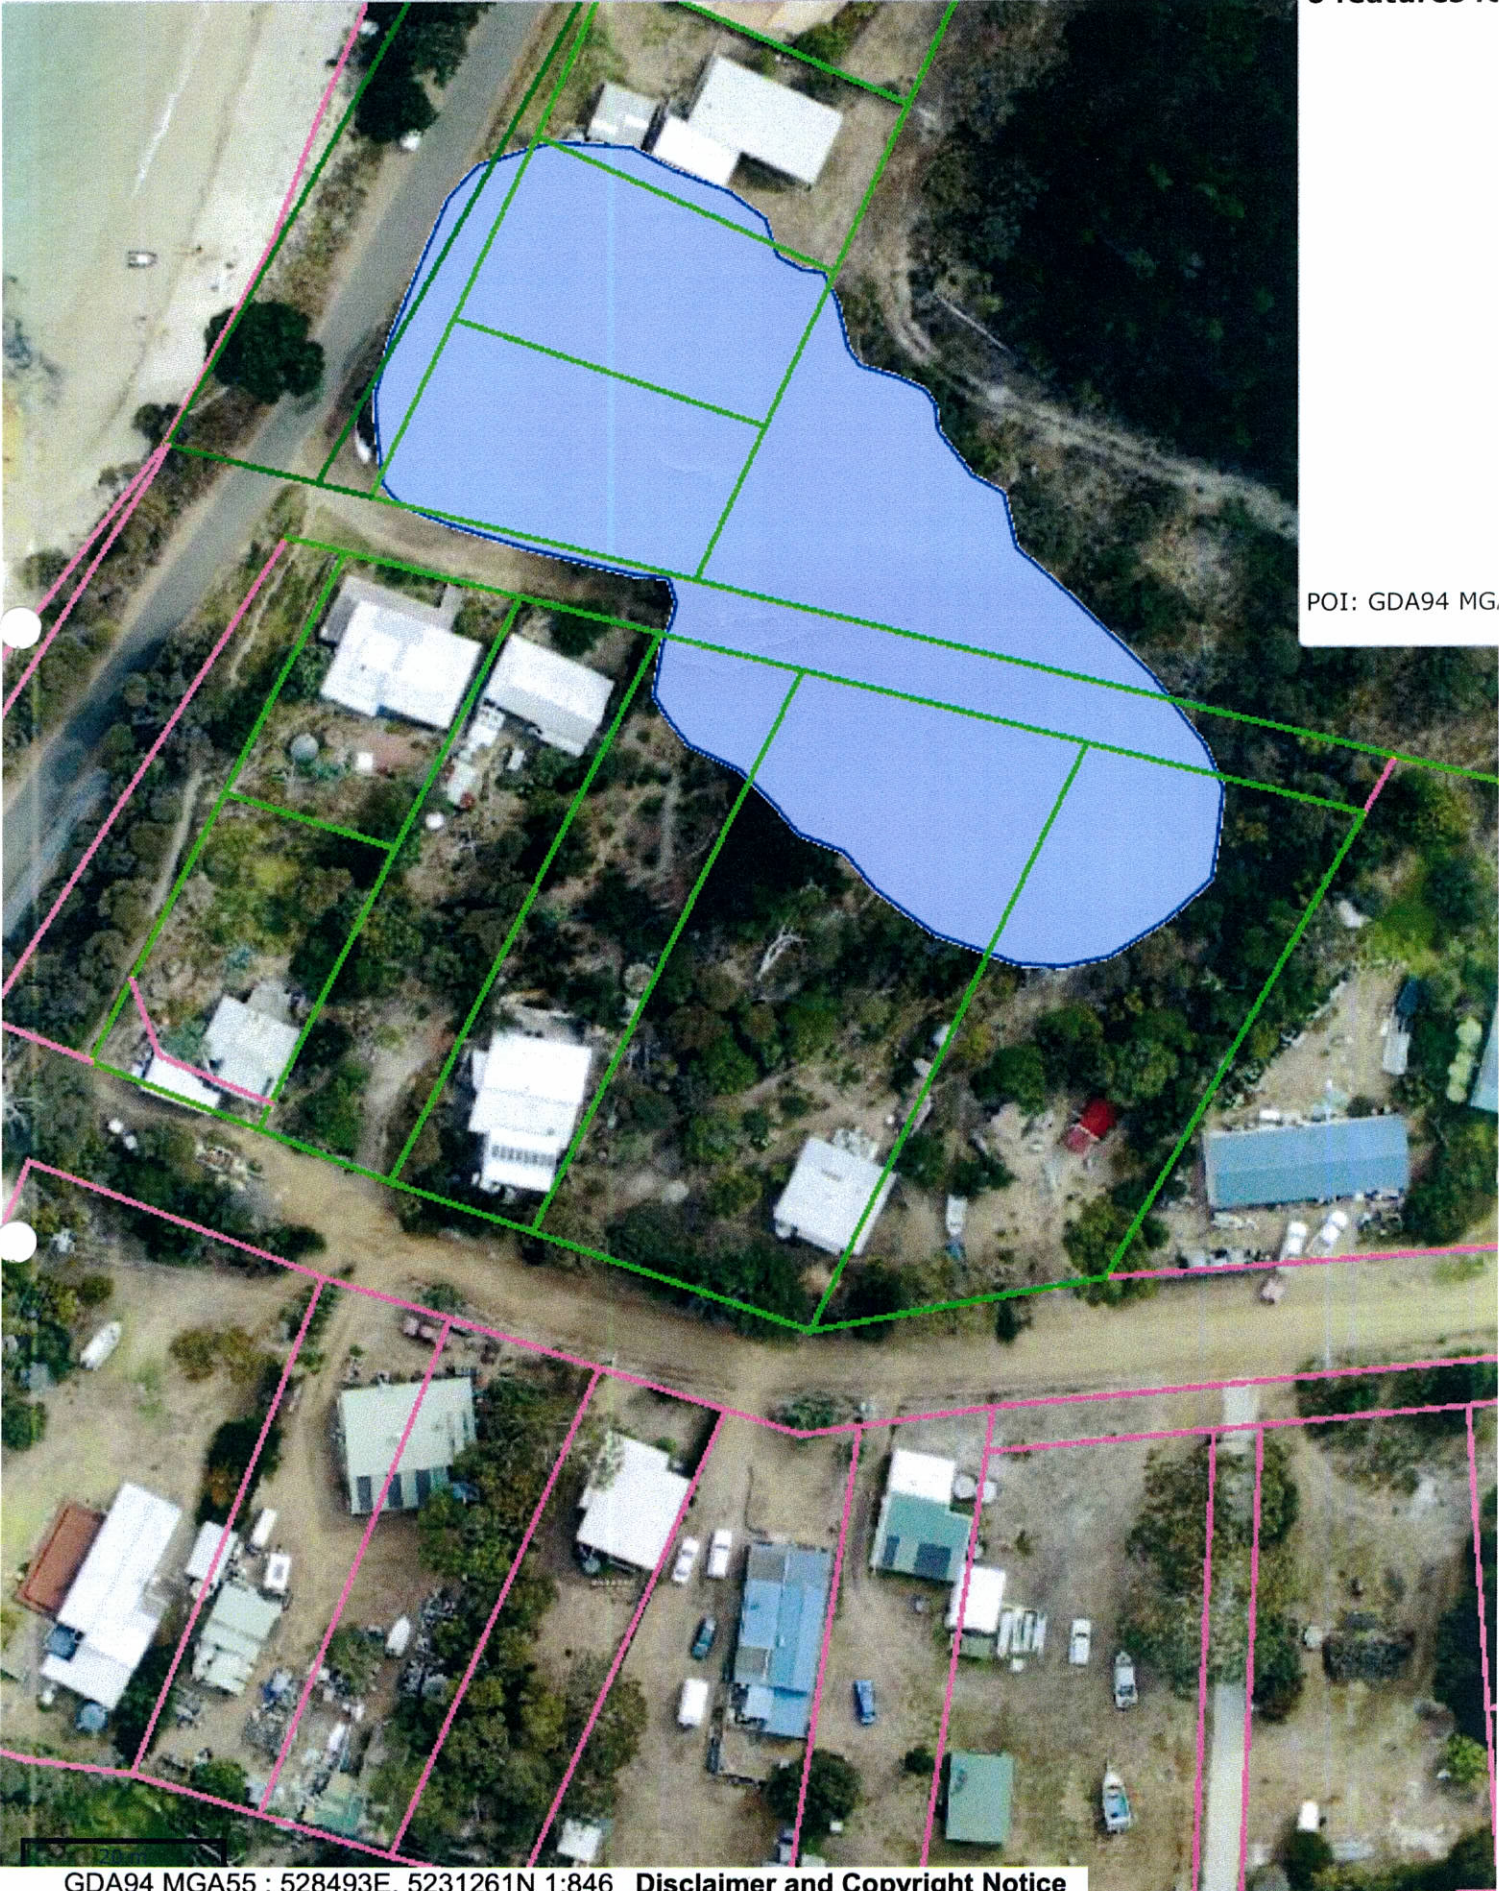
FIGURE 4
LANDSLIDE POLYGON AREA

The northern portion of the site (adjacent to a natural drainage line running east to west adjacent to the northern property boundary) is documented as hosting an active landslip, as defined on the Landslide Polygon Area plan (Figure 4). The landslip slip extends to the east, with the 'head' of the slip terminating on the neighbouring block C.T.23731/5.

There is very little evidence of the existence of a landslip on Number 16 (C.T.23731/4). It appears that there has been a significant amount of quarrying (sand mining) in the area, with the historical slip material (rubble) having been removed from the site. The presence of semi-mature regrowth trees within the slip site indicates that there has not been any active movement on this block for many (30+ minimum) years.

A small (1.5m maximum in height differential) can be observed at the base of the slope adjacent to the natural drainage line, and is the only evidence of any historic slip movement.
