# RECREATIONAL WATER QUALITY INVESTIGATION

## BLACKMAN'S BAY BEACH (SOUTH)

FIELD SURVEY

Kingborough Council

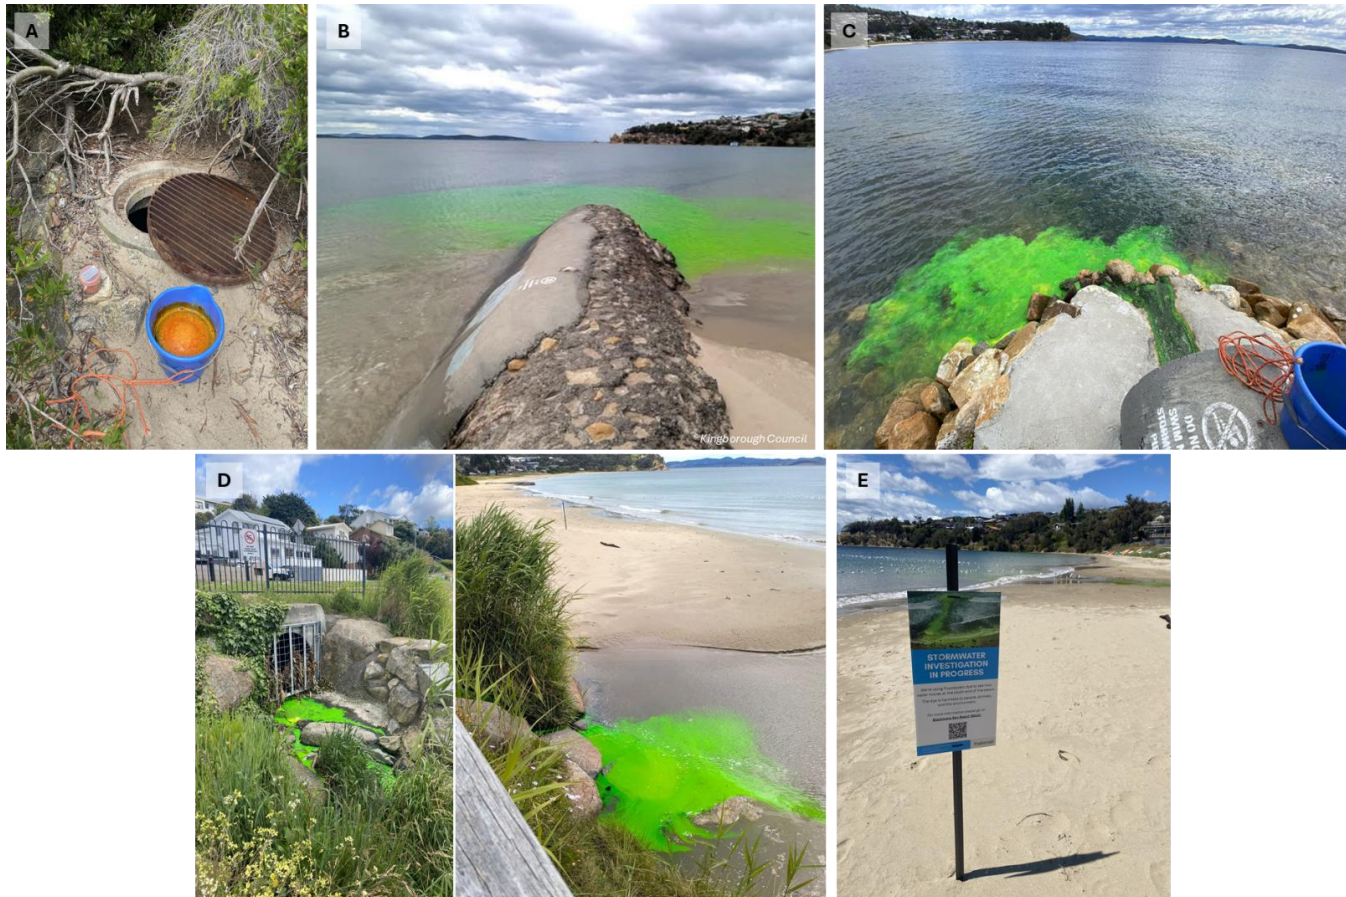
Figure 2. Fluorescein dye dosing into the three southern Blackmans Bay stormwater outfalls at high tide on 8 December 2025. (A) Dosing at sump on Mid Beach outfall, (B) dyed effluent discharging from the Mid Beach outfall (C) dosing directly into the discharging Flowerpot outfall, (D) dye-dosed stormwater discharging from Illawarra outfall to the drainage channel on the beach, and (E) Kingborough Council public information signage during the dye study.

| Date | Tide* | Wind (strength and direction) | Stormwater outfall | Notes |
|---|---|---|---|---|
| | | | Mid Beach | Low volume discharge at the time of dye study. Dosed at sump (Figure 2A) at 09h52, visible in bay at 10h06 (Figure 3B). |

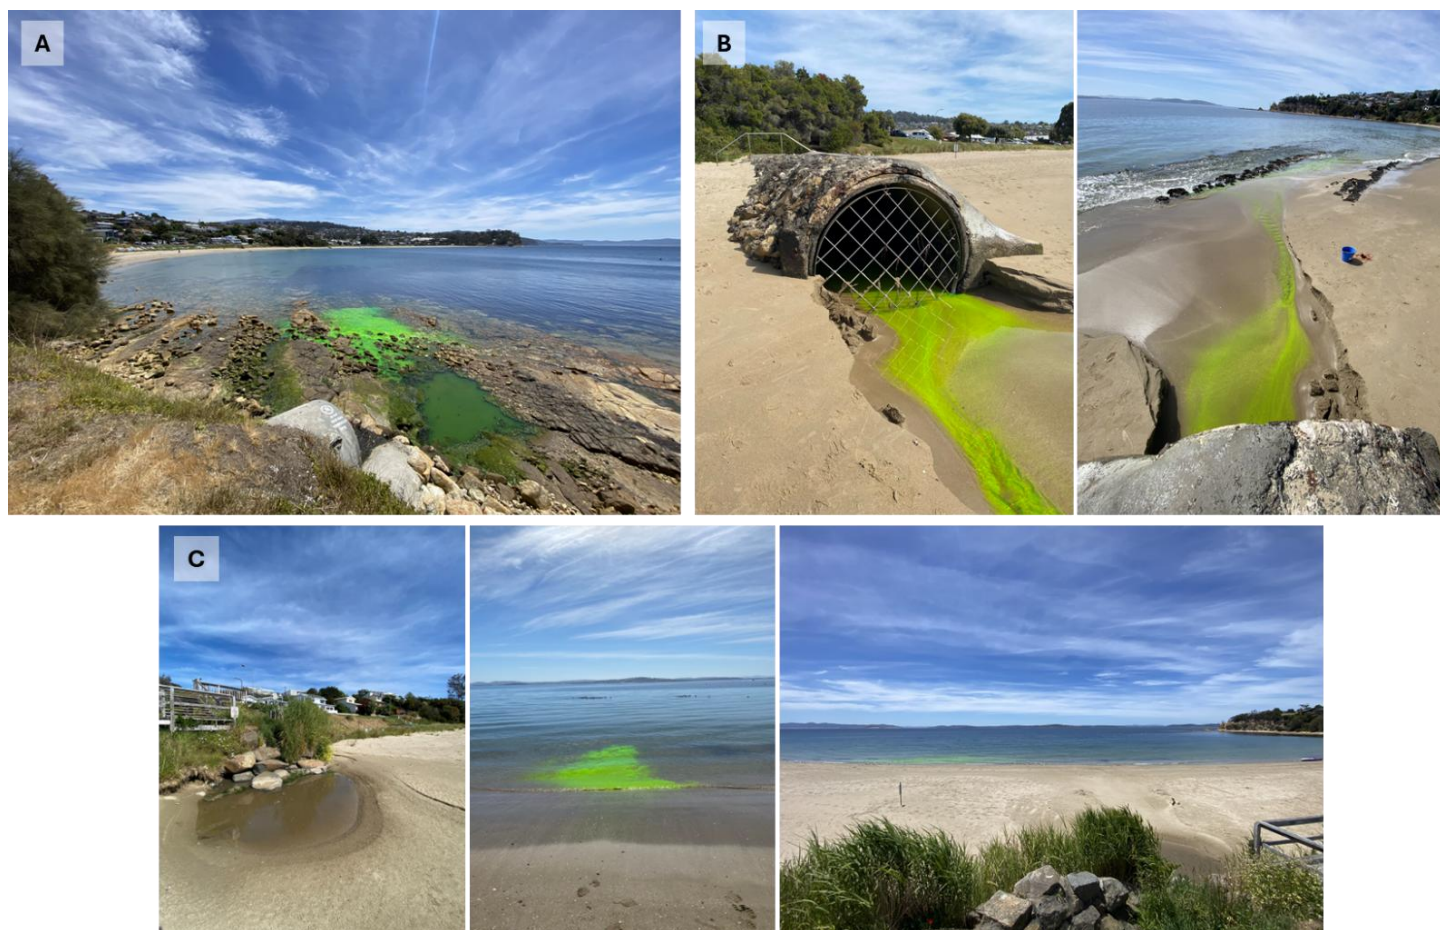
Figure 3. Fluorescein dye dosing into the three southern Blackmans Bay stormwater outfalls at low tide on 12 December 2025. (A) Flowerpot outfall, showing dye in rock pool, (B) dye-dosed stormwater discharging at low volume from Mid Beach outfall, and (C) no stormwater discharge from Illawarra outfall and no drainage channel across the beach, so dye was added directly to water at the shoreline.

On 12 December 2025, dye discharging from the three southern stormwater outfalls into the low-incoming tide varied in direction over the duration of the study period. The dye-dosed effluent was observed to initially travel south from the Mid Beach outfall and from the dosing point in front of the Illawarra outfall when the tide was low (30 minutes after low tide), similar to the outgoing tide (Figure 7, Figure 8). At low tide, dyed effluent discharging from the Flowerpot outfall was retained in the rocky intertidal area and was not clearly visible in the bay (Figure 3A, Figure 7, Figure 8).

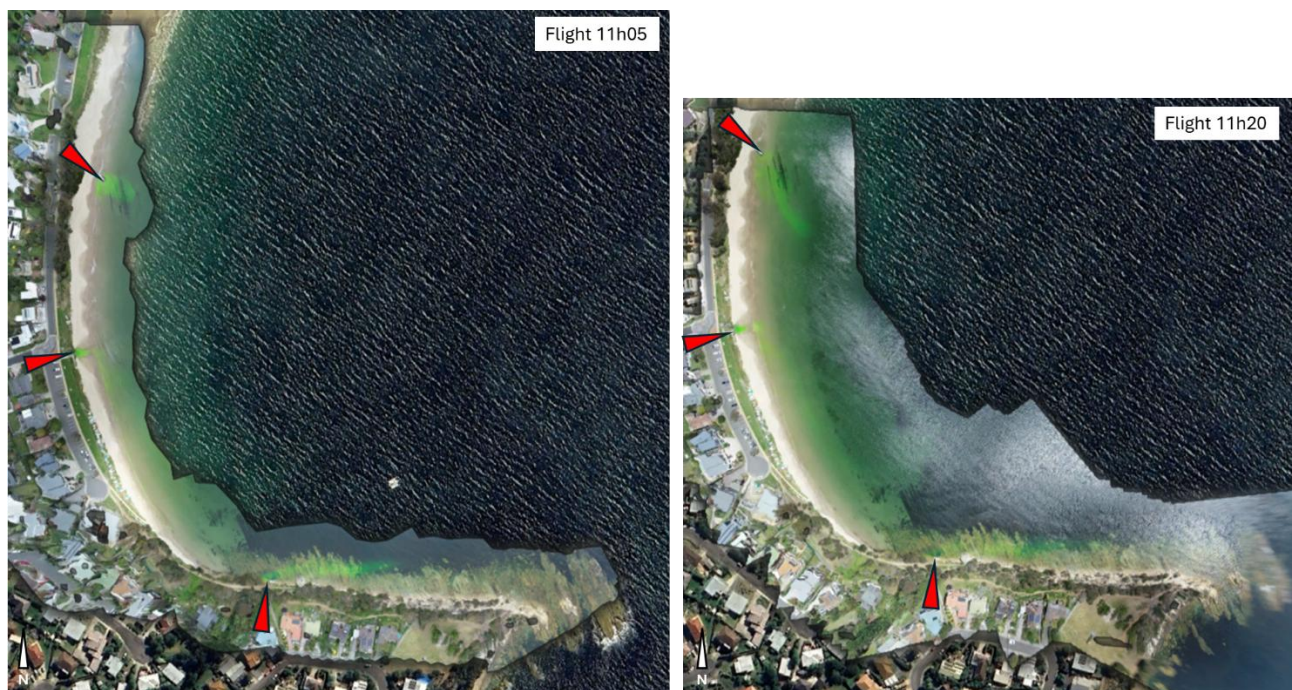
Figure 4. Orthomosaic of aerial images showing fluorescent dye discharging from the three southern Blackmans Bay outfalls (marked with red arrows) in the high-outgoing tide (background map: Google Earth Pro).

On 8 December 2025, dye discharging from the three southern stormwater outfalls into the high-outgoing tide was observed travelling south from the Mid Beach and Illawarra outfalls, and east along the rocky shoreline from the Flowerpot outfall (Figure 4, Figure 5).

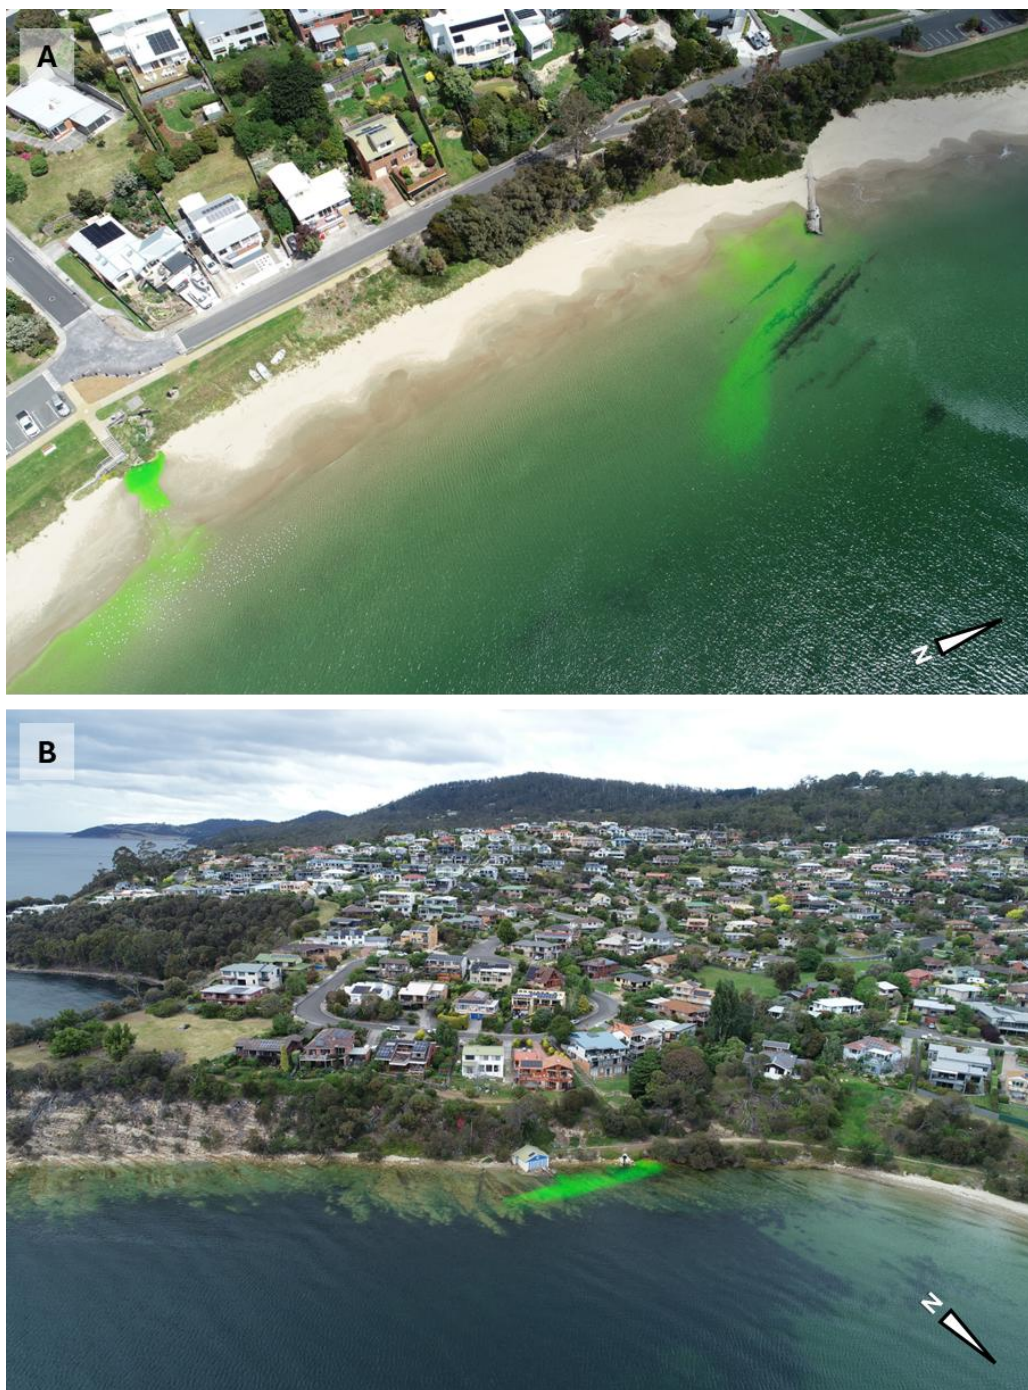
Figure 5. Non nadir aerial images of fluorescent dye discharging from (A) Mid Beach and Illawarra, and (B) Flowerpot stormwater outfalls in the high-outgoing tide.

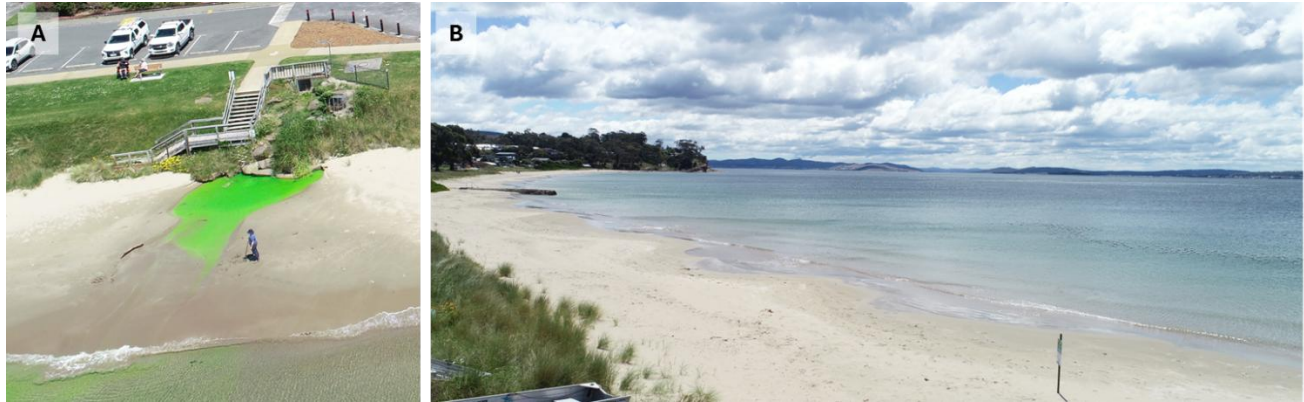
Figure 6. One hour after dye dosing, (A) the tide had dropped so that the Illawarra stormwater outfall was no longer discharging to the bay, and (B) the dye-dosed effluent from Mid Beach outfall had dispersed and was no longer visible.

On 8 December, the dye was observed in the environment for ~ 1 hour, until the dye discharging at the Mid Beach outfall had completely dispersed into the bay (no longer visible) and the tide had dropped so that the Illawarra outfall drainage channel on the beach was no longer discharging to the bay (Figure 6).

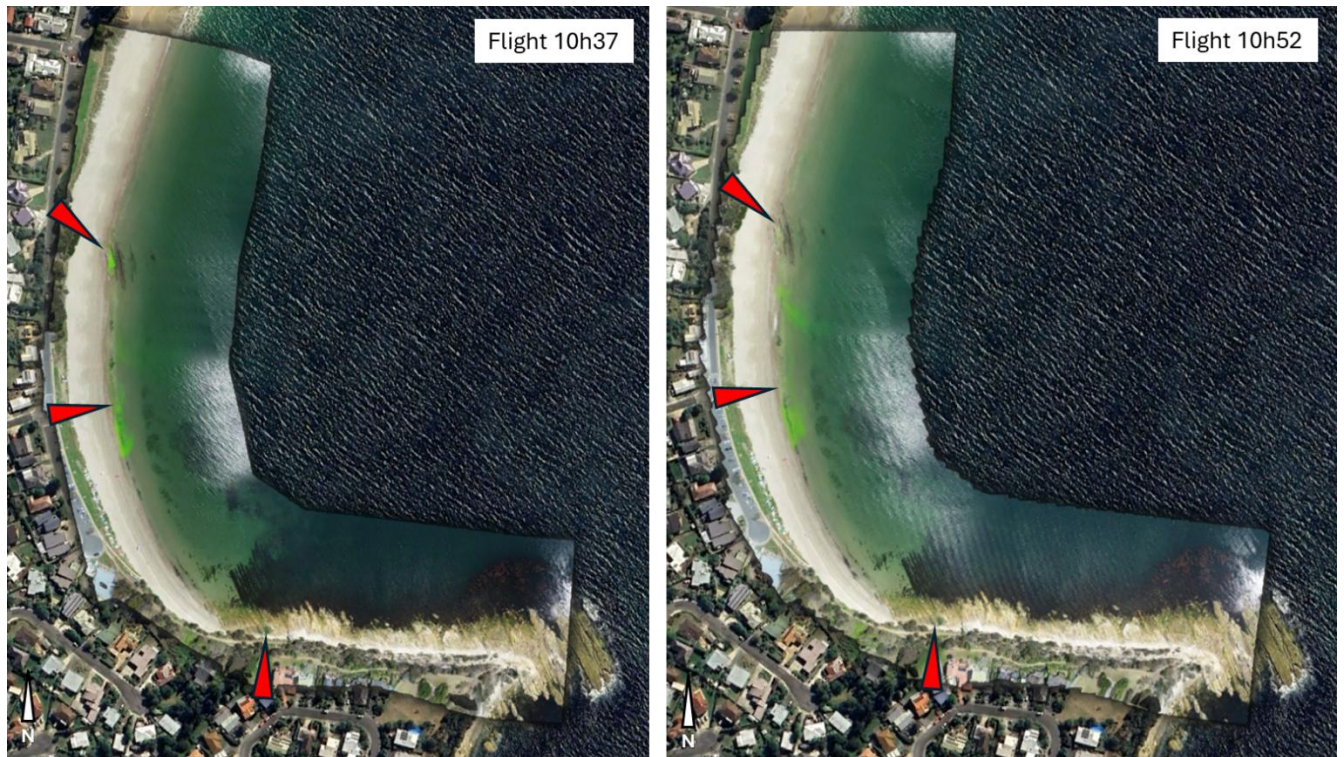
Figure 7. Orthomosaic of aerial images showing fluorescent dye discharging from the three southern Blackmans Bay outfalls (marked with red arrows) into low tide (background map: Google Earth Pro).

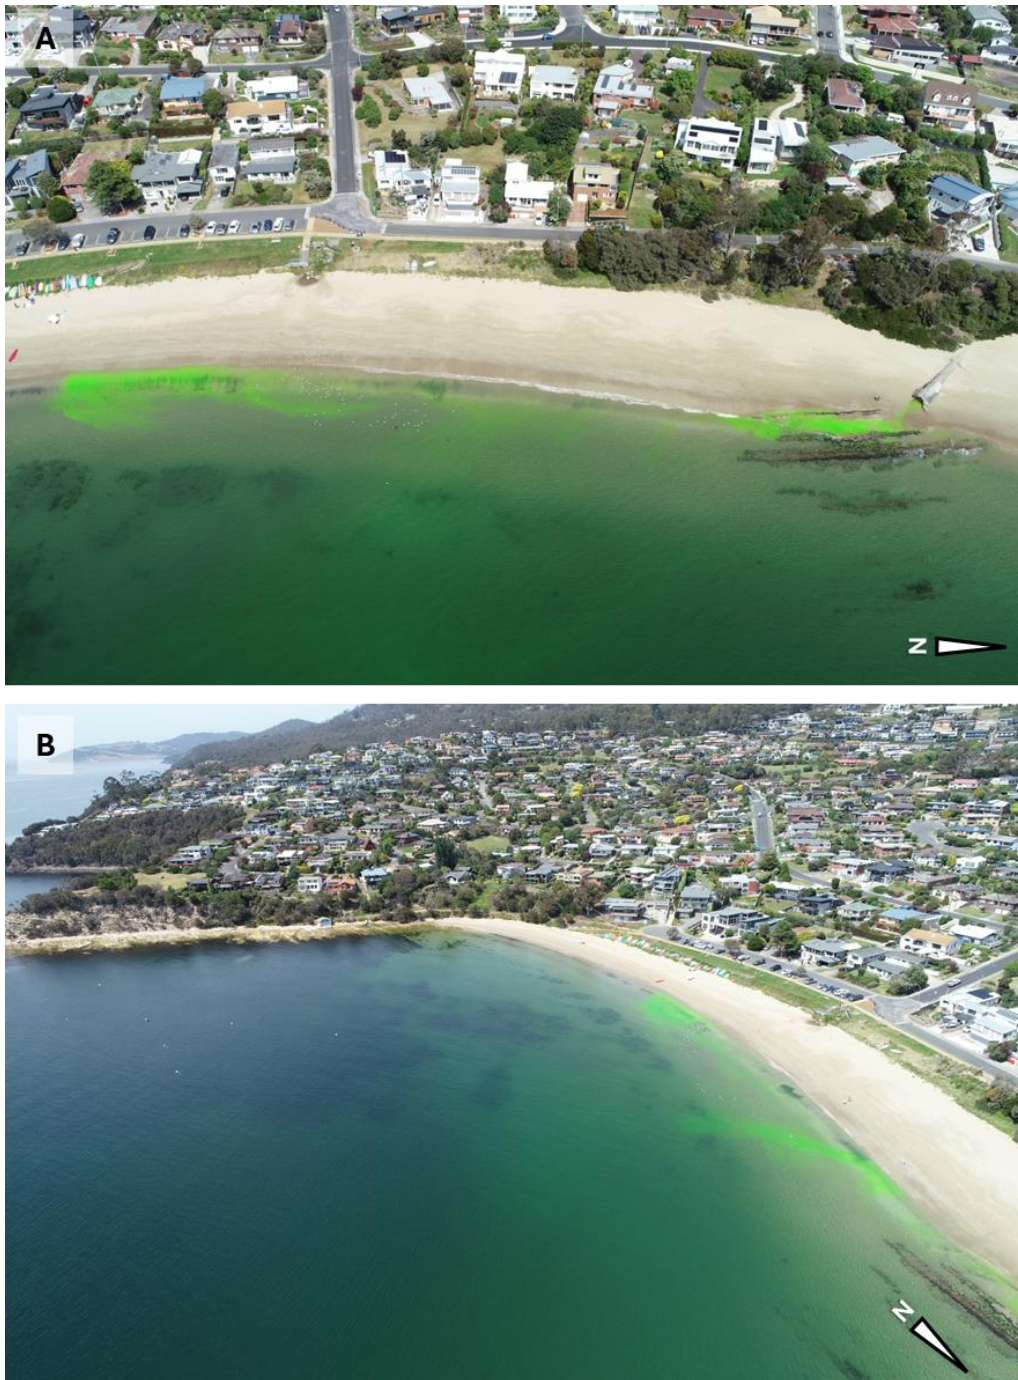
Figure 8. Non nadir aerial images of fluorescent dye discharging from (A) Mid Beach and Illawarra, and (B) all three stormwater outfalls in the low tide.

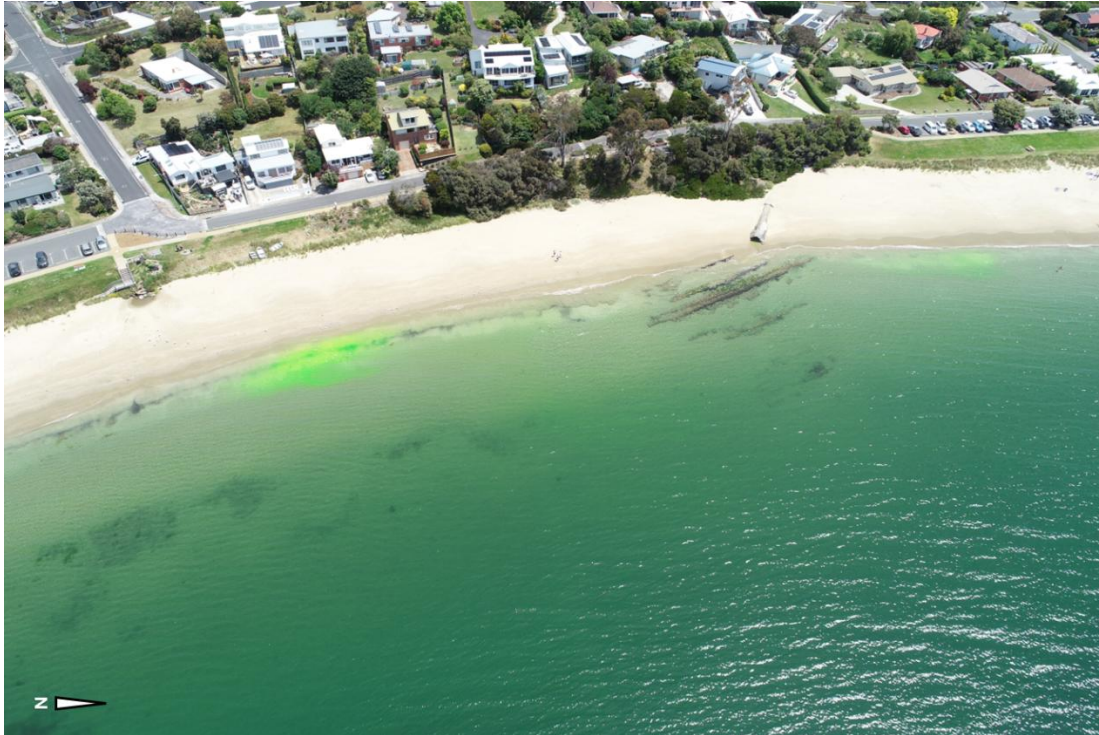
Figure 10. Non nadir aerial image of fluorescent dye discharging from Mid Beach and Illawarra outfalls in the incoming tide.

As flow from the incoming tide increased (~2 hours after low tide), the current was observed to change direction and dye-dosed effluent was observed travelling north along the shoreline from the Mid Beach and Illawarra outfalls, and to the east along the rocky shoreline from the Flowerpot outfall (Figure 9, Figure 10).

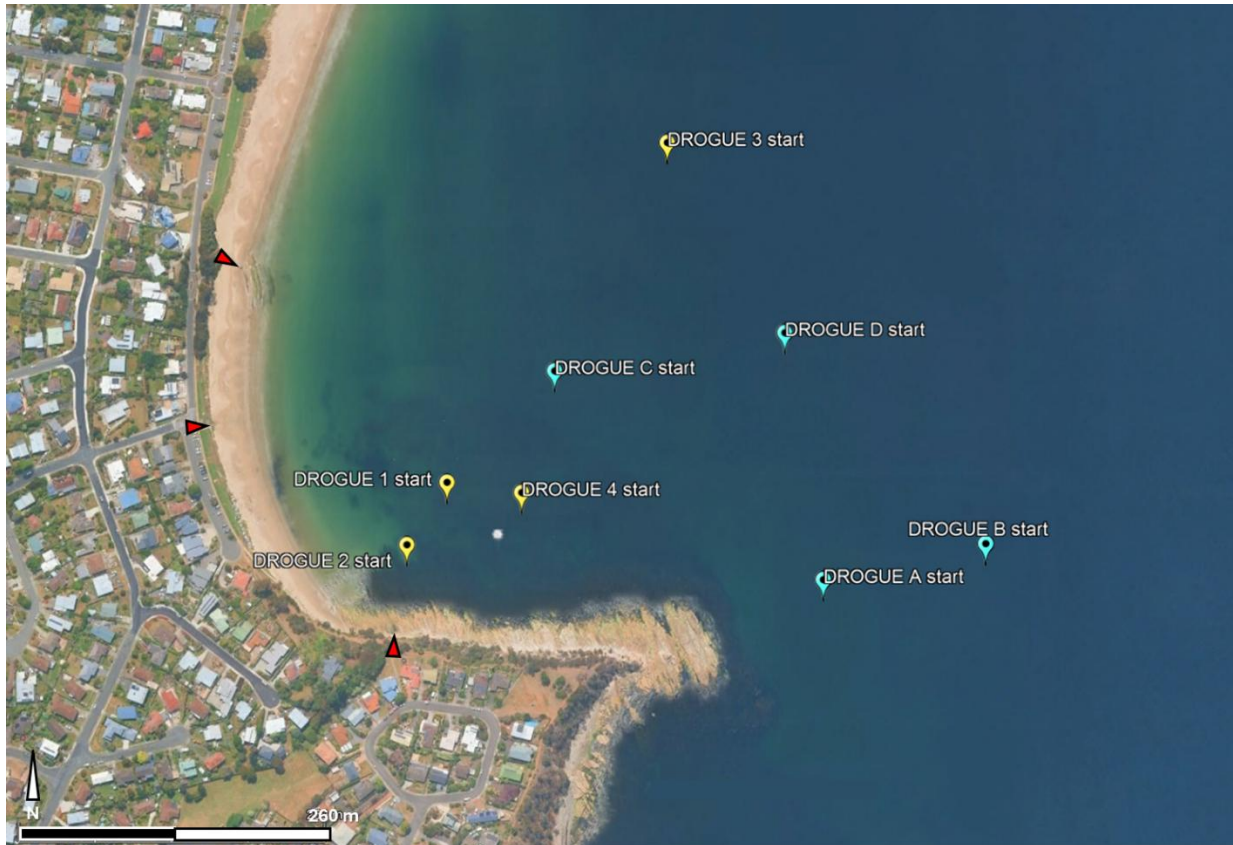
Figure 12. Starting locations of the two different types of drogues deployed in south Blackmans Bay, relative to the three stormwater outfalls in the area (locations marked with red triangles). Deeper water drogues A – D (blue markers) and shallow water drogues 1 – 4 (yellow markers).

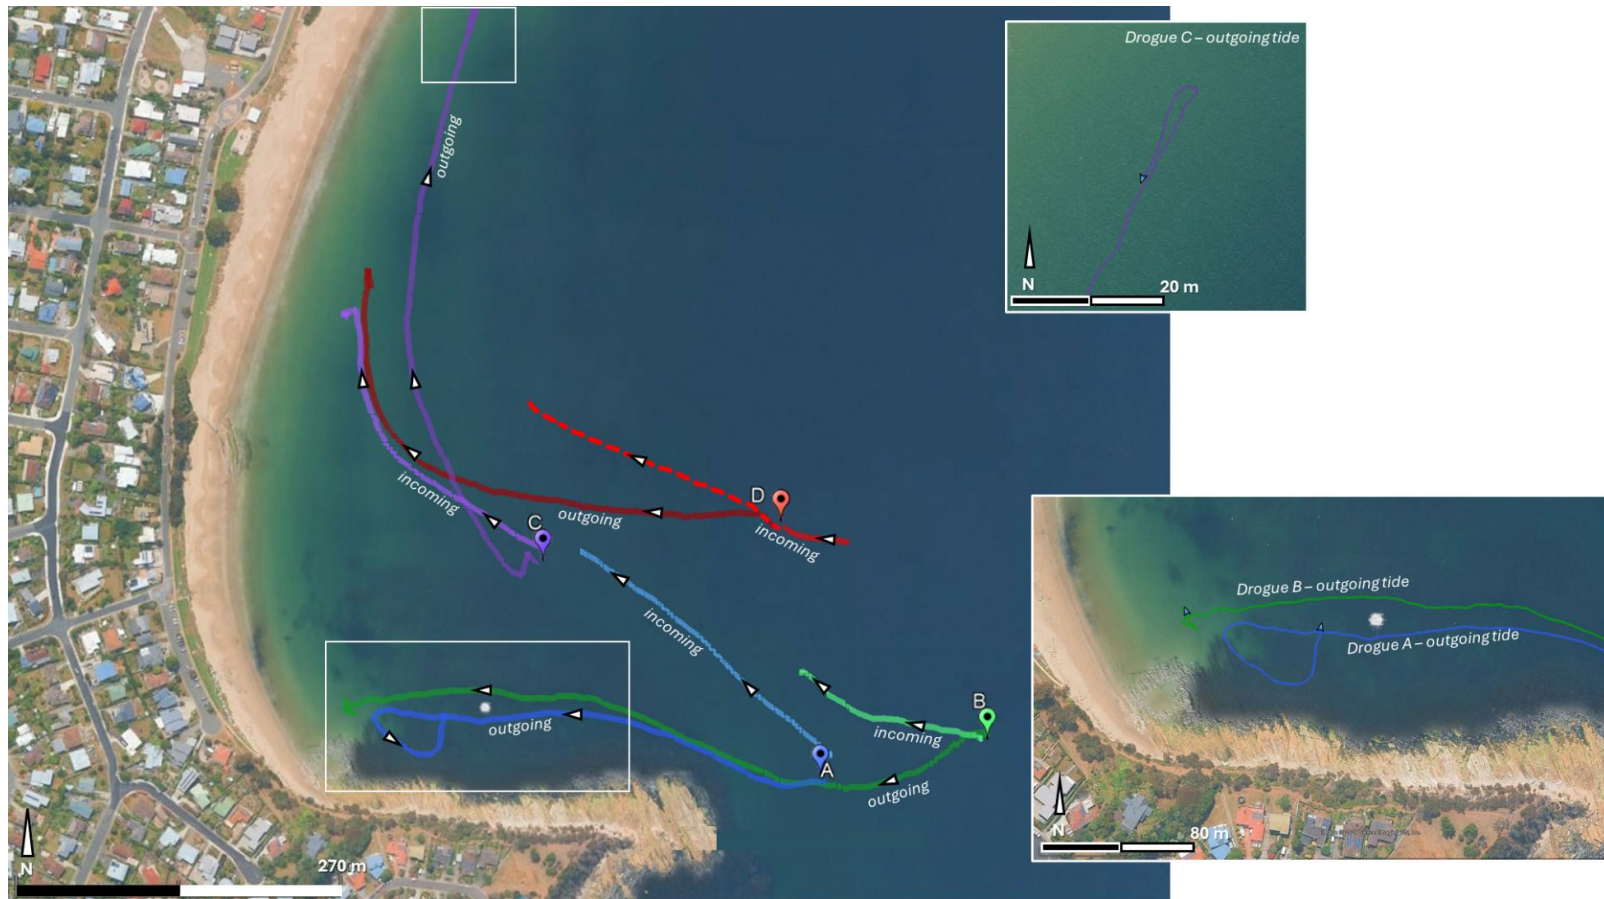
Figure 13. Track logs for four deeper water drogue deployments, from starting points A – D in the outgoing and incoming tide. Drogues were returned to the same starting point for both tides. White arrows show direction of drogue movement, inserts show detail of drogue movement at the end of outgoing tide deployment. Dashed line for drogue D in the incoming tide indicates presumed track of drogue to the recorded end point location (flat battery, track not fully recorded).

In the incoming tide, all four drogues travelled in an approximately north westerly direction, all moving inshore of their starting location (Figure 13). Drogue movement was slightly slower in the incoming tide.

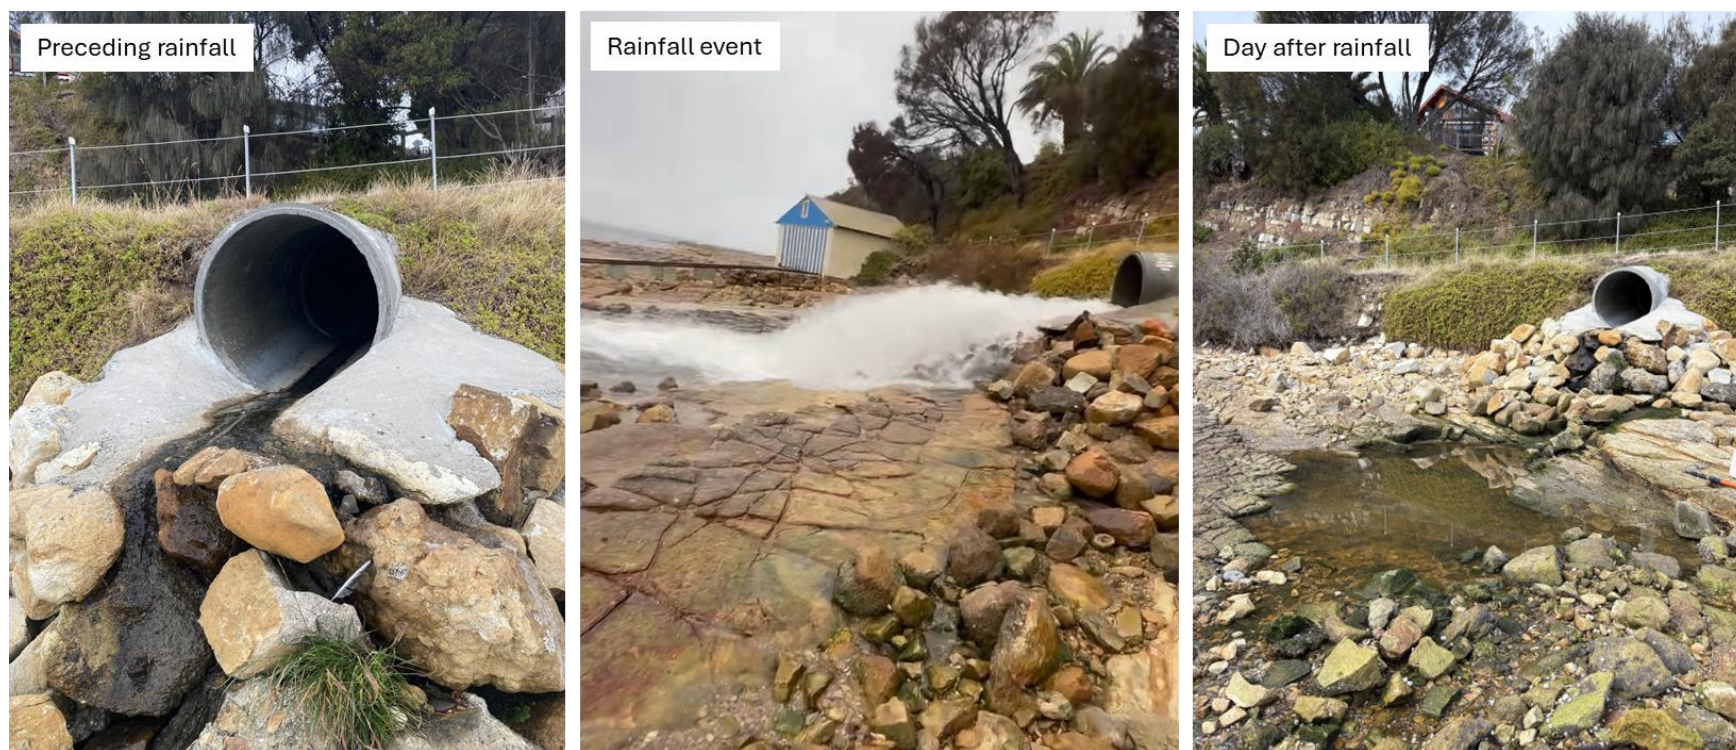
Figure 19. Conditions at the Flowerpot stormwater outfall and rockpool below during the March 2026 water quality sampling event, showing trickling discharge preceding rainfall (on 23 March 2026), high volume discharge during rainfall (24 March 2026) and trickling (minimal) discharge again after rainfall (26 March 2026).

| Sampling event | Rainfall preceding sampling period <sup>3</sup><br><i>Hobart (Dennes Pt)</i> | Total rainfall recorded during event <sup>2</sup><br><i>Hobart (Dennes Pt)</i> | Stormwater observations at the time of sampling |
|---|---|---|---|
| <b>23 – 26 March 2026</b> | 0 mm for 10 days (5 days) | 17.4 mm (20.6 mm) | <ul style="list-style-type: none"> <li>• Stormwater discharging from Mid Beach outfall on all sampling days. High discharge rate and elevated water level at sump on rainfall days.</li> <li>• Stormwater discharging from Illawarra outfall on all sampling days. No pool below Illawarra outfall at start of sampling (23/03), pool present and sampled on all other sampling days (Figure 18).</li> <li>• Stormwater discharging from Flowerpot outfall on all sampling days (Figure 19).</li> </ul> |

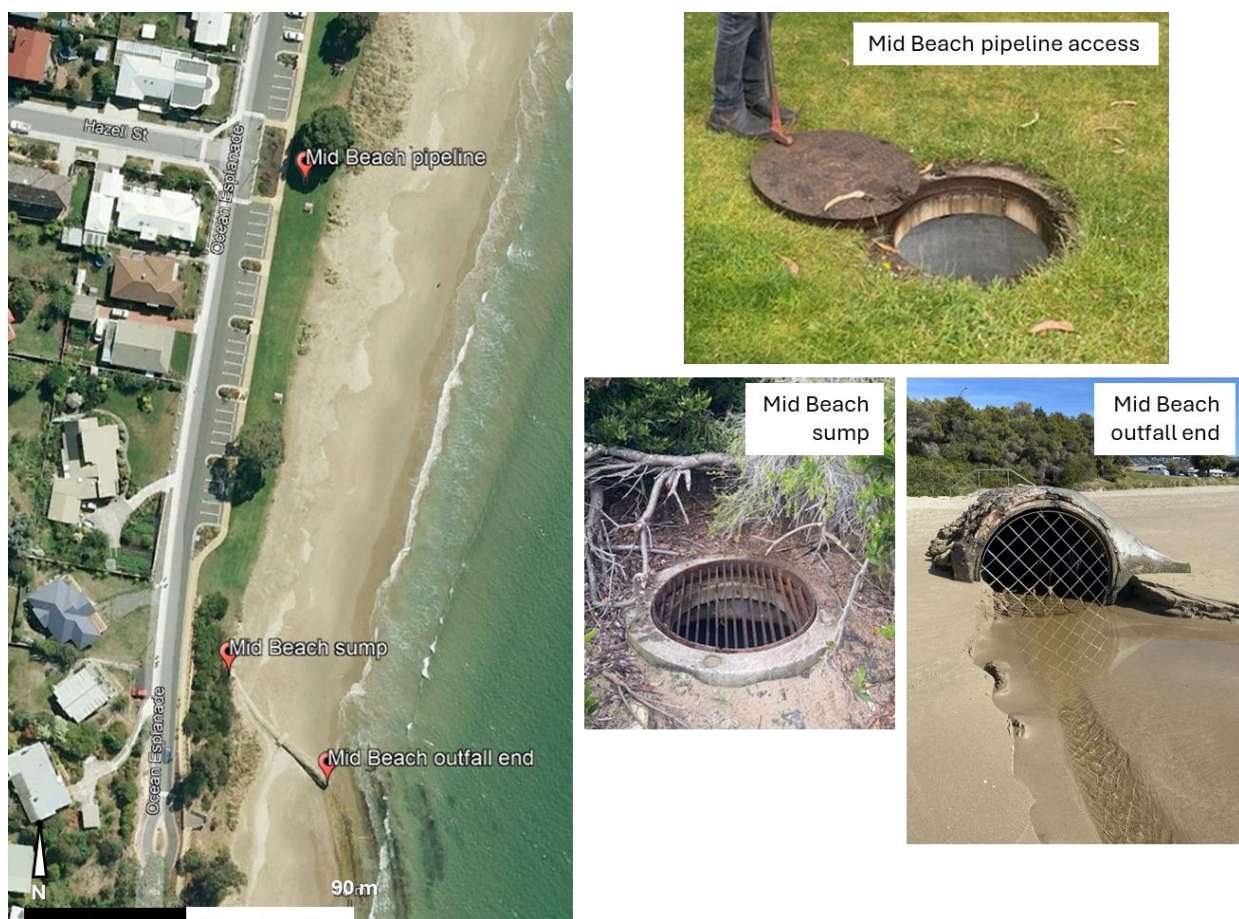
Figure 20. The Mid Beach outfall, showing location of the access point on Ocean Esplanade opposite Hazell Street (Kingborough Council Mid Beach stormwater sampling point), location of sump and the outfall end on the beach.

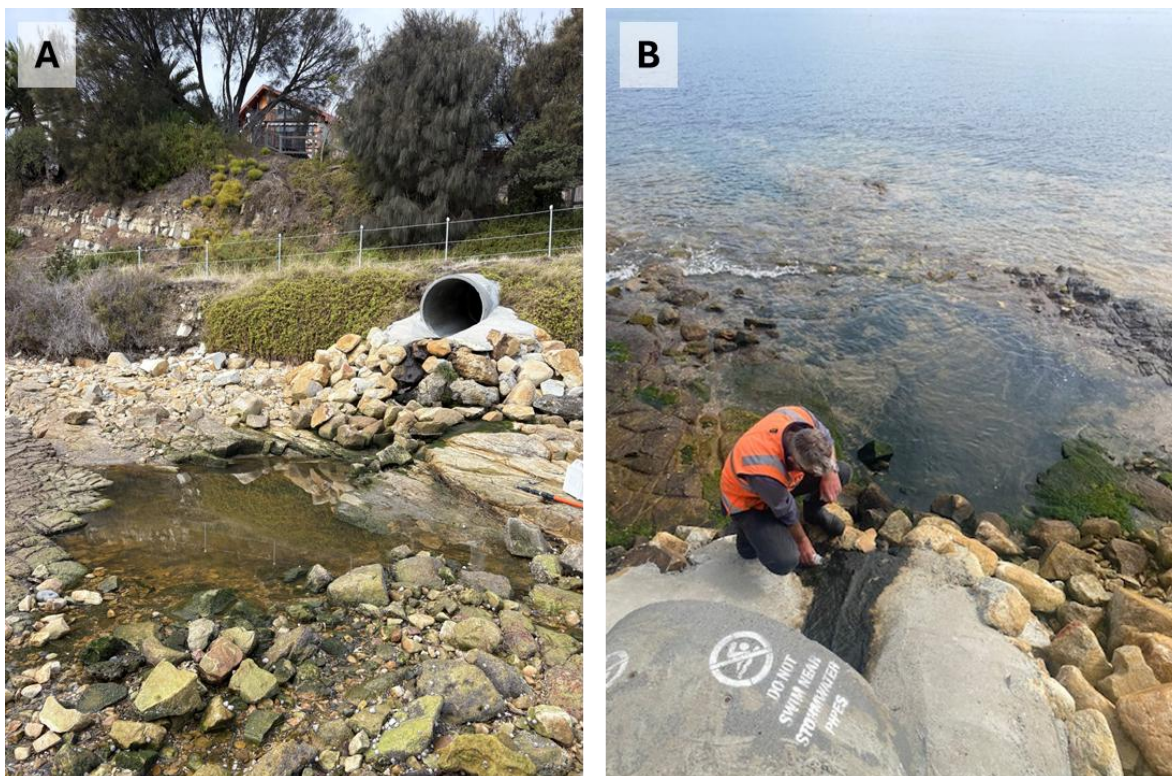
Figure 22. Rockpool below the Flowerpot stormwater outfall at south Blackmans Bay at (A) low tide when isolated from the bay, and (B) mid tide when flushed by seawater. See Figure 2C for image of high tide at this site.

Discharging stormwater at the southern end of Blackmans Bay is also retained in pools below the other two stormwater outfalls (Flowerpot and Illawarra, Figure 1) for periods of time. Stormwater was observed discharging from both the Flowerpot and Illawarra outfalls on every occasion that Marine Solutions visited Blackmans Bay since commencing this study (November 2025 to April 2026), usually as a trickle of stormwater unless following a rainfall event.

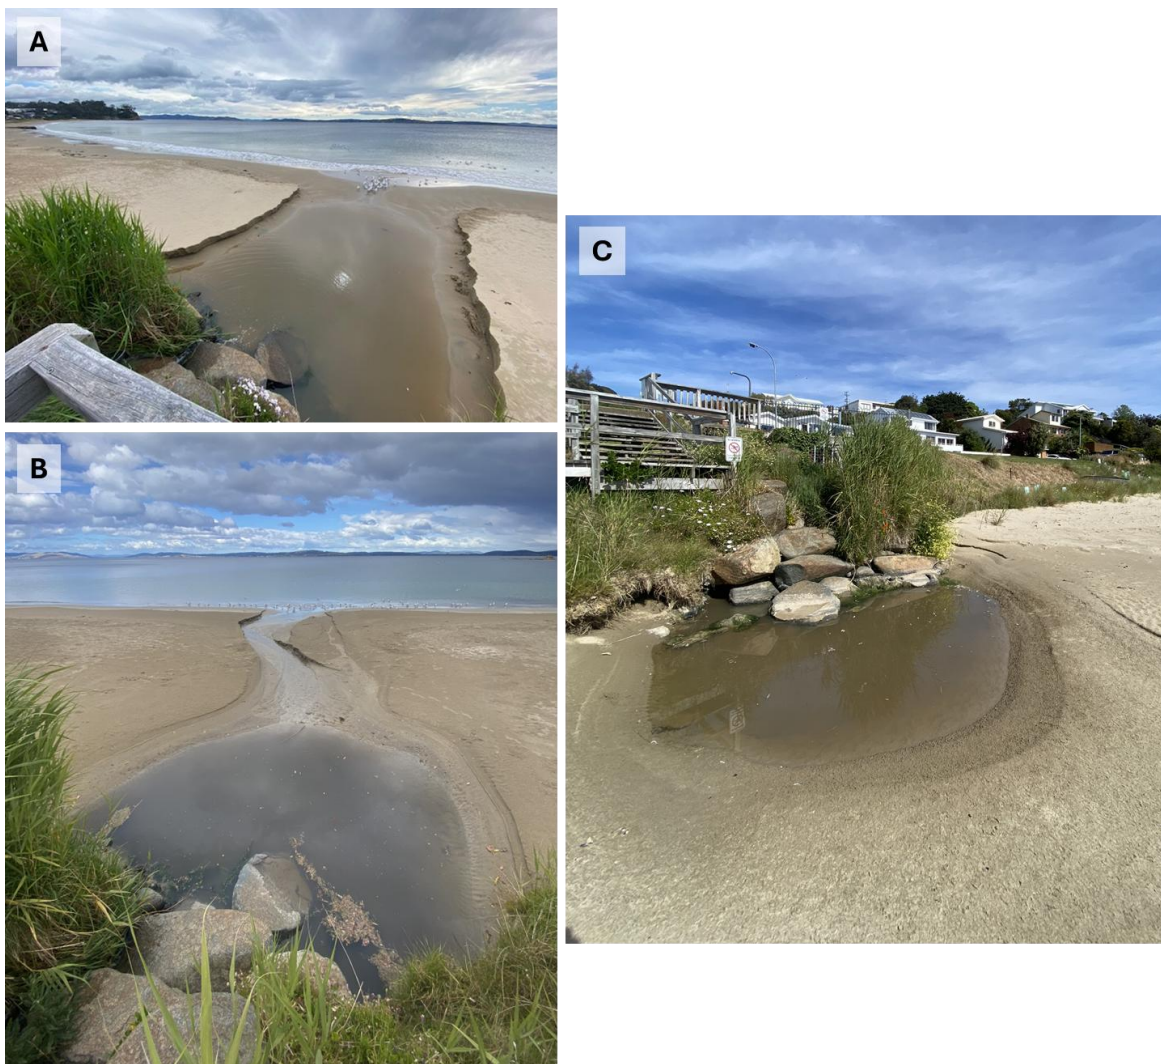
Figure 23. Pool below the Illawarra stormwater outfall at south Blackmans Bay at (A) high tide and high discharge, (B) lower tide and discharge, and (C) low discharge and isolated from the bay.
