## LANDSLIDE RISK ASSESSMENT

### **PROPOSED DRIVEWAY 14 BATCHELORS ROAD - SANDFLY**

**Client:** Lachlan Joyce  
**Certificate of Title:** 134464/1  
**Investigation Date:** Monday, 20 January 2025

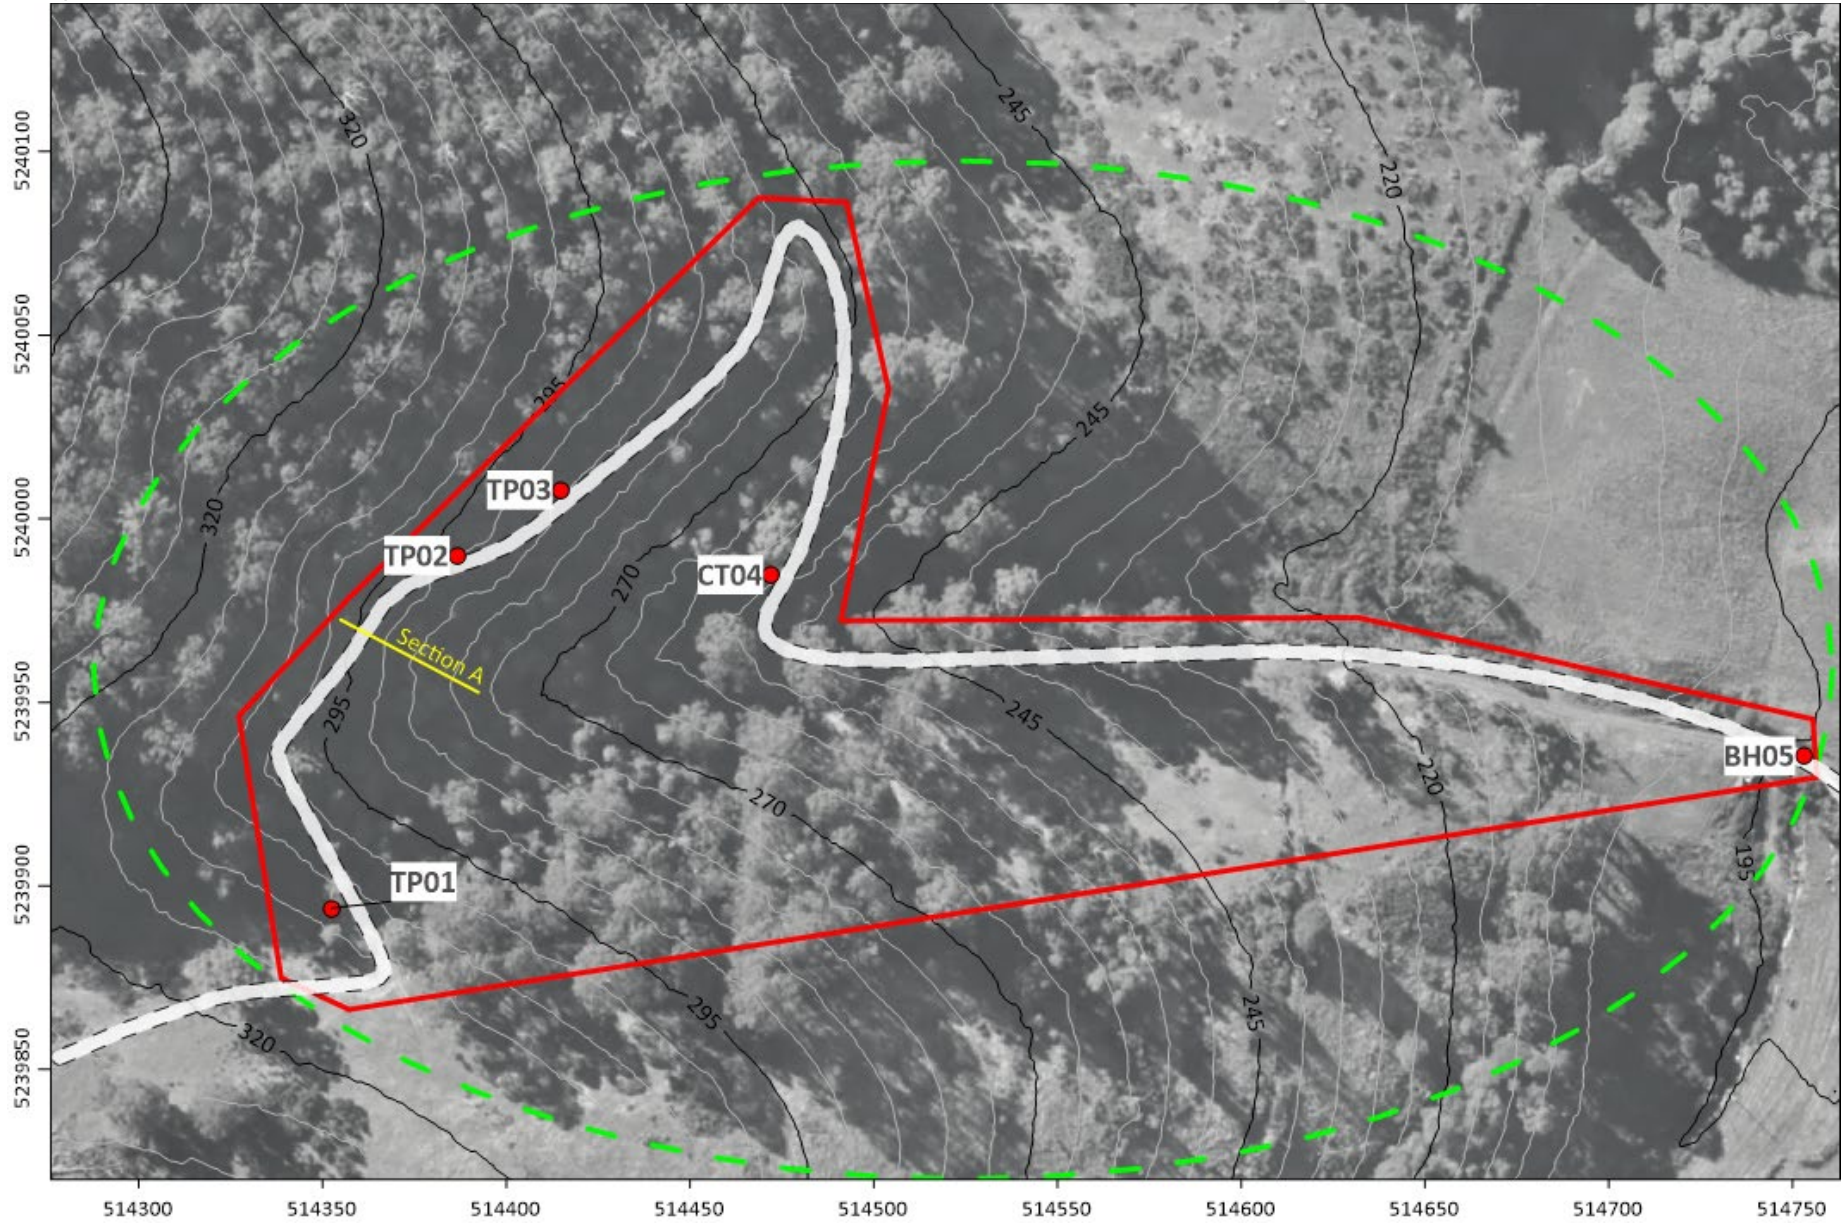
Map 4 Soil testing locations and geotechnical model cross section

Within the lifetime of the proposed works, it LIKELY that the margins of the road near cross Section A and Test Pit TP2 will become unstable and slide. The probability that road will be damaged is inferred to be reduced to POSSIBLE through measures such as preventing water from draining into the FILL (including into tension cracks). Other options may be considered such as road stabilisation works to further reduce the probability, but given to road can be widened into the cut, then the overall consequences (as a proportion of the overall area of the road impacted) may be reduced instead.

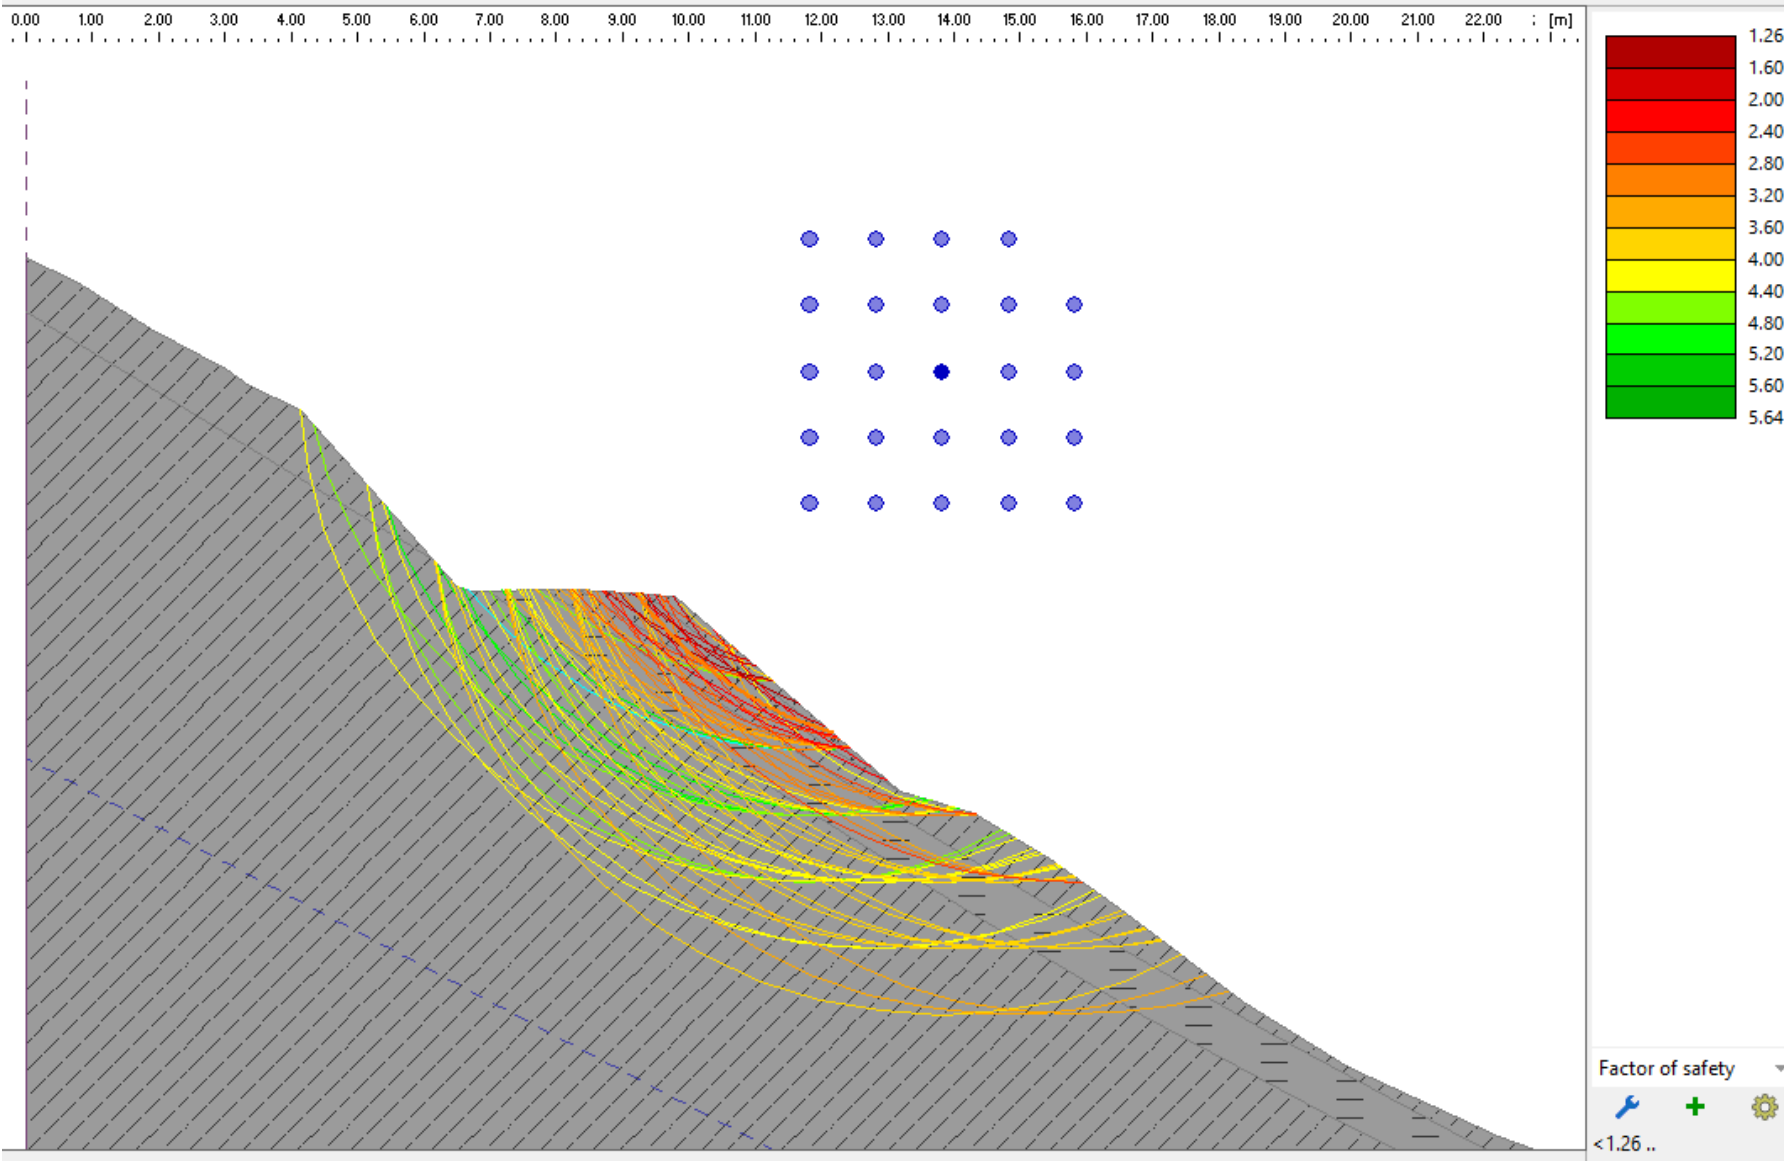
# Attachment 5 Slope Stability Assessment

**Slope stability verification (Bishop)**

Factor of safety =  $1.26 < 1.30$

**Slope stability NOT ACCEPTABLE**
