## GEOTECHNICAL SITE INVESTIGATION

### **4571 BRUNY ISLAND - MAIN ROAD PROPOSED VISITOR ACCOMMODATION**

**Client: Nic Danger**

**Investigation Date: 01/05/2026**

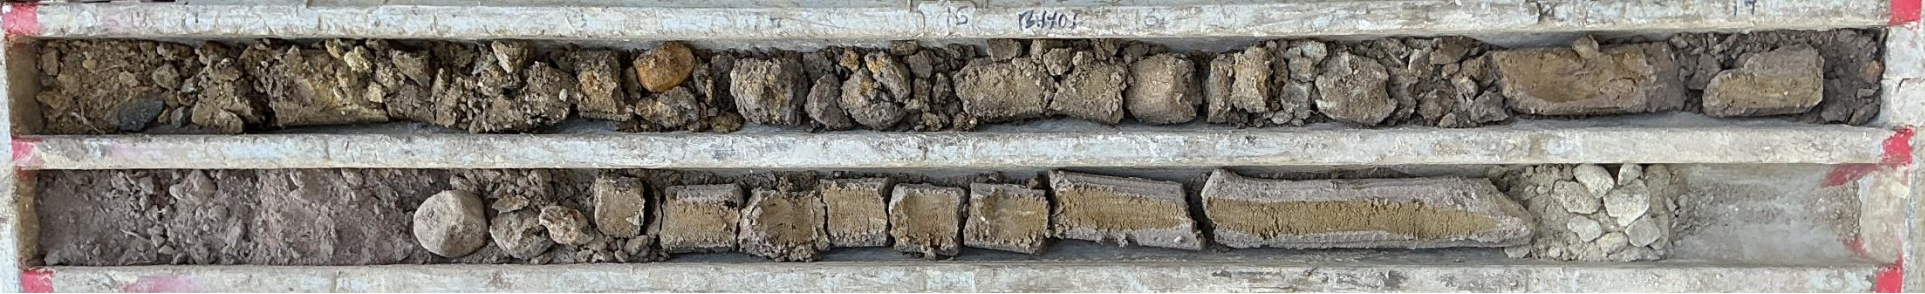
BH01 encountered fill materials extending to approximately 1.0 m depth. The fill profile comprised Clayey GRAVEL with silt and trace sand near the surface, underlain by Silty Sandy CLAY and Sandy CLAY fill containing gravel and sand-sized doleritic material. The fill soils were generally massively structured and ranged from very loose near surface to stiff and very stiff with depth.

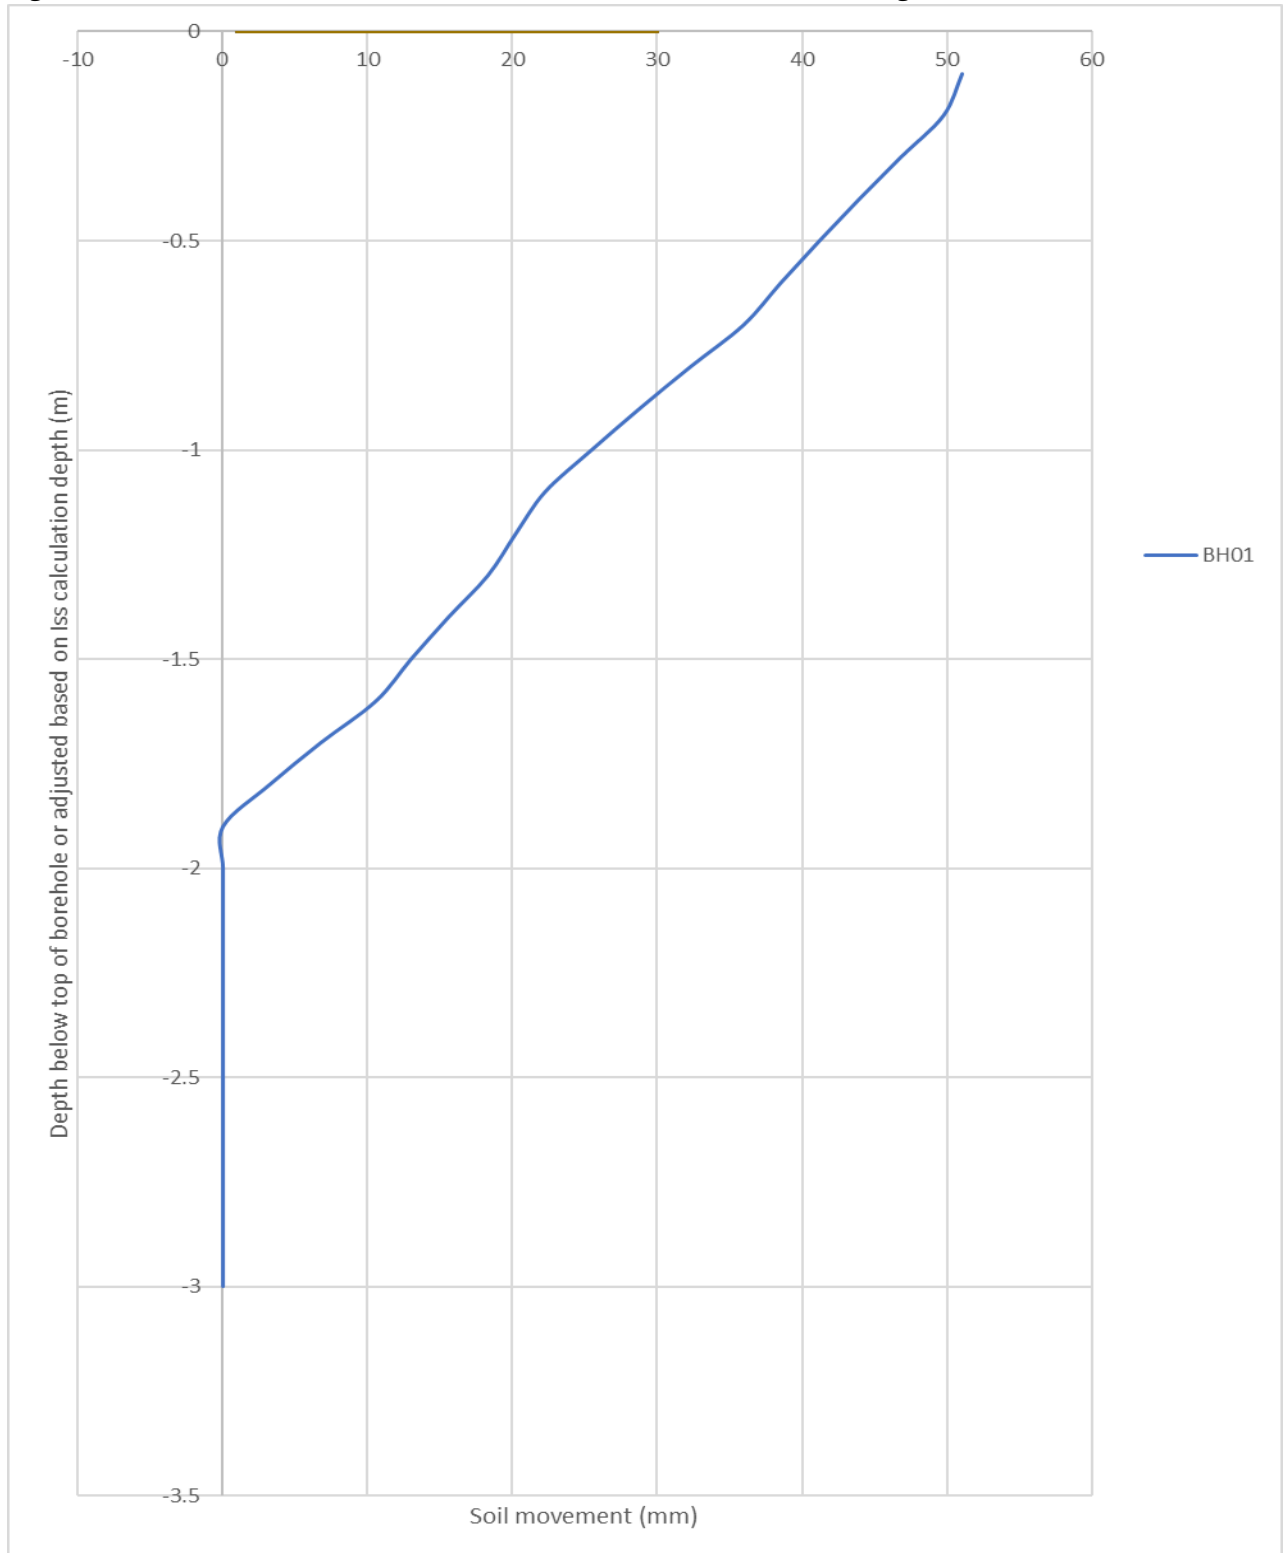
Figure 2 Calculated Characteristic Soil Movement Based on Soil Testing

According to AS 2870 Section 2.3, calculations consider the depth of groundwater and bedrock. Soil characteristic movements based on lab testing are presented in Figure 2.
