Preliminary Arboricultural Report

Homes Tasmania

**47 Summerleas Road,
Kingston, 7050, TAS**

Tree Pioneers Pty Ltd
ABN: 15 687 986 876
Franklin,
Tasmania, 7113

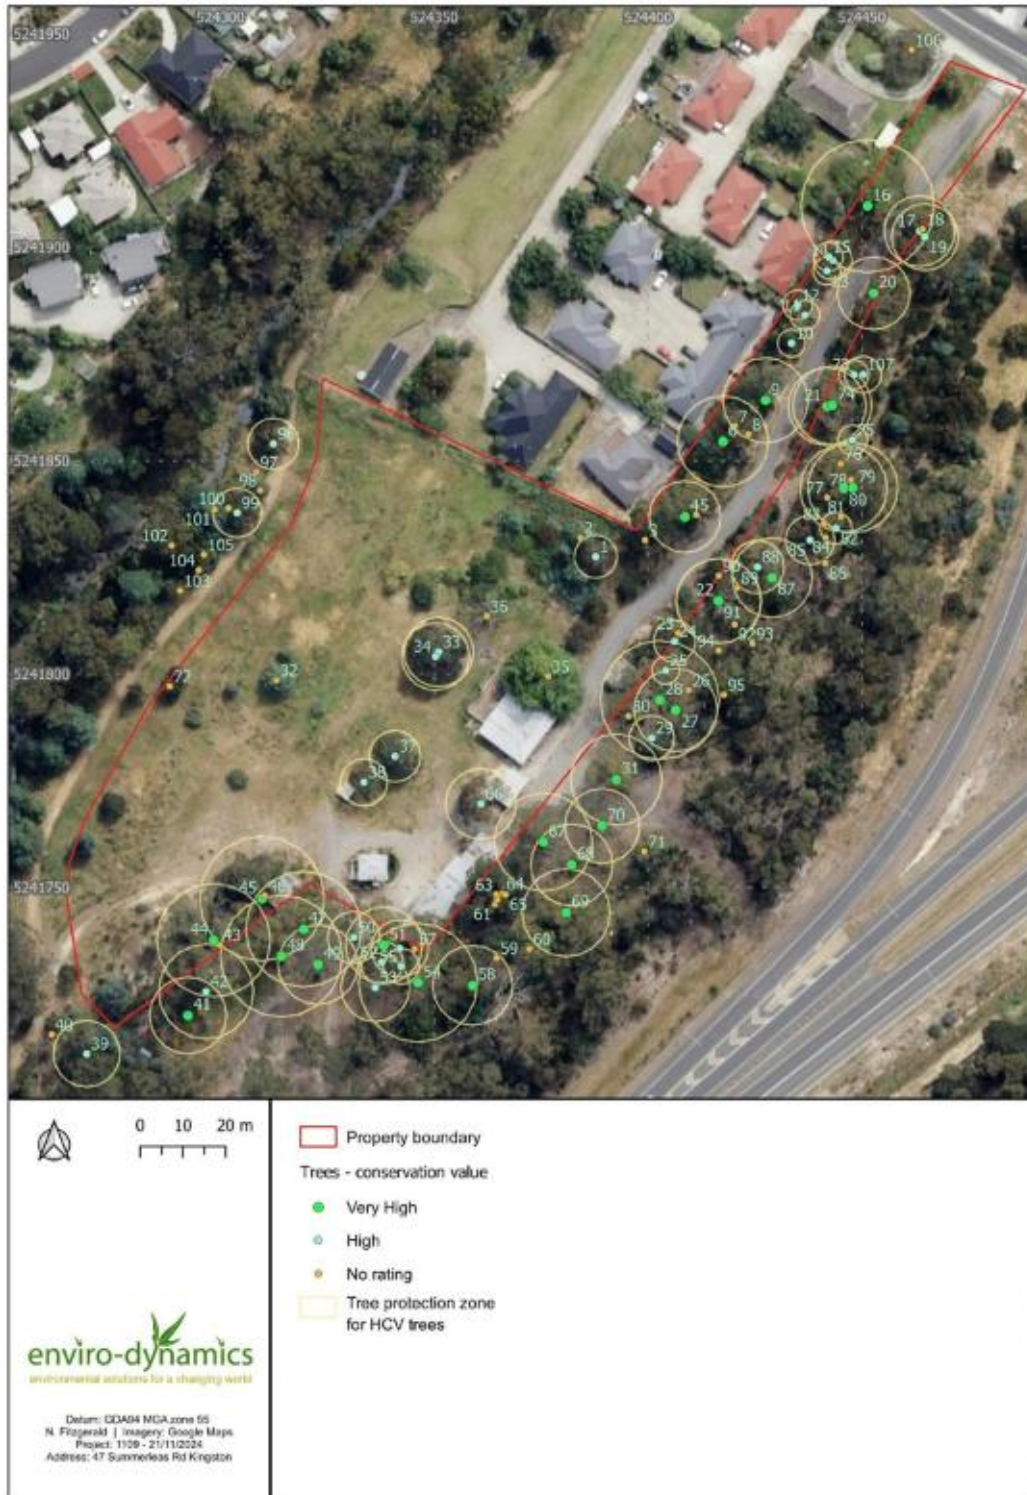
Figure. 1 Map of site with tree numbers and TPZ. Map provided by Enviro-Dynamics.

The site is in the municipality of Kingborough. The site is at 47 Summerleas road, Kingston. There is a proposed development to the site. There are plans to build 26 units. There are 107 trees within 15m of the proposed development. The site is a vacant block with an existing access road. The trees appear to be accustomed to the access road. Map (Figure 1) shows dwellings which are not present.
