ARBORICULTURAL IMPACT ASSESSMENT

UPGRADE OF EXISTING VEHICLE ACCESS

BULK EARTH WORKS IN TREE ROOT ZONES

283 SANDFLY ROAD  
MARGATE 7054

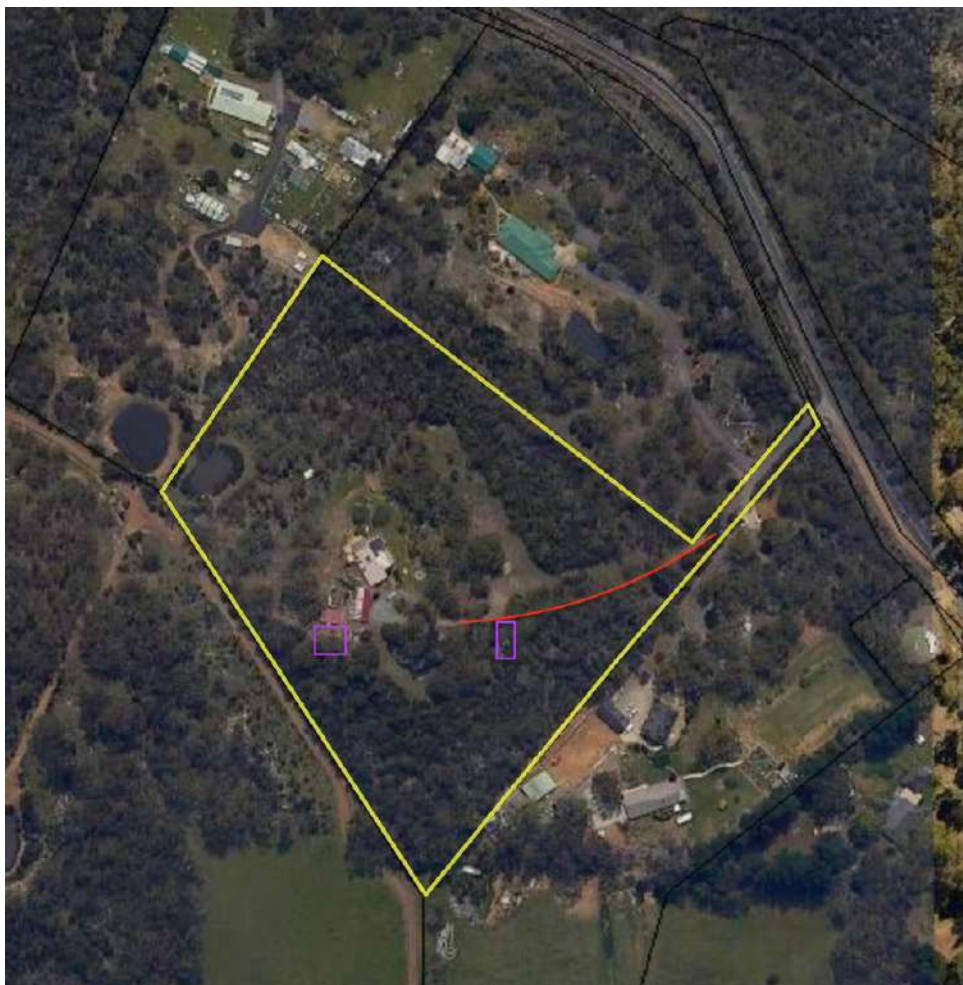
**Figure 1:** The site at 283 Sandfly Rd, Margate. The survey route along the vehicle access is indicated by the red line and the areas of fill to be retrospectively assessed are indicated by the mauve rectangles (Source –[www.maps.thelist.tas.gov.au](http://www.maps.thelist.tas.gov.au))

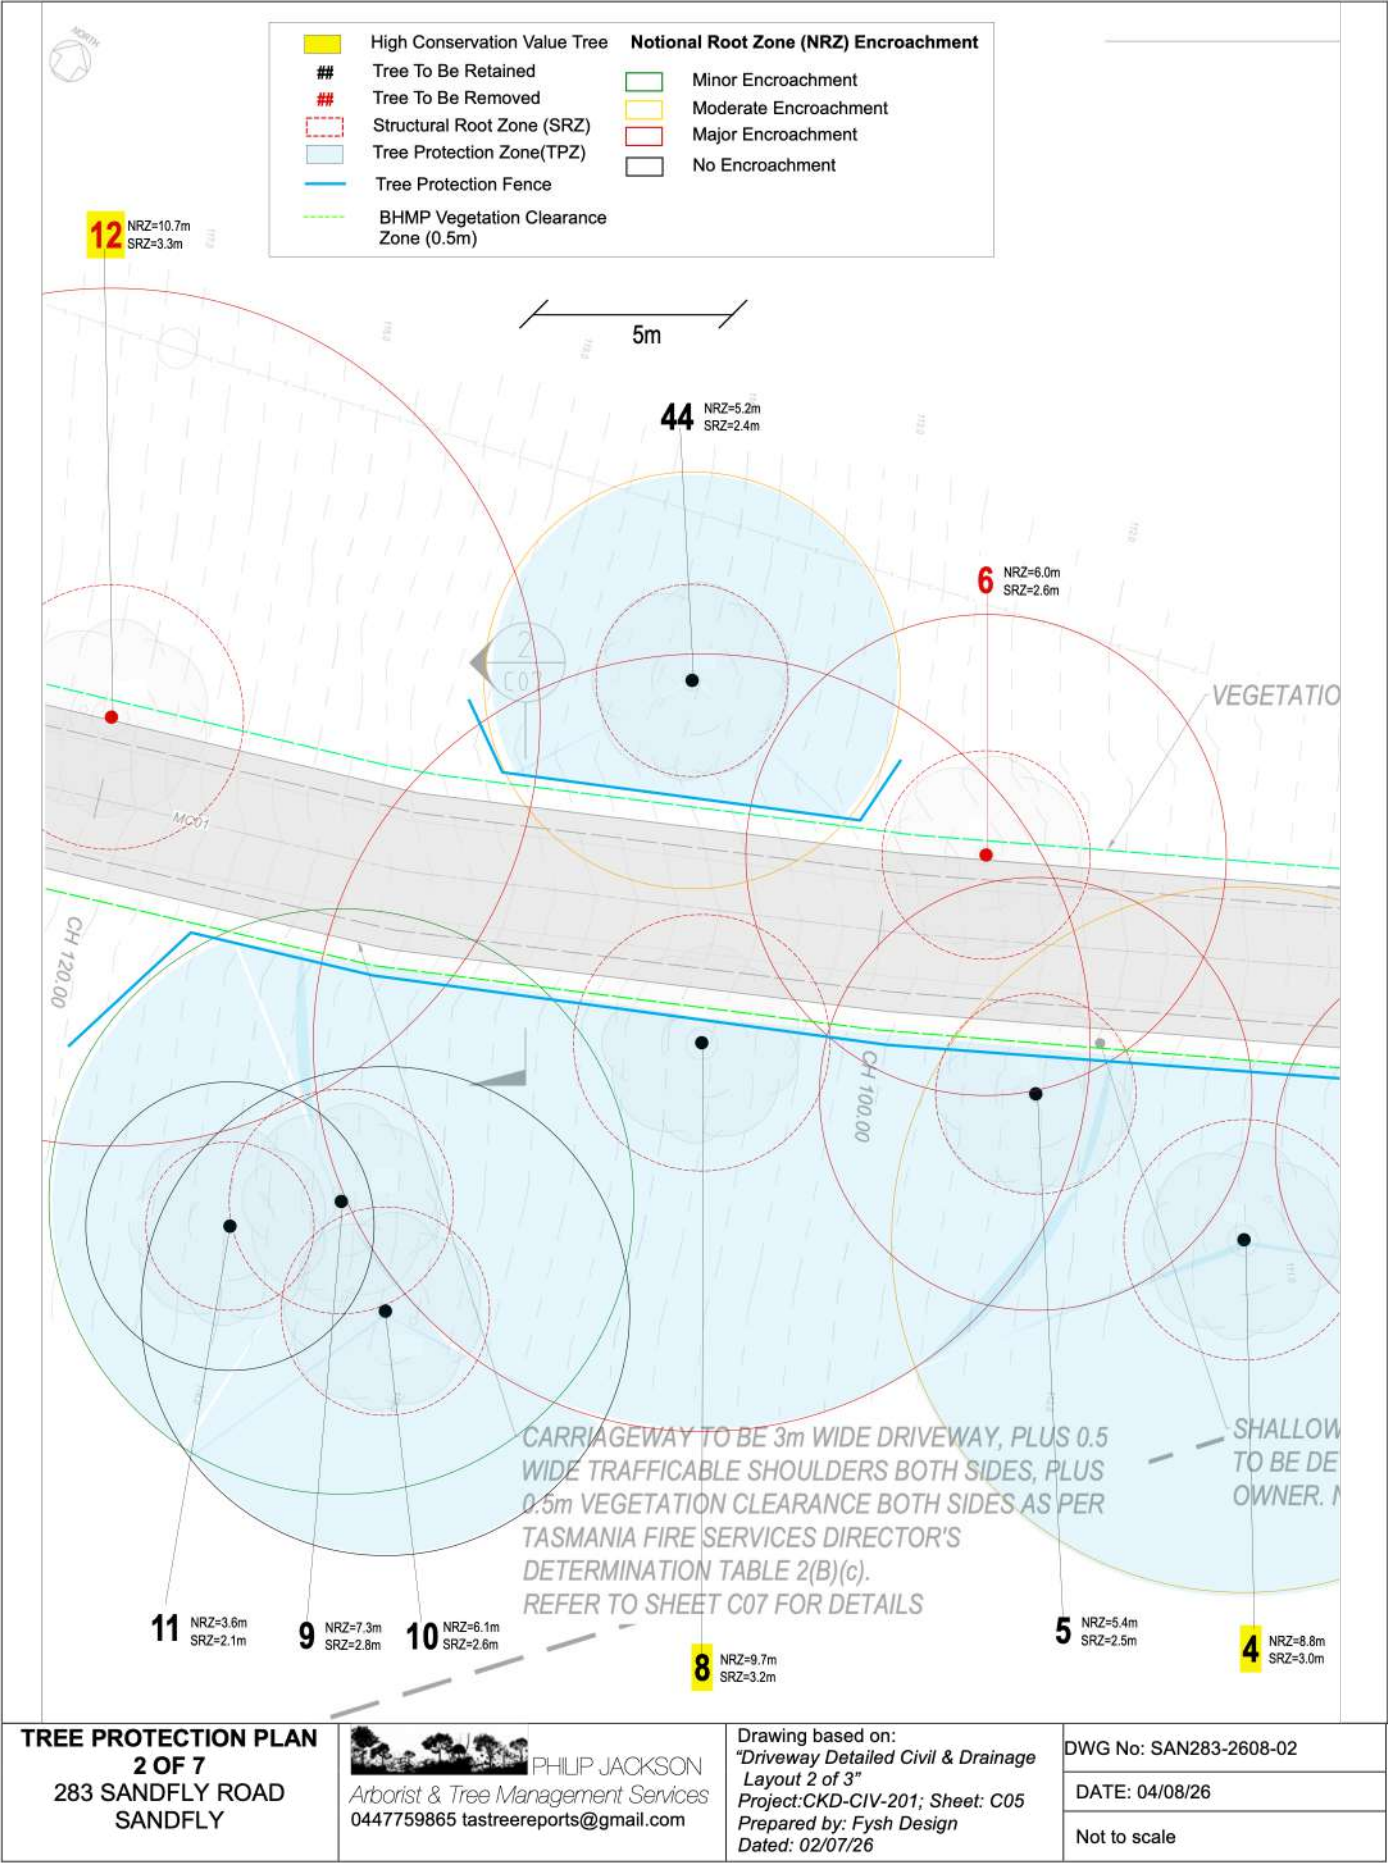
- 5.2.2.1 The proposed upgrade of the existing access will result in a notionally **unacceptable** level of encroachment on the NRZ area of HCV tree **8** as well as trees **3, 5, 16, 17, 18, 22, 23 & 31** including works within their Structural Root Zones (SRZ). Surface disturbance, excavation & compaction associated with typical vehicle access demolition, upgrade & sealing works will likely sever/damage significant absorbing & structural roots resulting in an **unacceptable** adverse impact & potential instability of these trees. However it is likely that the proposed works can be successfully achieved with tolerable long term impact if appropriate protective measures are properly implemented and controlled in accordance with the tree protection measures outlined in with **sub-item 6.4.2 & item 6.6** of the **Tree Protection Specification (TPS)** presented in **Section 6** of this document.
