# **PRELIMINARY LANDSLIDE RISK ASSESSMENT**

**283 Sandfly Road, Margate, TAS, 7054**

**02 June 2024**

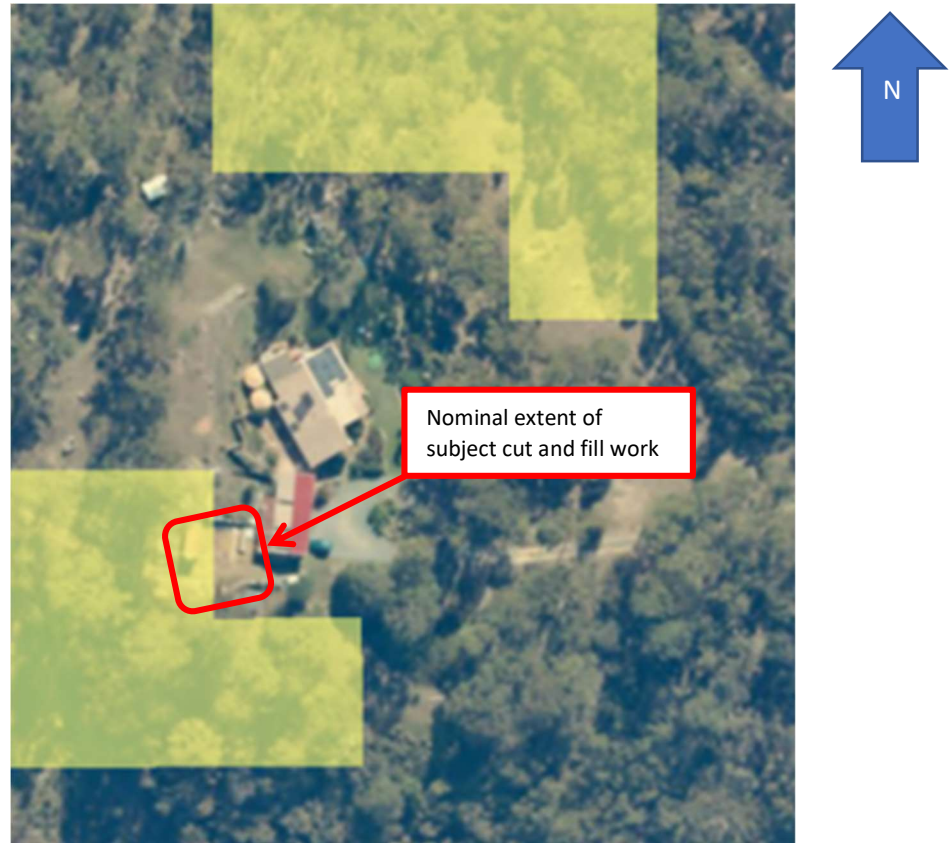
**Figure 1** – *ListMap* aerial imagery of the Owners’ property. Subject area of cut and fill works highlighted. Low hazard band from Landslide Planning Map shown yellow.
