LANDSLIDE RISK ASSESSMENT

Proposed Dwelling

13 Coop Court
Kingston,
TAS
7050

SJM Property Developments
(Aus) Pty Ltd

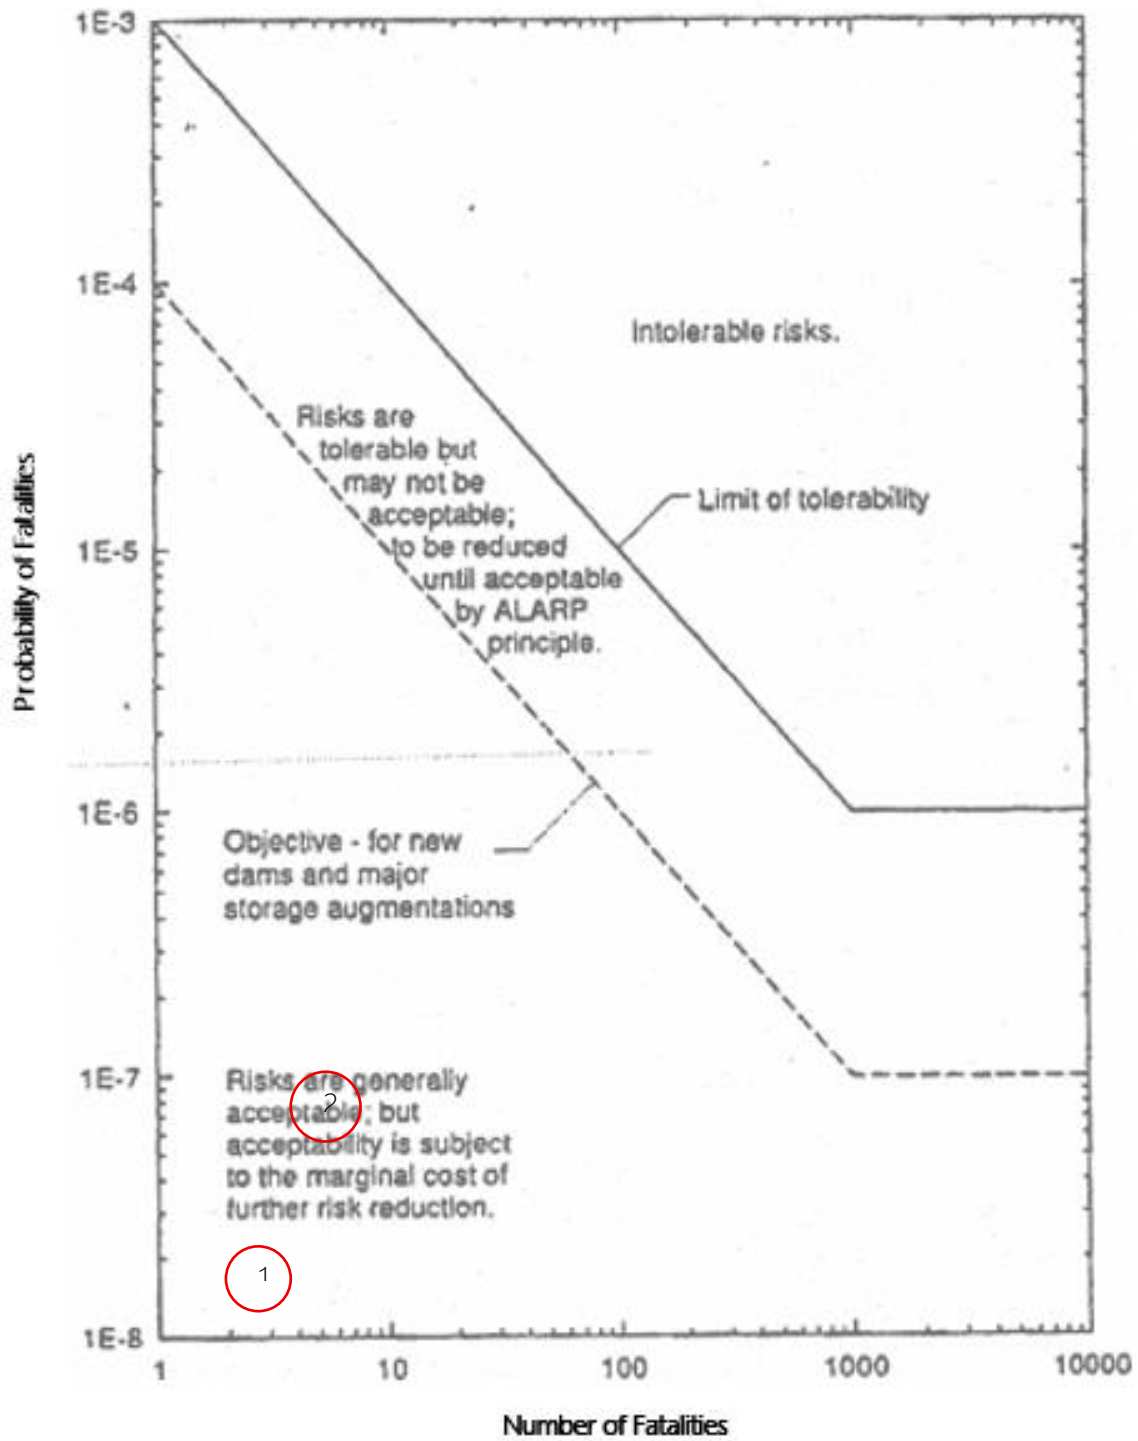
Figure 7 Societal Risk Graph of Probability of Fatalities vs Number of Fatalities (ANCOLD 1998)

The Societal Risk Graph plot presented in Figure **Error! Reference source not found.** showing the estimated individual risks for scenarios 1 and 2 as presented in Figure 6 (outlined in the AGS 'Landslide Risk Management Concepts and Guidelines', 2000). The risks are estimated based on people in the structure spending up to 12 hours per day in internal areas the property.
